# **NASA completes investigation of July 2014 Terrier-Improved Malemute sounding rocket failure**

January 13 2015, by Keith Koehler

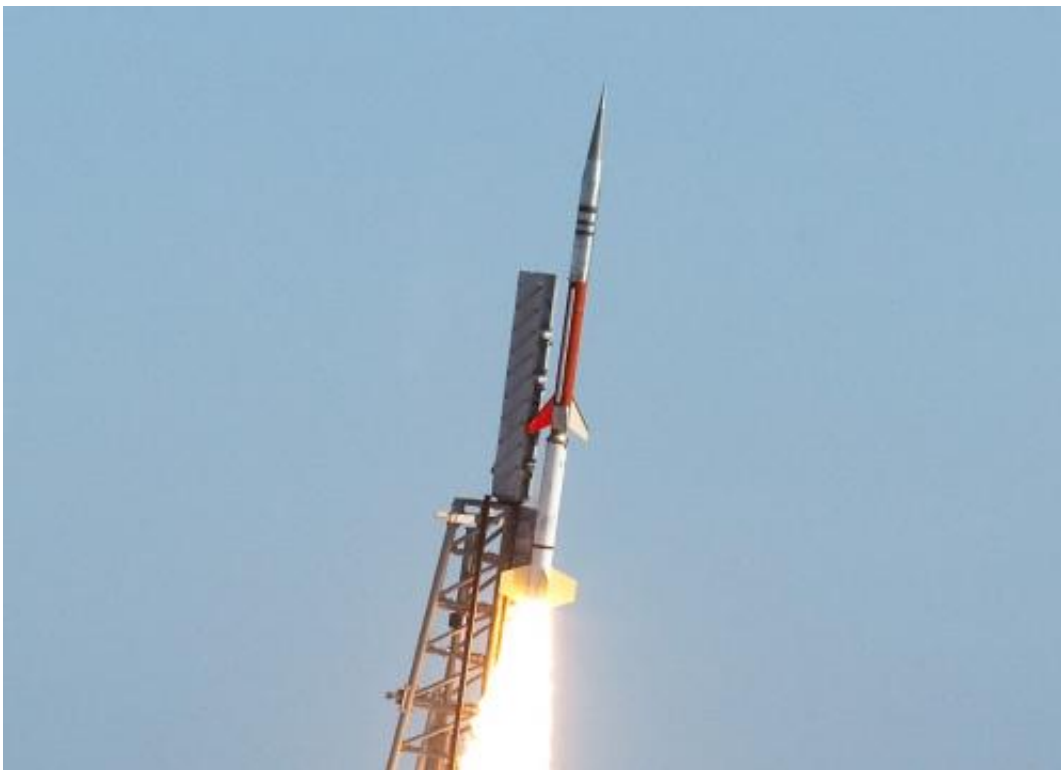
File photo of a Terrier-Improved Malemute sounding rocket. Credit: NASA
