Structural, regulatory and human error were factors in Washington highway bridge collapse

August 26 2016

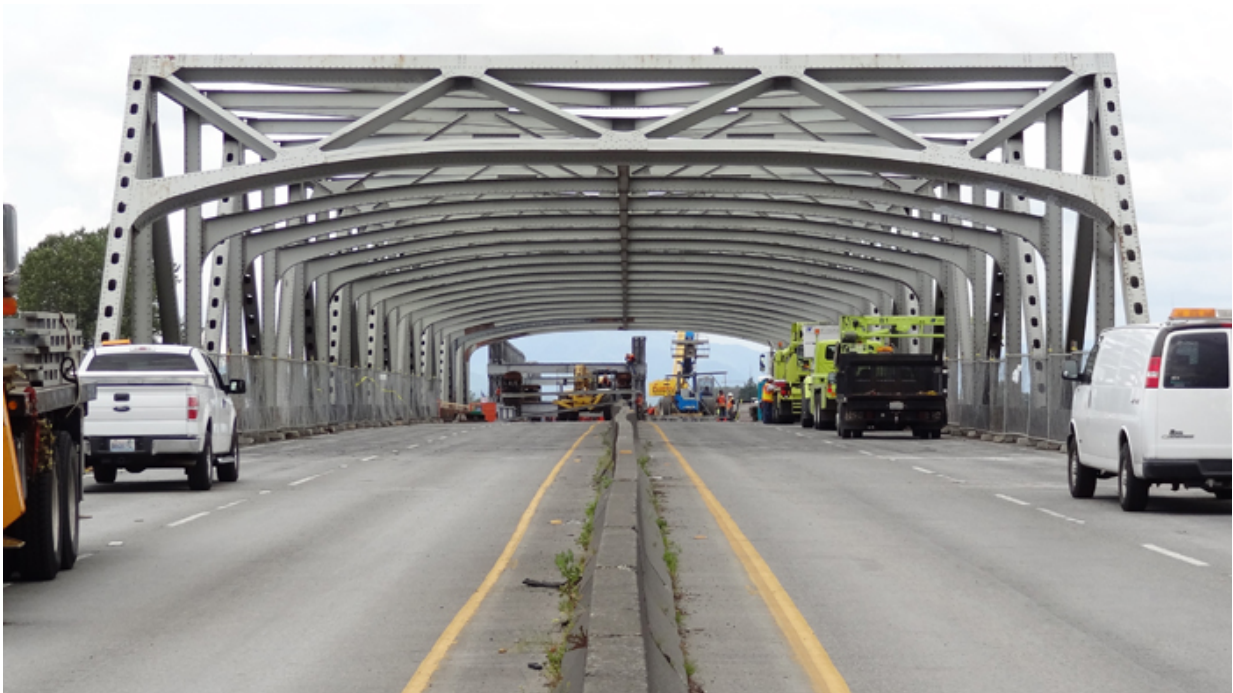
A key factor in the crash was the curved opening of the bridge. The posted height was the maximum in the center, not the lower curved section above the outer lanes, which the truck hit. Credit: Tim Stark

How did an oversized vehicle receive a permit for a bridge with lower clearance than its height? Inaccurate record-keeping, Stark said. The opening of the bridge was curved, so that the clearance over the far lanes was lower than the clearance in the center lanes. However, the Washington Department of Transportation only keeps the maximum clearance in its bridge database, which is used to issue permits for oversized vehicles.

"The key issue in this case is the variable vertical bridge clearance," Stark said. "Many bridges have a square opening, so the clearance is the same across all lanes. The problem with this bridge was that it curved down over the edge lanes. The oversized trailer was 15 feet 9 inches tall. The database said the bridge was 17 feet 3 inches, which was in the center - almost two feet higher than the edges, which is where the oversized trailer was traveling."

Benekohal recommended that other states adopt the Illinois Department of Transportation's policy of reporting the lowest vertical clearance of a bridge, rather than the highest, and its periodic use of LIDAR to verify clearance numbers, which can be affected by repavement, snow or other factors.
