## **Repair Costs of Seismic Test House Could Have Been Prohibitive**

December 22 2006

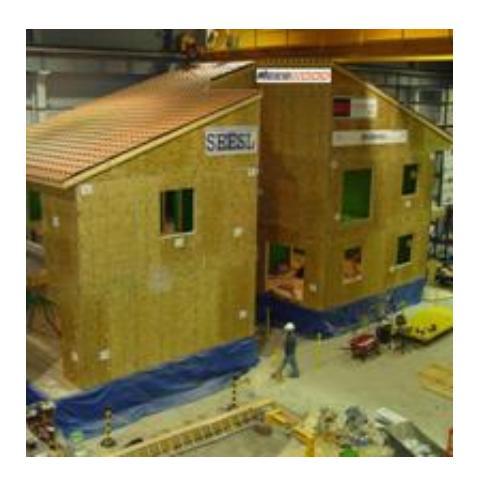
A two-story, 1,800 square-foot, fully furnished townhouse was built and placed inside the lab on two moveable, piston-powered shake tables, among the largest of their kind in the United States. Engineers and researchers jolted, shook and rattled the house in a series of five mock earthquakes that grew in size and magnitude. Credit: Texas A&M University
