# Draft NIST report on Cowboys facility collapse released for comment

October 6 2009

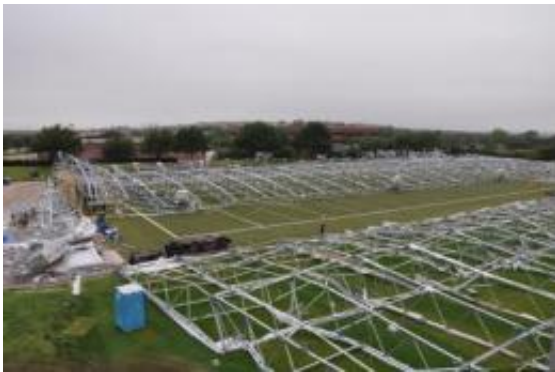
This is an overall view of the collapsed Dallas Cowboys practice facility after the fabric covering was removed. Credit: NIST

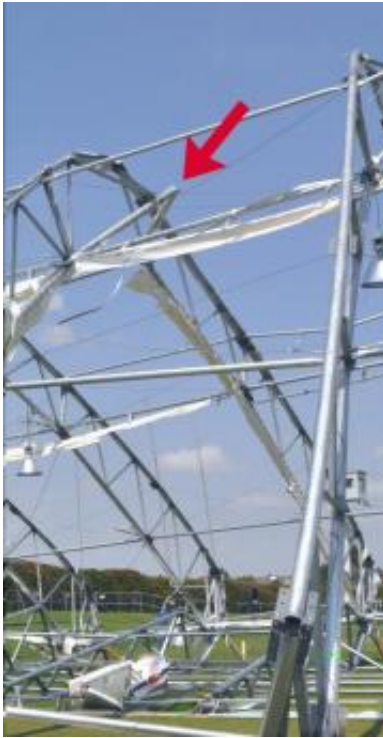
The buckling of the steel frame of the Dallas Cowboys practice facility is seen in the upper left of the photograph (marked by arrow). Credit: NIST

- Buckling of the inner chord (inner side of the roof truss) of a frame in a section of the roof on the east side resulted in the formation of a kink in the frame.
- Failures of the east and west "knees" (connections between the side walls and the roof) allowed the frame to sway eastward with the wind.
- Compressive failure of the east side at the roof's highest point (ridge) led to fractures of the nearby inner and outer chords in the vicinity of the ridge.
- A progression of frame failures throughout the structure resulted in total structural collapse.
