Structural, regulatory and human error were factors in Washington highway bridge collapse

August 26 2016

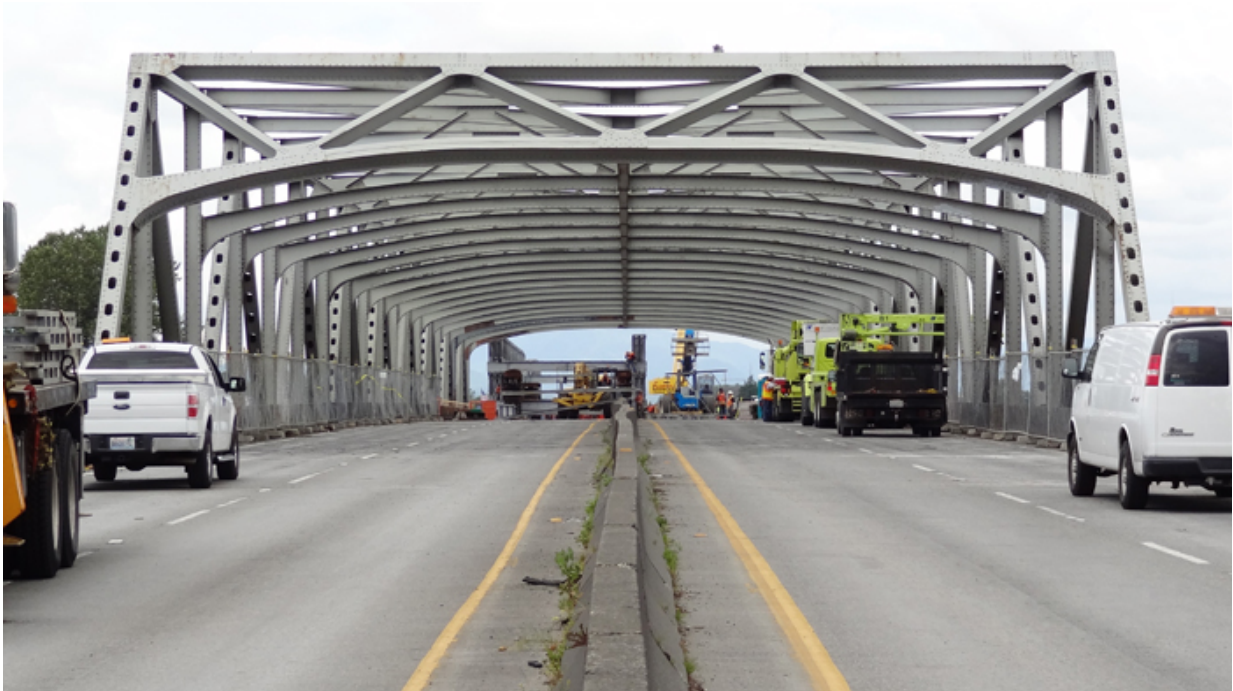
A key factor in the crash was the curved opening of the bridge. The posted height was the maximum in the center, not the lower curved section above the outer lanes, which the truck hit. Credit: Tim Stark

How did an oversized vehicle receive a permit for a bridge with lower clearance than its height? Inaccurate record-keeping, Stark said. The opening of the bridge was curved, so that the clearance over the far lanes was lower than the clearance in the center lanes. However, the Washington Department of Transportation only keeps the maximum clearance in its bridge database, which is used to issue permits for oversized vehicles.

"The key issue in this case is the variable vertical bridge clearance," Stark said. "Many bridges have a square opening, so the clearance is the same across all lanes. The problem with this bridge was that it curved down over the edge lanes. The oversized trailer was 15 feet 9 inches tall. The database said the bridge was 17 feet 3 inches, which was in the center - almost two feet higher than the edges, which is where the oversized trailer was traveling."

The structural analysis revealed that the impact to the second cross-frame, rather than the first, caused so much damage because the way it

twisted pulled down the top of the [bridge](#) truss, which in turn caused the entire structure to fail.

Benekohal recommended that other states adopt the Illinois Department of Transportation's policy of reporting the lowest vertical clearance of a bridge, rather than the highest, and its periodic use of LIDAR to verify clearance numbers, which can be affected by repavement, snow or other factors.

"I think one of the interesting things about this failure is that the initial damage of where the truck hit was not a primary support, it was a cross beam, and the damage cascaded, causing the entire collapse," LaFave said. "We then looked at ways to reinforce bridges with this design, to increase the capacity and reduce the chance of this kind of failure occurring. We can selectively add supports so there are ways to redistribute the impact load, so the structure can remain stable and stay standing even if there's damage to a particular area."
