Spectacular video captures catastrophic SpaceX Falcon 9 rocket explosion during prelaunch test

September 2 2016, by Ken Kremer

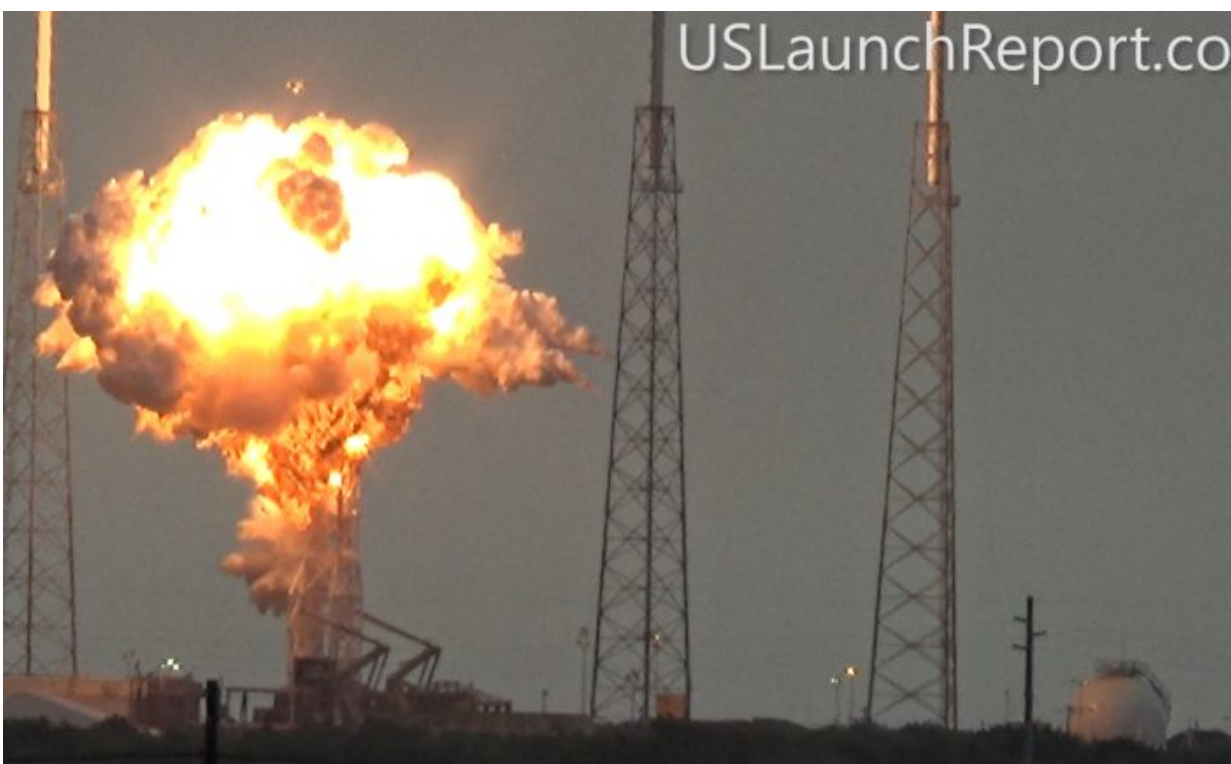
SpaceX Falcon 9 rocket moments after catastrophic explosion destroys the rocket and Amos-6 Israeli satellite payload at launch pad 40 at Cape Canaveral Air Force Station, FL, on Sept. 1, 2016. A static hot fire test was planned ahead of scheduled launch on Sept. 3, 2016. Credit: USLaunchReport

As seen in the still image above and the full video below, the rocket failure originated somewhere in the upper stage.

"Originated around upper stage oxygen tank. Cause still unknown. More soon."
