Brumadinho dam collapse: The danger emerged after the decommissioning, study reveals

January 16 2024, by Benedikt Vogel

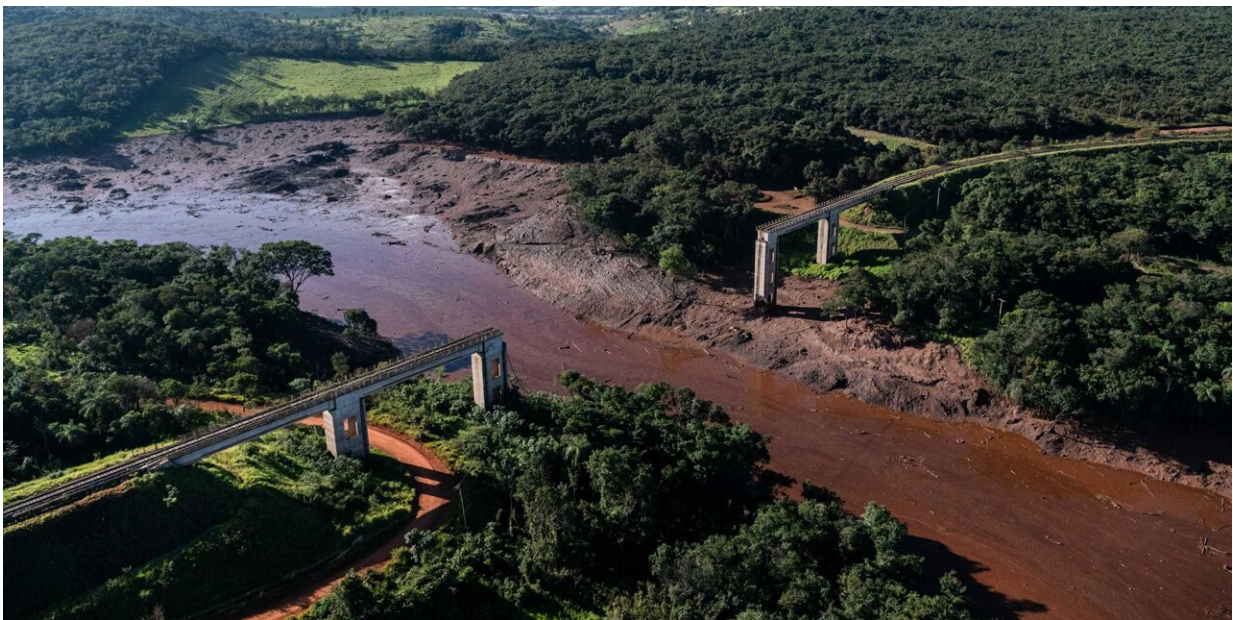
The mudslide came without warning and destroyed the mine site, neighbouring settlements and a railway bridge, killing 270 people. Credit: Eric Marmor / IDF Spokesperson, CC BY-SA 3.0, Wikimedia Commons

A huge mudslide of about 10 million cubic meters of liquefied tailings flooded the site of the mine, destroying neighboring settlements and taking a railway bridge with it. At least 270 people were killed. The ecosystem of the Paraopeba River downstream of the mine was ruined. Although the dam had a monitoring system, no one had foreseen the disaster.

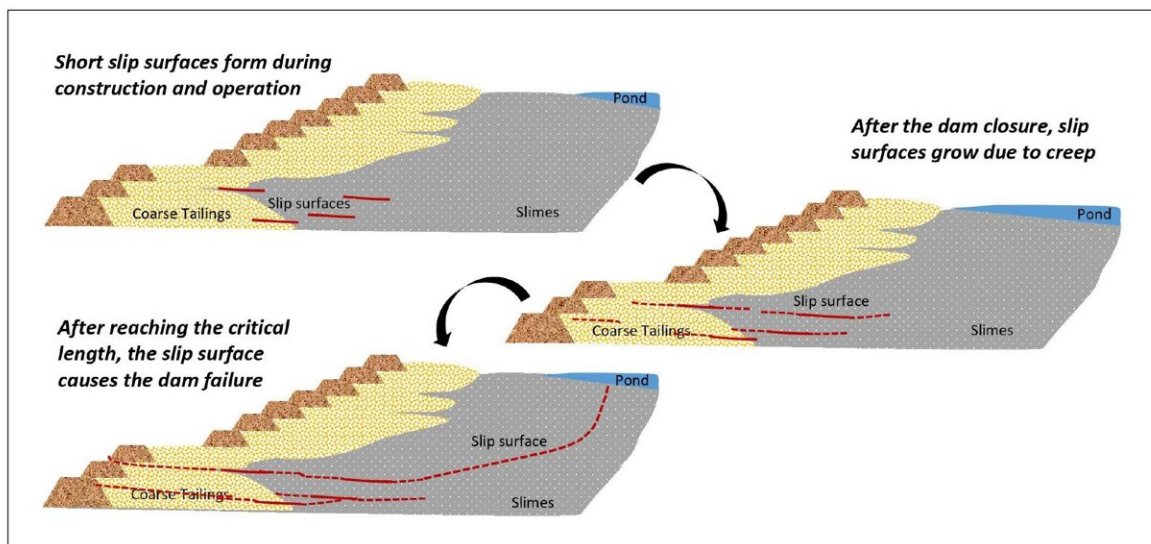
During construction, short slip surfaces formed in the deposits of the tailings dam (above). These grew after decommissioning due to creep deformation (centre) and reached the critical length (bottom) that caused the collapse of the dam. Credit: IGT/ETH Zurich

The work done by Professor Puzrin's team now shows how this could happen. According to the new findings, some initial slip surfaces had already appeared in the dammed tailings at the height of the second dam step during the dam's construction. With the progress of construction, these slip surfaces increased in length but remained too short to cause a collapse.

However, after the tailings dam was decommissioned in 2016—suggests the ETH team's modeling—these surfaces continued to expand horizontally and eventually reached a critical length. As a result, the layers of tailings began to move, causing the dam to burst under their weight and triggering the deadly mudslide.

According to the model, what caused the slip [surface](#) to grow is known as creep deformation. These deformations in the fine-grained, brittle tailings are tiny, slowly accumulating displacements caused by uneven pressure distribution between the grains in the overlying deposits.

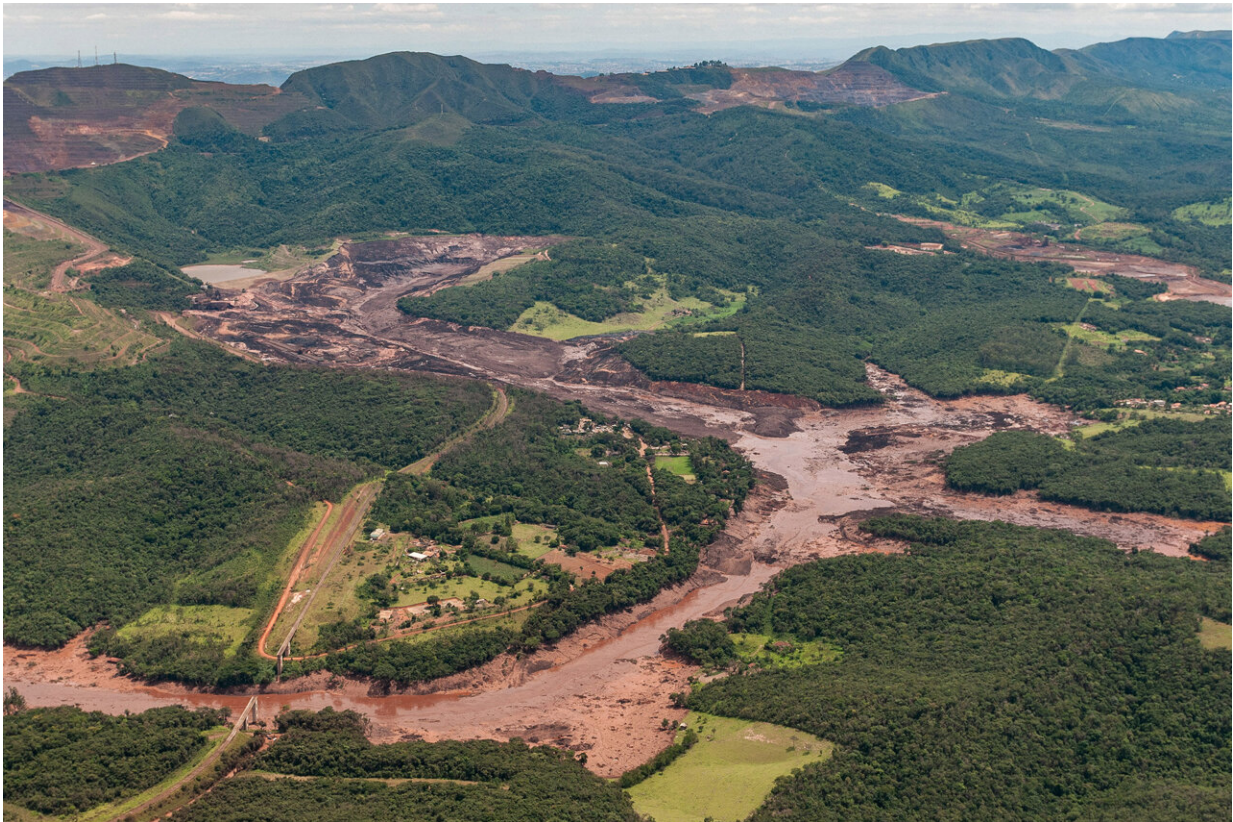
Image of the devastation two days after the dam collapse in January 2019. Top left: The leaking tailings pond. Bottom left: The destroyed railway bridge. Credit: Ibama from Brasil—Brumadinho, Minas Gerais, CC BY-SA 2.0, Wikimedia Commons
