# NIST WTC 7 Investigation Finds Building Fires Caused Collapse

21 August 2008

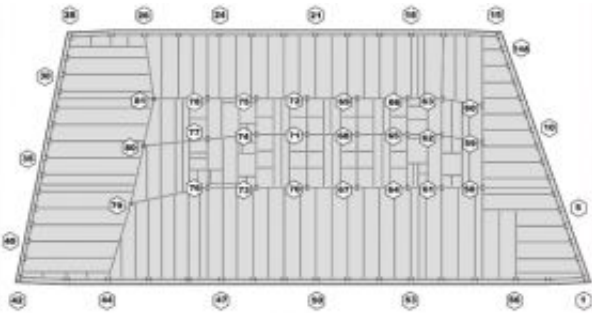
Typical WTC 7 floor showing locations of columns (numbered). The buckling of Column 79 was the initiating event that led to the collapse of WTC 7. The buckling resulted from fire-induced damage to floors around Column 79, failure of the girder between Columns 44 and 79, and cascading floor failures

the collapse of WTC 1 ignited fires on at least 10 floors of WTC 7, and the fires burned out of control on six lower floors. The heat from these uncontrolled fires caused thermal expansion of the steel beams on the lower floors of the east side of WTC 7, damaging the floor framing on multiple floors. Eventually, a girder on Floor 13 lost its connection to a critical interior column that provided support for the long floor spans on the east side of the building. The displaced girder and other local fire-induced damage caused Floor 13 to collapse, beginning a cascade of floor failures down to the fifth floor. Many of these floors had already been at least partially weakened by the fires in the vicinity of the critical column. This collapse of floors left the critical column unsupported over nine stories.

“When this critical column buckled due to lack of floor supports, it was the first domino in the chain,” Sunder explained. “What followed in rapid succession was a progression of structural failures. Failure first occurred all the way to the roof line—involving all three interior columns on the most eastern side of the building. Then, progressing from east to west across WTC 7, all of the columns in the core of the building failed. Finally, the entire façade collapsed.”

- More robust connections and framing systems to better resist effects of thermal expansion on the structural system.
- Structural systems expressly designed to prevent progressive collapse, which is the spread of local damage from a single initiating event, from element to element, eventually resulting in the collapse of an entire structure or a disproportionately large part of it. Current model building codes do not require that buildings be designed to resist progressive collapse.

- Better thermal insulation (i.e., reduced conductivity and/or increased thickness) to limit heating of structural steel and to minimize both thermal expansion and weakening effects. Insulation has been used to protect steel strength, but it could be used to maintain a lower temperature in the steel framing to limit thermal expansion.

- Improved compartmentation in tenant areas to limit the spread of fires.
- Thermally resistant window assemblies to limit breakage, reduce air supply and retard fire growth.
