In Depth: Tide out on Titan? A soft solid surface for Huygens

November 30 2005

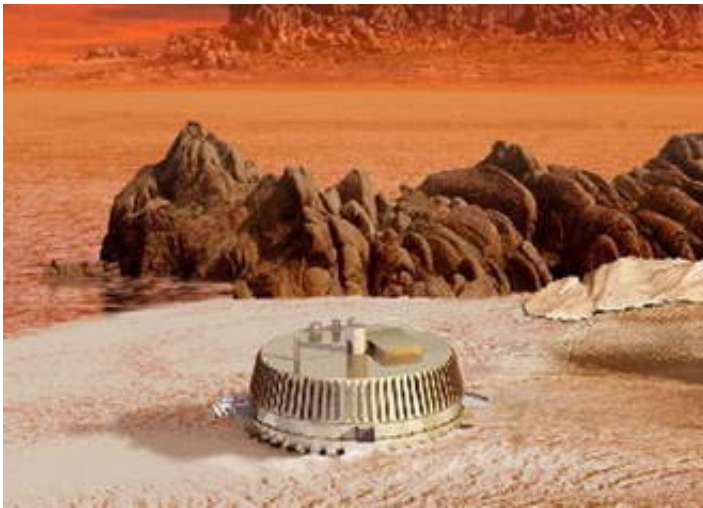
Image: Huygens descent and landing overview. Credits: ESA/C.Carreau
