# SMART-1 impact flash and debris: Crash scene investigation

September 7 2006

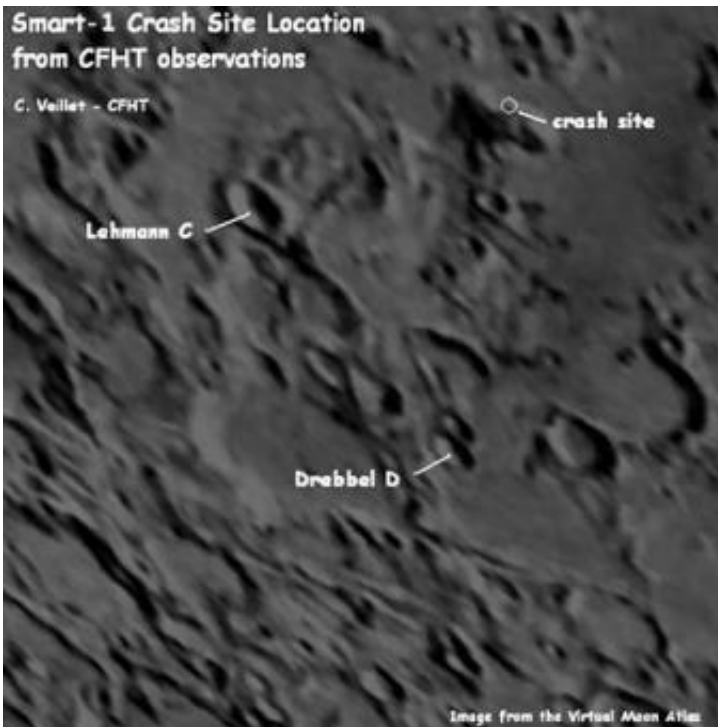
This image shows the location of the SMART-1 impact, as estimated by the Canada-France-Hawaii Telescope (CFHT). To determine the location, the CFHT scientists used the position of the flash relative to a pair of reference craters visible as bright areas on the CFHT images, and a map of the Moon as seen from Mauna Kea at the time of the impact using the Moon Virtual Atlas. A simple triangulation allowed to pinpoint the impact area within a couple of kilometres. The crash site determined from the CFHT observations is actually almost coinciding with the last ESA predictions before the impact. Courtesy of CFHT. Credits: Canada-France-Hawaii Telescope / 2006

This is also in agreement with the coordinates newly derived from the position of the infrared impact flash observed by the Canada-France-Hawaii telescope (CFHT).

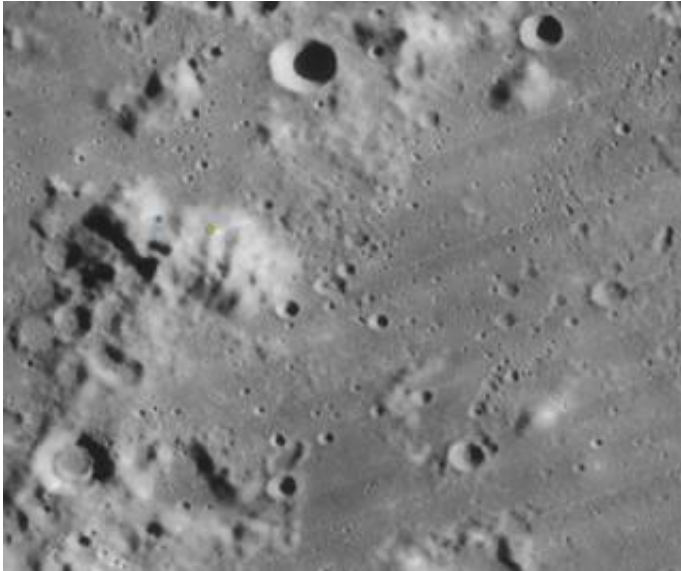
This image shows a 3D view of the SMART-1 impact location, as generated by USGS scientist Mark Rosiek. The blue star indicates the approximate impact site assuming that the coordinate system used to produce the reference Clementine Base Mosaic is correct. The yellow star indicates the approximate impact site using USGS's lunar control network revised with respect to the Clementine Base Mosaic. The distance separating the blue and yellow stars is about 7 kilometres. In this image North is up. Credits: USGS/ Mark Rosiek
