# Hubble Instruments Slated for On-Orbit 'Surgery'

July 24 2008

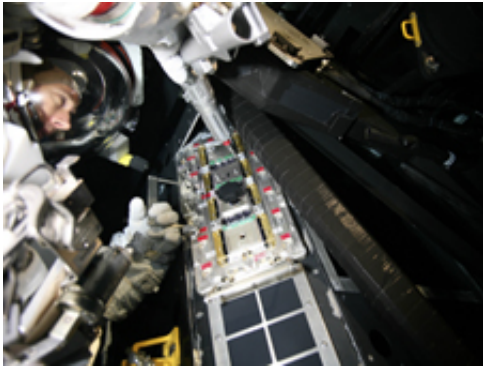
Astronaut Andrew Feustel practices installing the Fastener Capture Plate on an underwater mockup of the Advanced Camera for Surveys at the Neutral Buoyancy Laboratory in Houston. Astronauts will attempt to repair the instrument during Servicing Mission 4 to Hubble. Credit: NASA

To avoid the debris issue, NASA engineers designed a fastener capture plate. Using the custom drill, astronauts will first remove four screws to install the transparent "capture plate" over the electronic access panel. Tiny, labeled holes in the plate will allow them to then insert the drill bit and remove screws as the capture plate contains them. When all of the screws have been removed, the entire capture plate can be released as one unit, safely taking the access panel and all debris with it.
