Phoenix Monitors Frosty Clumps on its Struts

September 9 2008

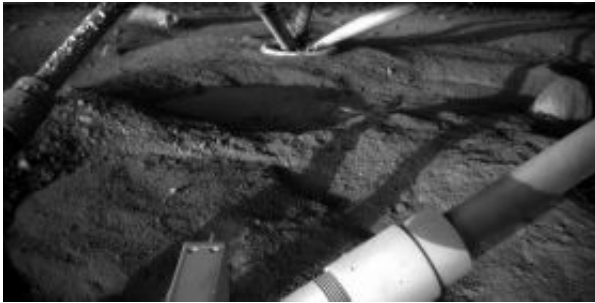
The Robotic Arm Camera on the Phoenix Mars Lander took this view under the spacecraft on Sept. 1, 2008, the 97th Martian day of the mission after landing. The lander leg strut at upper left features clumps larger than those seen three months ago. Also, exposed patches beneath the lander are darker than they used to be. (NASA/JPL-Caltech/University of Arizona/Max Planck Institute)

The Robotic Arm Camera on NASA's Phoenix Mars Lander took this image on Sept. 1, 2008, at about 4 a.m. local solar time during the 97th Martian day, or sol, since landing.

The view underneath the lander shows growth of the clumps adhering to leg strut (upper left) compared with what was present when a similar image was taken about three months earlier.

The view in this Sol 97 image is southward. Illumination is from the early morning sun above the northeastern horizon. This is quite different from the illumination in the Sol 8 image, which was taken in mid-afternoon.

The science team has discussed various possible explanations for these clumps. One suggestion is that they may have started from a splash of mud if Phoenix's descent engines melted icy soil during the landing. Another is that specks of salt may have landed on the strut and began attracting atmospheric moisture that freezes and accumulates. The clumps are concentrated on the north side of the strut, usually in the shade, so their accumulation could be a consequence of the fact that condensation favors colder surfaces.

In this image, compared with the one from three months earlier, the flat, smooth patches of ice exposed underneath the lander seem to be partly covered by darker material left behind as ice vaporizes away. The flat patch in the center of the image has the informal name "Holy Cow," based on researchers' reaction when they saw the initial image of it.
