Heritage site under attack by flowers

December 20 2011

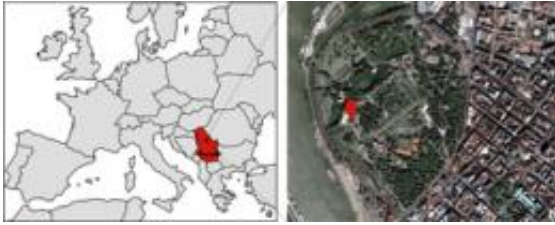
North and South gates of the Belgrade fortress. Credit: V. Matovic

In collaboration with Philippe Colomban, CNRS researcher at LADIR, the University of Belgrade and the Serbian Highway Institute analyzed the black crusts on the “King's Gate” of the fortress. Their objective was to determine the actual deterioration process in order to propose the most appropriate conservation solutions to the authorities. Different samples of the limestone and lime mortars were studied by porometry, X-ray diffractometry, infrared and Raman spectroscopy, electron microscopy and elementary analysis.
