What's the best irrigation canal liner?

May 25 2012

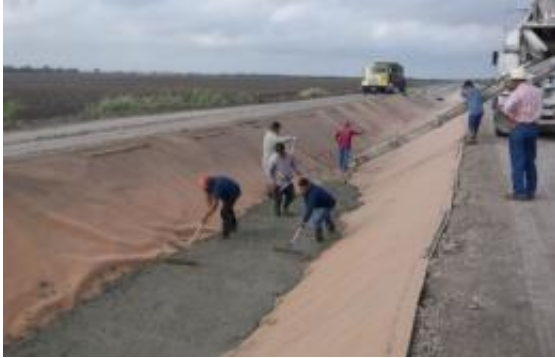
Workers in Hidalgo County spread concrete over a synthetic canal liner made of polyester. Credit: Texas AgriLife Extension, Askar Karimov

- Polyester with protective barrier of 2 to 3 inches of shotcrete.
- PVC with protective barrier of 2 to 3 inches of concrete.
- Polypropylene (Two polypropylene layers over a coarse fabric reinforcement).
- Ethylene propylene diene monomer, commonly known as EPDM, rubber (non-reinforced, 0.045 inch thick).
- Polyurethane (two layers of plastic over a non-permeable reinforcement).
- Thermoplastic PolyOlefin, commonly known as TPO, geomembrane (0.045 inch thick).
- Reinforced Ethylene propylene diene monomer (0.045 inch thick).
- Reinforced FPP-R, (a rubber-based product over a non-permeable membrane).

“It’s a synthetic liner with a protective barrier on top of concrete or shotcrete.” he said.
