NASA shows first 'crime scene' photo of Mars landing

August 7 2012, by Kerry Sheridan

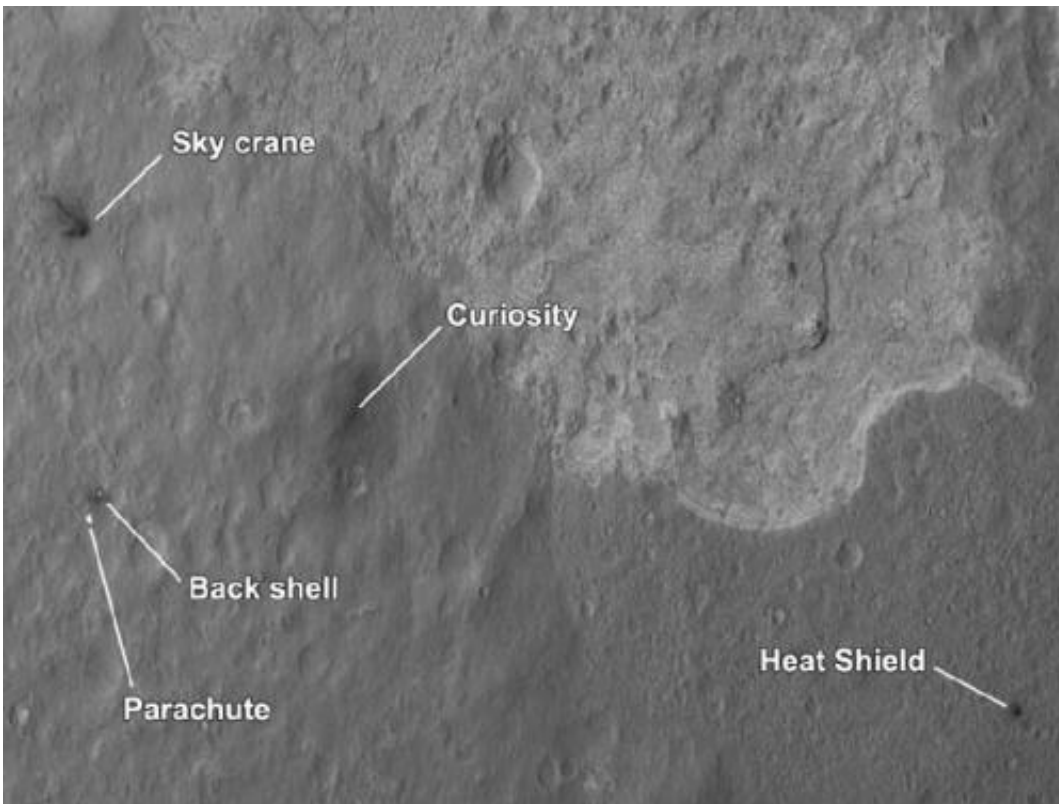
The four main pieces of hardware that arrived on Mars with NASA's Curiosity rover were spotted by NASA's Mars Reconnaissance Orbiter (MRO). The High-Resolution Imaging Science Experiment (HiRISE) camera captured this image about 24 hours after landing. The large, reduced-scale image points out the strewn hardware: the heat shield was the first piece to hit the ground, followed by the back shell attached to the parachute, then the rover itself touched down, and finally, after cables were cut, the sky crane flew away to the northwest and crashed. Relatively dark areas in all four spots are from disturbances of the bright dust on Mars, revealing the darker material below the surface dust. Around the rover, this disturbance was from the sky crane thrusters, and forms a

bilaterally symmetrical pattern. The darkened radial jets from the sky crane are downrange from the point of oblique impact, much like the oblique impacts of asteroids. In fact, they make an arrow pointing to Curiosity. This image was acquired from a special 41-degree roll of MRO, larger than the normal 30-degree limit. It rolled towards the west and towards the sun, which increases visible scattering by atmospheric dust as well as the amount of atmosphere the orbiter has to look through, thereby reducing the contrast of surface features. Future images will show the hardware in greater detail. Our view is tilted about 45 degrees from the surface (more than the 41-degree roll due to planetary curvature), like a view out of an airplane window. Tilt the images 90 degrees clockwise to see the surface better from this perspective. The views are primarily of the shadowed side of the rover and other objects. The image scale is 39 centimeters (15.3 inches) per pixel. Image credit: NASA/JPL-Caltech/Univ. of Arizona

The latest black and white picture released Tuesday was taken by the Mars Reconnaissance Orbiter as it flew about 300 kilometers (185 miles) above the landing site of Gale Crater, near Mars' equator.

It shows the Mars Science Laboratory rover, nicknamed Curiosity, with the now defunct sky crane about 650 meters (yards) away to the northwest.

The parachute and backshell of the spacecraft that separated before it lowered down landed about 615 meters away from the rover to the southwest.

The heat shield appears to be about 1,200 meters from the rover to the southeast.

"Hopefully in our future images we be able to get even better, more detail," she said, adding that the dark areas in the photo show where dust was kicked up during the landing.

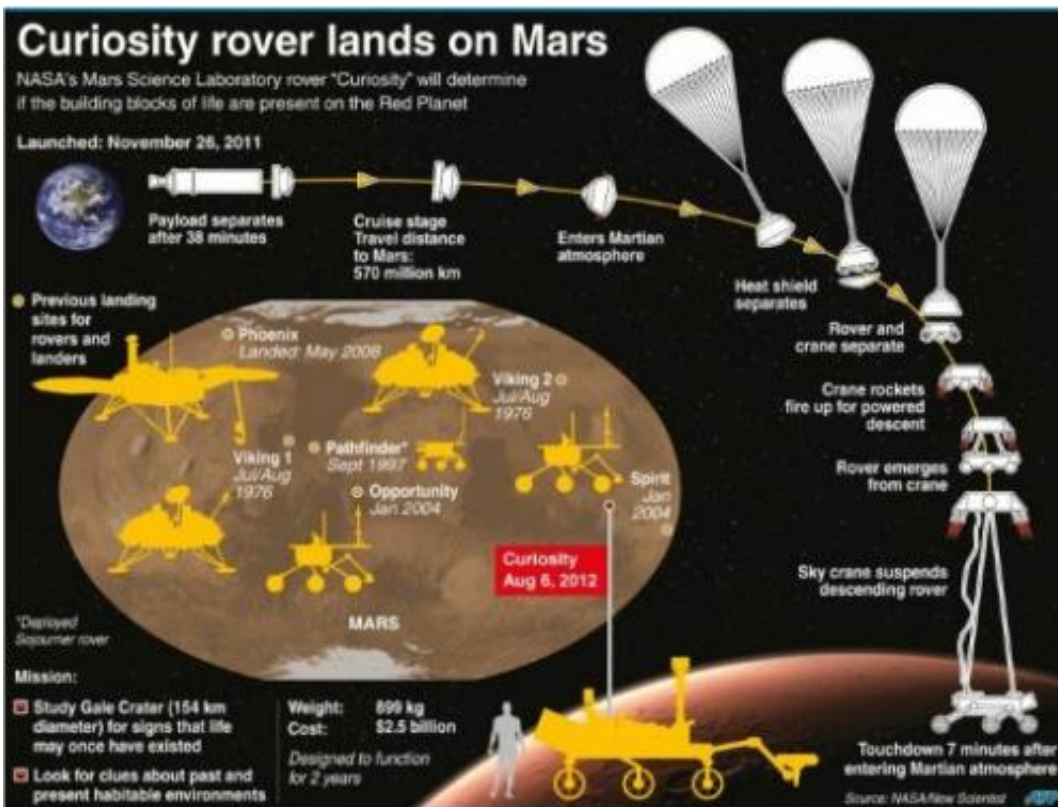
Graphic on NASA's Mars Science Laboratory landing, as well as previous touchdowns for rovers and landers on the Red Planet.
