Restoration and recommendations for flood-damaged bottomlands

March 20 2013

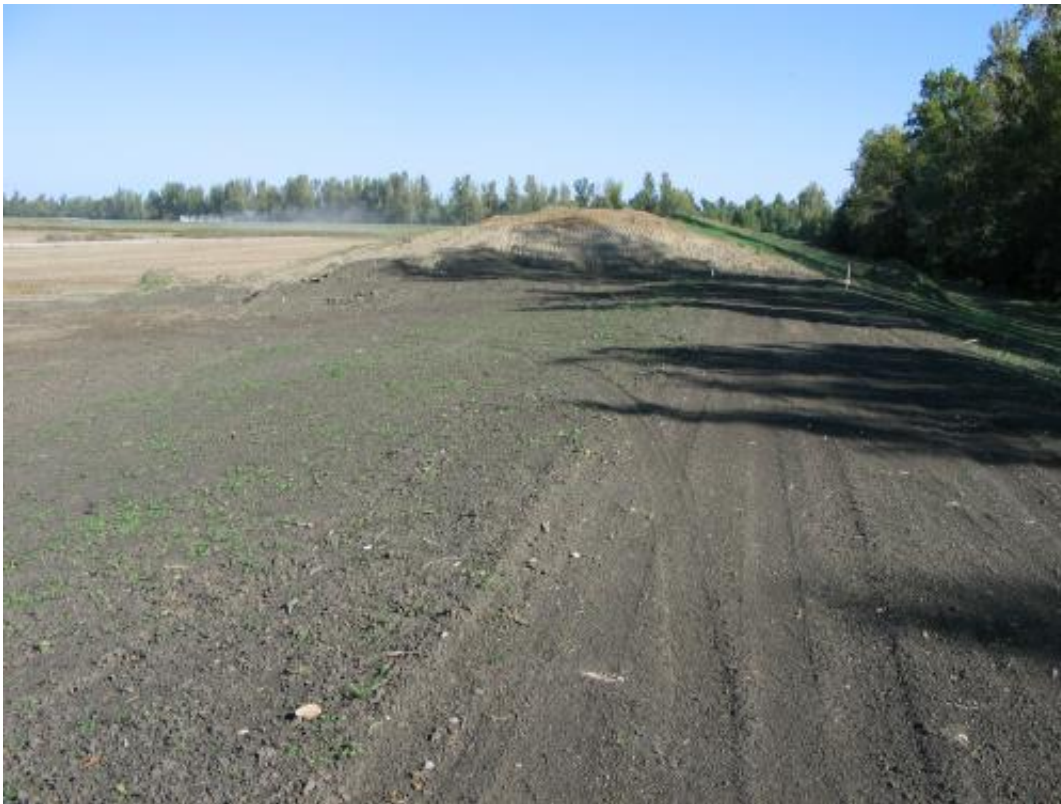
The original 60.5-foot Birds Point fuse plug was blown up using 265 tons of TNT on May 2, 2011. The USACE filled in the crater lake and temporarily patched the levee by putting in a patch that was 55 feet high in fall of 2011. In 2012 they restored it to the original height. Credit: University of Illinois
