# Plastic pad clogs Fukushima water cleaning system

September 29 2013

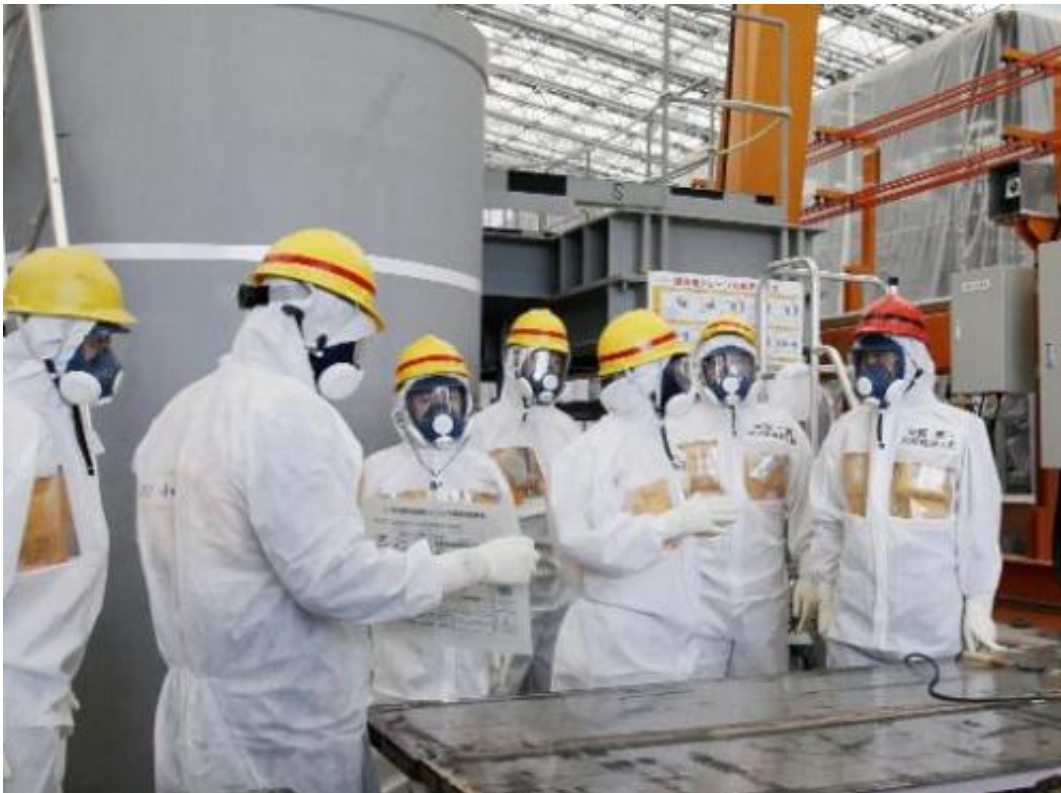
Japan PM Shinzo Abe (right) is briefed about the advanced liquid processing system (ALPS) on a visit to the stricken Fukushima nuclear power plant on September 19, 2013

A piece of plastic padding which clogged up a drain is thought to have caused the breakdown of a decontamination system at Japan's crippled Fukushima nuclear plant, the operator said Sunday.

Workers found that a plastic pad, which fixed a ladder in the system, had worked loose and got stuck in a drain, probably causing the defect, said operator Tokyo Electric Power Co.

The ALPS system was switched on early Friday but was stopped late evening the same day when it was found not to be properly flushing fluid used to remove [radioactive particles](#), TEPCO said in a statement.

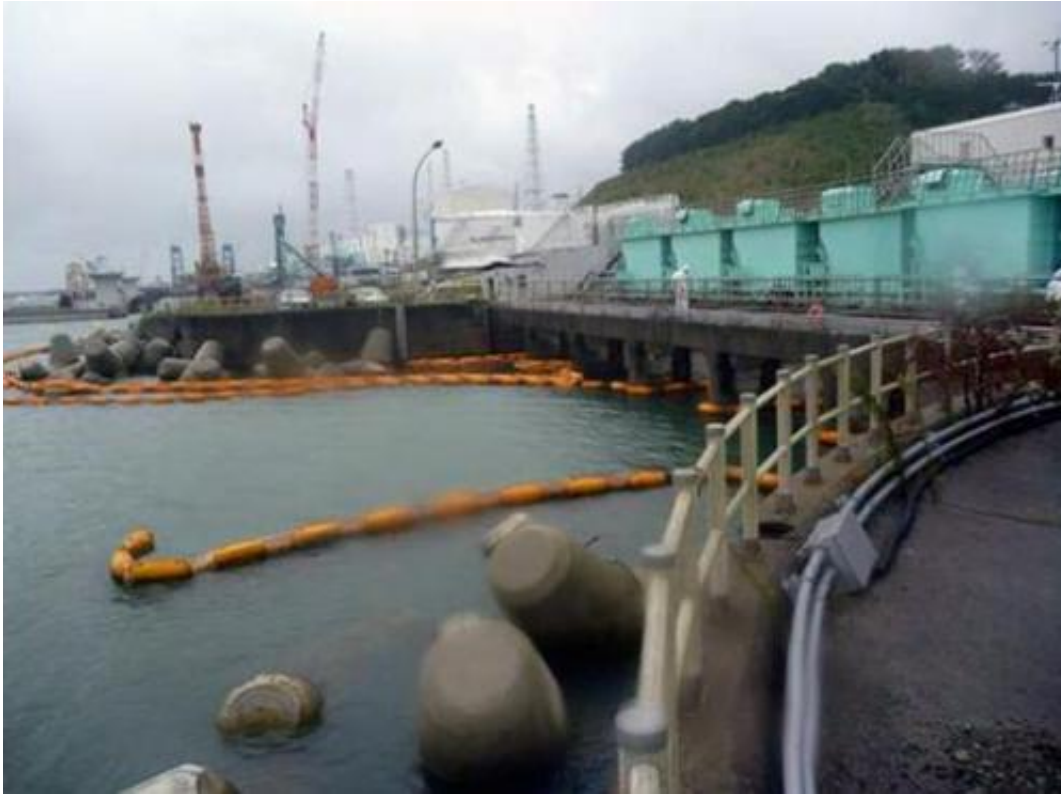
A silt fence, a device to trap sediment before water flows into the sea, at the stricken Fukushima nuclear power plant on September 26, 2013
