Google street view—tool for recording earthquake damage

October 30 2013

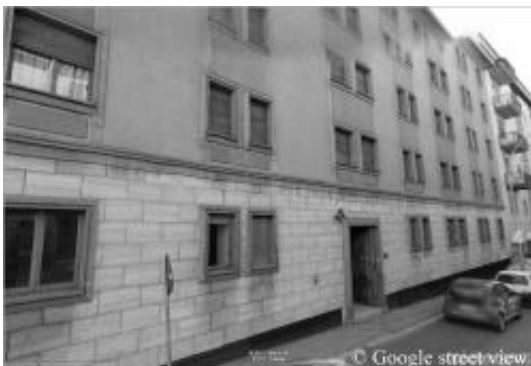
Location: <i>L'Aquila / Via XX Settembre</i> L7
	Coordinates: <i>42.3468° N / 13.3950° E</i>
	Date before: <i>2008-08</i> Date after: <i>2011-07-10</i>
	EMS98 Building Type: <i>concrete frame</i> Vulnerability Class: <i>C</i> Damage Grade: <i>3</i>
Comments: <i>The heavy white arrows indicate the interpreted differential horizontal motion of the building levels, which caused the shear failure of the walls in the first and second floor.</i>

Google Earth's aerial views have helped capture an overview of damage to L'Aquila and specific collapsed structures. But the Google street views show the details – fractures, plaster breaks and collapsed walls. The scans help identify the damage caused by the quake rather than a lack of building maintenance or disrepair.

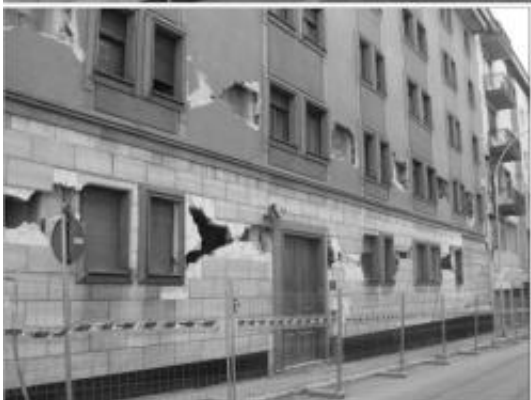
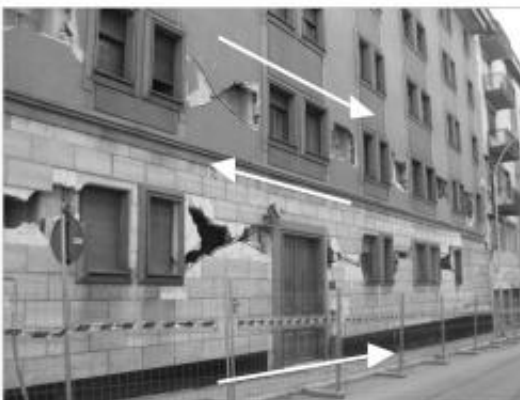
These images use Google street view scans to identify quake-related damage.
 Credit: K-G Hinzen/SRL
