Western Wall weathering: Extreme erosion explained

August 11 2014

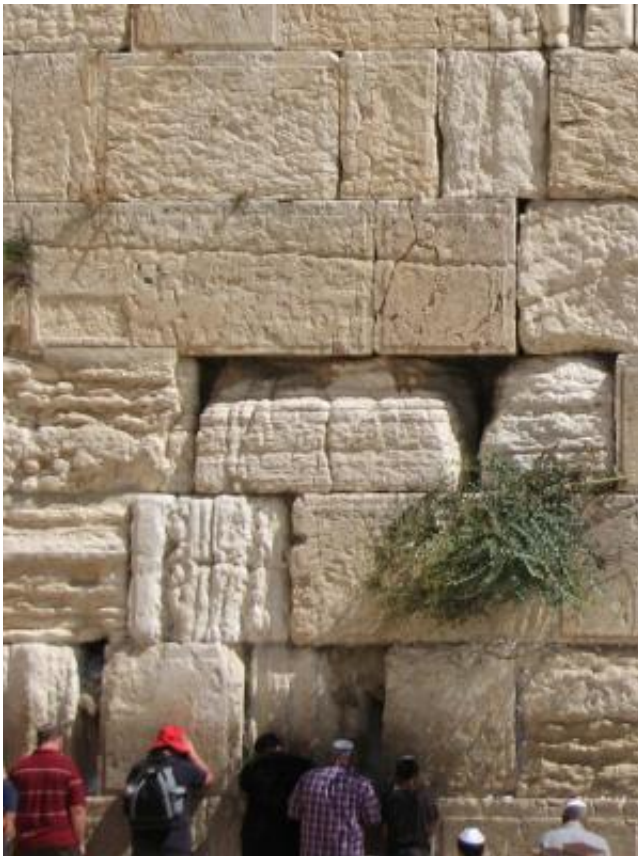
Part of the Western Wall shows highly eroded blocks alongside well preserved stones. Credit: (Photo: Dr. Simon Emmanuel, Hebrew University)

In some cases, extreme erosion rates in fine-grained micritic limestone blocks were up to 100 times faster than the average rates estimated for the coarse-grained limestone blocks. In some places these stones had receded by tens of centimeters, potentially weakening the overall structure.

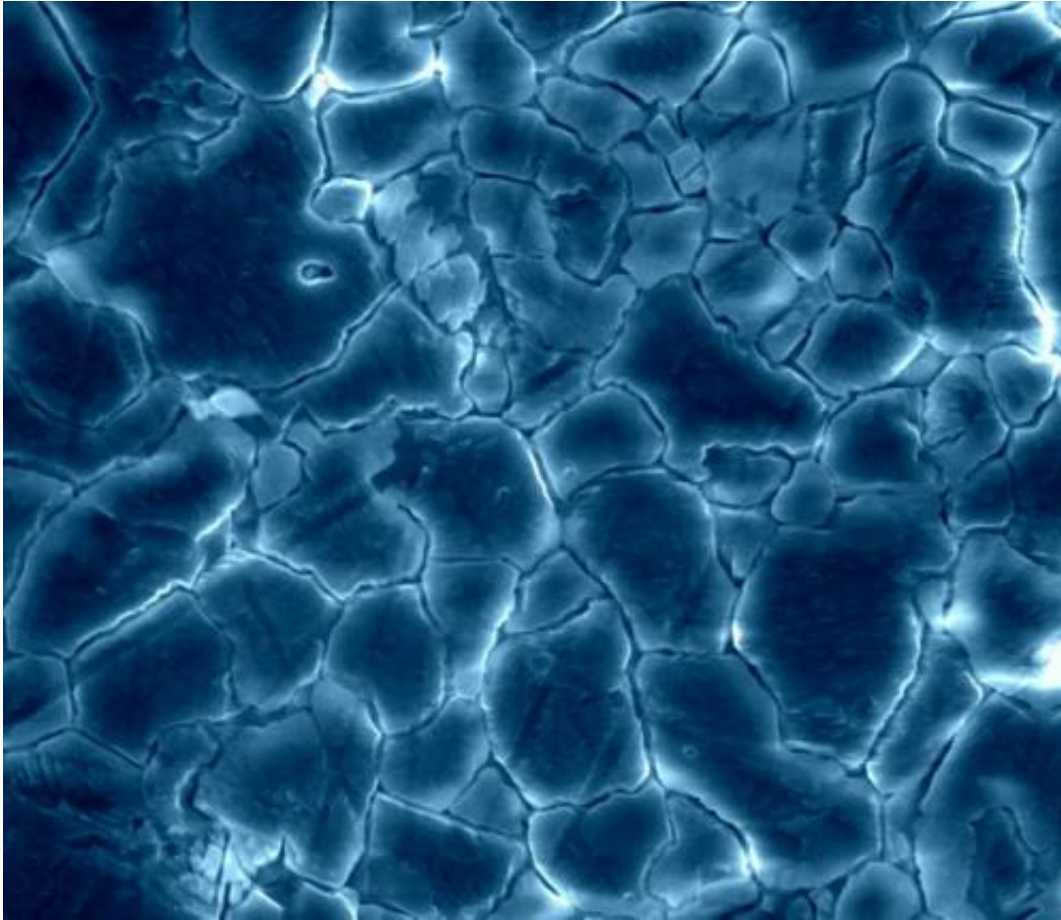
A microscope image of Jerusalem limestone made up of tiny crystals. Credit: Dr. Simon Emmanuel, Hebrew University

As reported in an article accepted for publication in the journal *Geology*, they found that stones made up of relatively large crystals were resistant to wear, so that they were almost unchanged in the 2000 years since they were originally put in place. By contrast, limestone with very small crystals (about one thousandth of a millimeter in size) eroded far more quickly.

To understand what causes the two types of rock to behave differently, the researchers collected samples from ancient quarries thought to have supplied the stones for the Second Temple. Using a powerful atomic force microscope, they were able to see how the rocks disintegrated when they came into contact with water. During the experiments on rocks made up of small crystals, tiny particles rapidly detached from the surface of the rock. These experiments simulated the way in which rain water interacts with limestone in nature.
