# Damage to the cockpit gives a clue to loss of flight MH17

September 11 2014, by Geoffrey Dell

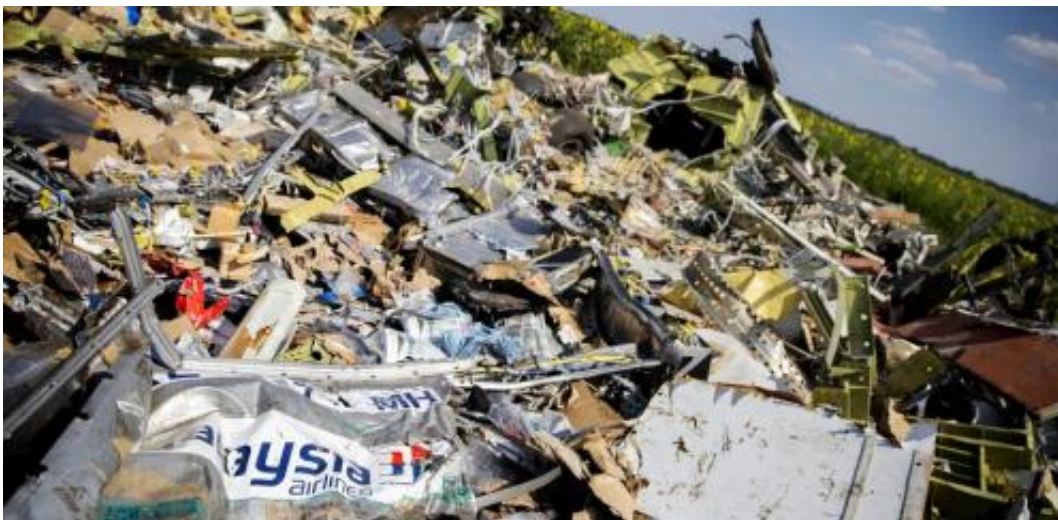
Some of the debris from the Boeing 777 Malaysia Airlines Flight MH17 plane crash site. Credit: EPA/Jerry Lampen

The photographs (one above) included in the Dutch report clearly show this damage is atypical to that evident on the rest of the fuselage skin surfaces, which can be seen in other photographs of the wreckage.

These new photographs clearly show sections of forward fuselage structure with multiple holes where the skin is bent inwards around the circumference of each hole. This is consistent with the penetration of small high-energy projectiles, which would be the case with the proximity detonation of the warhead of a missile.

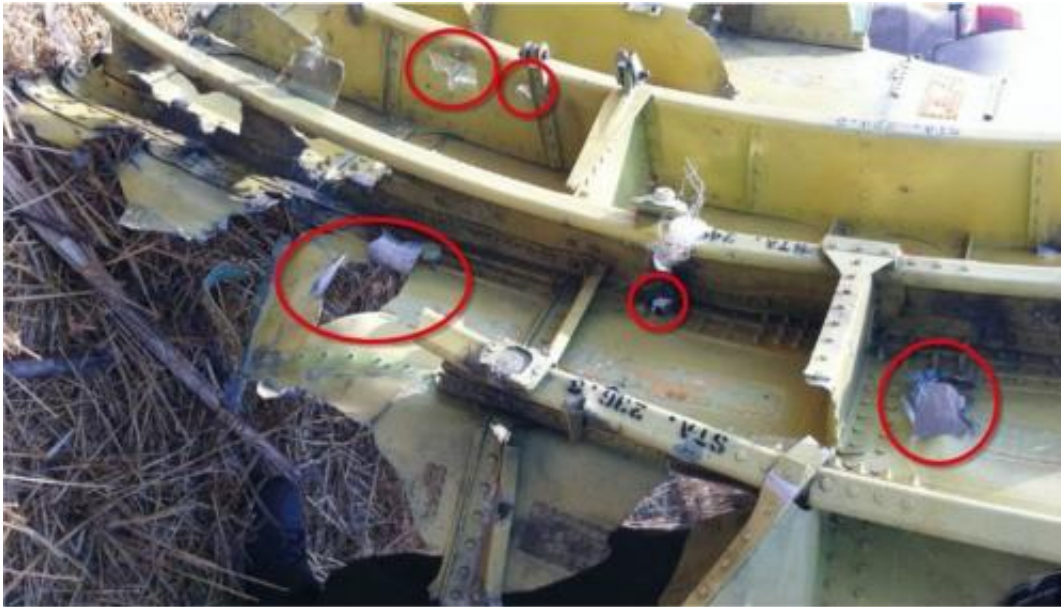
There is also evidence of similar penetrations in the cockpit floor. This suggests some of the projectiles from any warhead entered through the

fuselage skin above the cockpit and then exited through the cockpit floor.

Part of the inside cockpit roof showing penetration by objects from outside.  
Credit: DCA/Dutch Safety Board

Below the cockpit floor of the Boeing 777 – as in most modern airliners – is the Electronics and Engineering (E&E) compartment, which houses most of the aircraft's avionics, flight-management computers and other critical "black boxes". Penetration of the E&E compartment by the high-speed projectiles would no doubt have caused catastrophic damage to critical control systems.

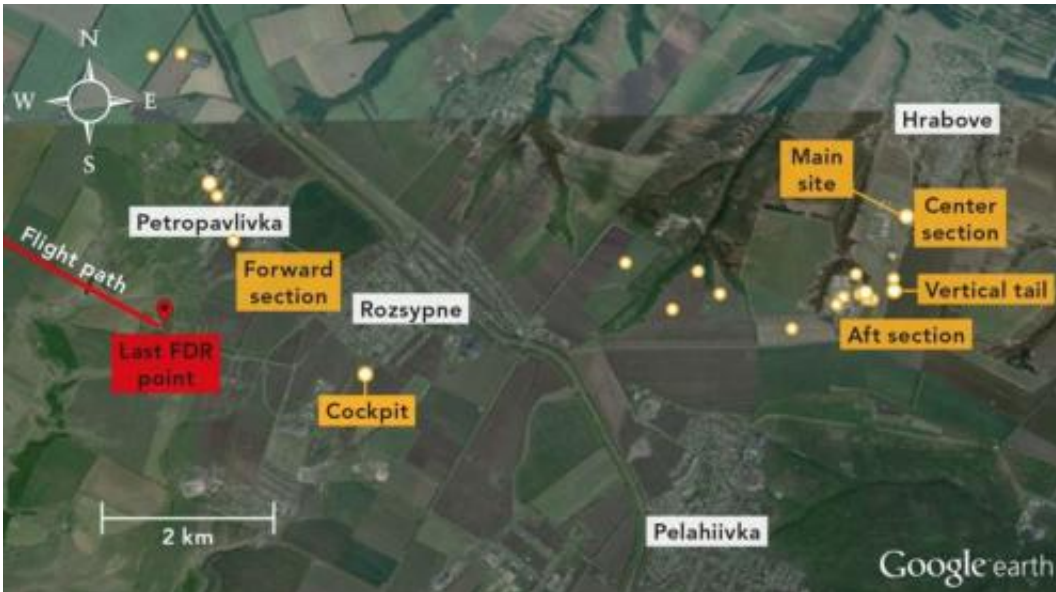
It is of interest too that the area map of the flight path in the report showed the main accident scene many degrees off the flight path the aircraft was supposedly on.

The last location of the aircraft in flight taken from the flight data recorder (FDR). Wreckage distribution is grouped per section of the aircraft. Credit: Dutch Safety Board

This may have been due to simple errors in the depiction on the map. But if the map was accurate, it opens speculation that the aircraft did not immediately or completely break up when the missile detonated.

If so, the heavy components, in particular the engines, would most likely have followed ballistic trajectories to the ground on roughly the same bearing as the direction of flight.
