Antares explosion investigation focuses on first stage propulsion failure

November 4 2014, by Ken Kremer

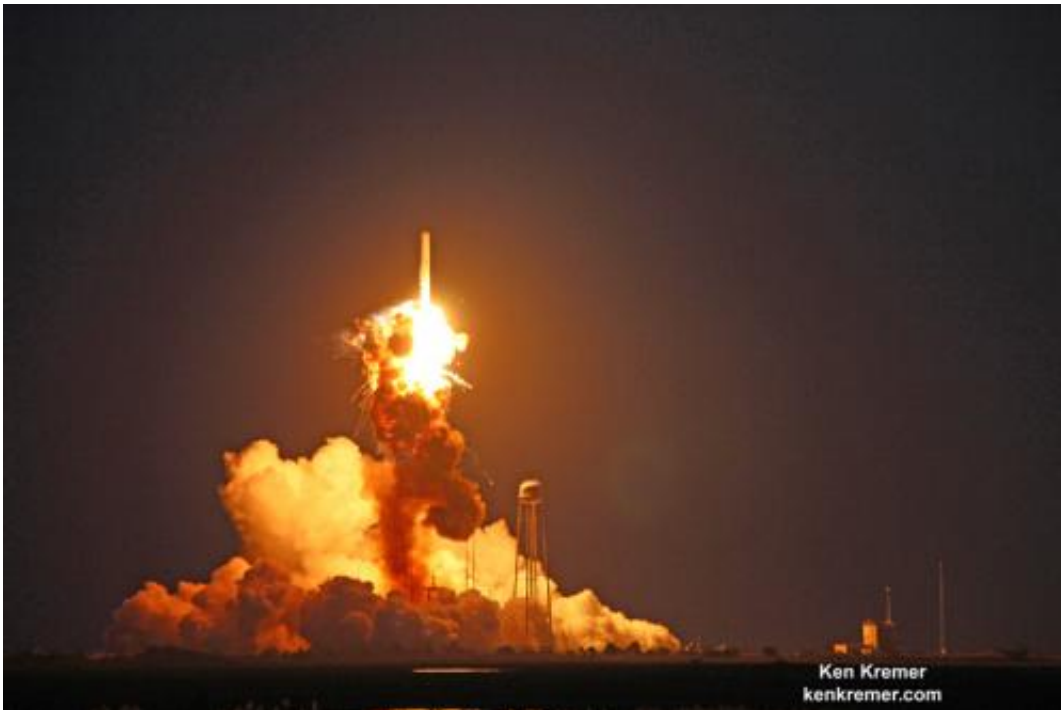
First stage propulsion system at base of Orbital Sciences Antares rocket appears to explode moments after blastoff from NASA's Wallops Flight Facility, VA, on Oct. 28, 2014, at 6:22 p.m. Credit: Ken Kremer

Numerous photos and videos from myself (see herein) and many others clearly show a violent explosion emanating from the base of the two stage rocket. The remainder of the first stage and the entire upper stage was clearly intact at that point.

"Evidence suggests the failure initiated in the first stage after which the vehicle lost its propulsive capability and fell back to the ground impacting near, but not on, the launch pad," Orbital said in a statement.

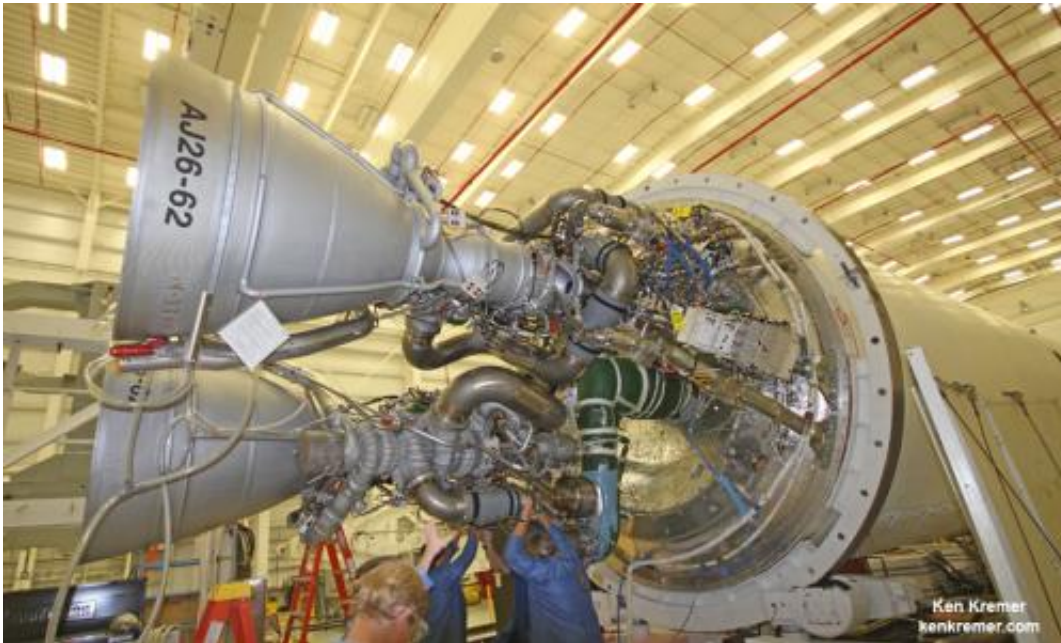
Orbital Sciences technicians at work on two AJ26 first stage engines at the base of an Antares rocket during exclusive visit by Ken Kremer/Universe Today at NASA Wallops. These engines powered the successful Antares liftoff on Jan. 9, 2014 at NASA Wallops, Virginia bound for the ISS. Credit: Ken Kremer

The 14 story Antares rocket is a two stage vehicle. The liquid fueled first stage is filled with about 550,000 pounds (250,000 kg) of Liquid Oxygen and Refined Petroleum (LOX/RP) and powered by a pair of AJ26 engines originally manufactured some 40 years ago in the then Soviet Union and designated as the NK-33.

Earlier this year an AJ26 engine failed and exploded during acceptance testing on May 22, 2014 at NASA's Stennis Space Center in Mississippi. An extensive analysis and recheck by Orbital Sciences was conducted to clear this pair for flight.

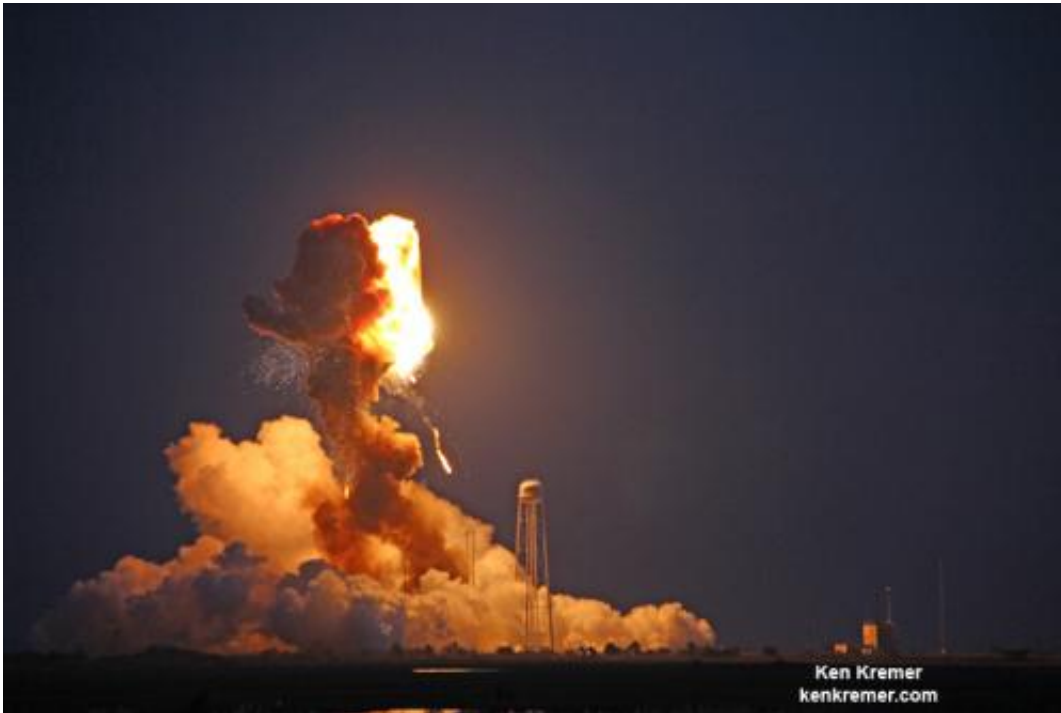
Orbital Sciences Antares rocket explodes moments after blastoff from NASA's Wallops Flight Facility, VA, on Oct. 28, 2014, at 6:22 p.m. Credit: Ken Kremer
