UA-led HiRISE camera spots long-lost space probe on Mars

January 16 2015

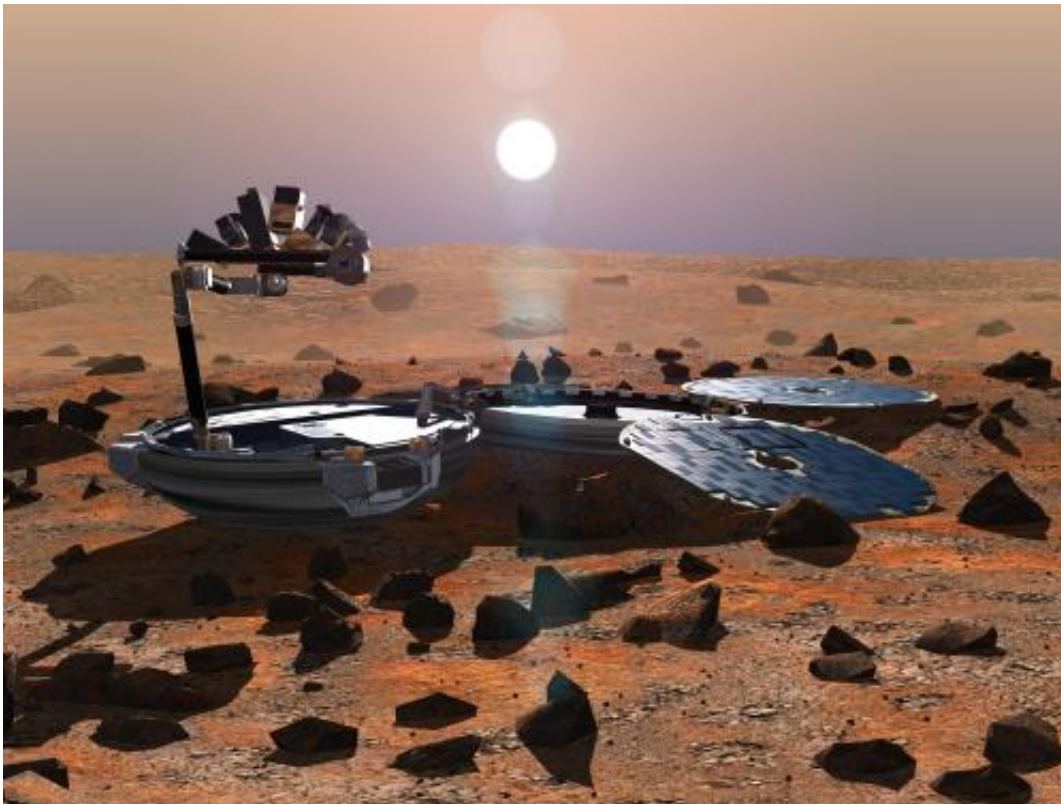
Upon landing, Beagle 2 was designed to unfold like a pocket watch into its main components, a petal-like array of solar panels and a robotic arm bristling with scientific instruments. (Artist's impression) Credit: Beagle2.com

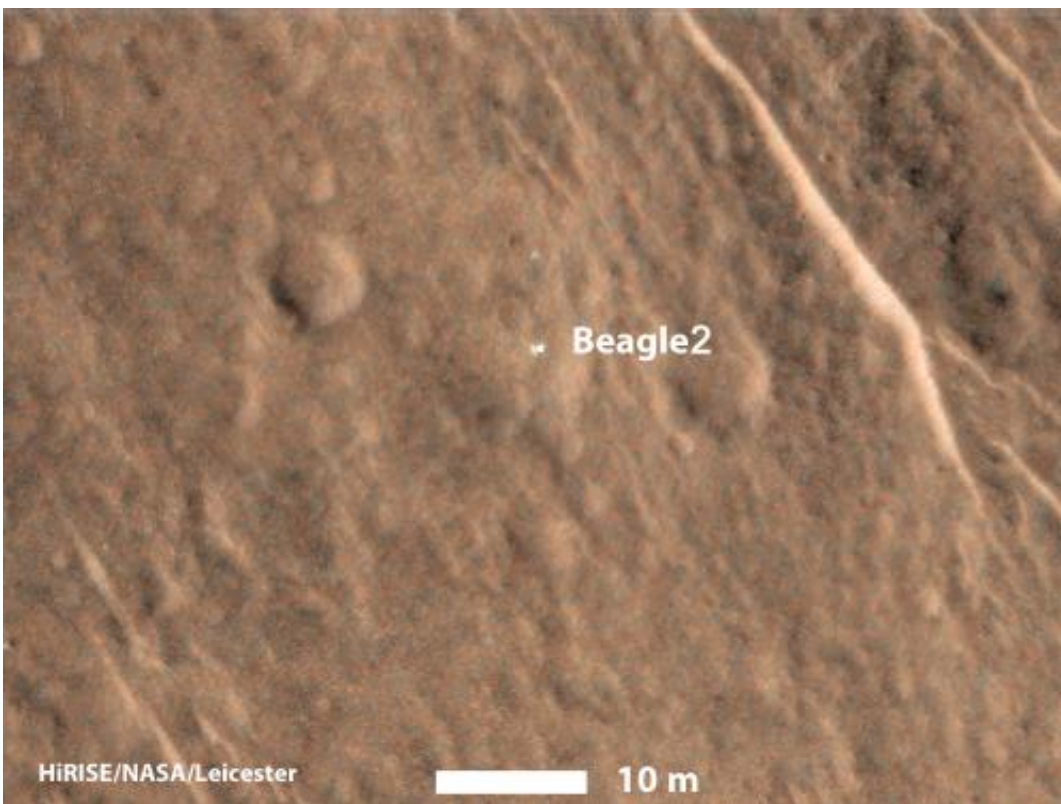
HiRISE image of the Beagle 2 landing site. Credit: HiRISE/NASA-JPL/Univ. of Leicester

The team acquired several more images, which showed a bright spot that seemed to move around.

"That was consistent with Beagle 2," McEwen said. "Because its solar

panels were arranged in petals, each one would reflect light differently depending on the angles of the sun and MRO, especially if the lander was resting on sloping ground."

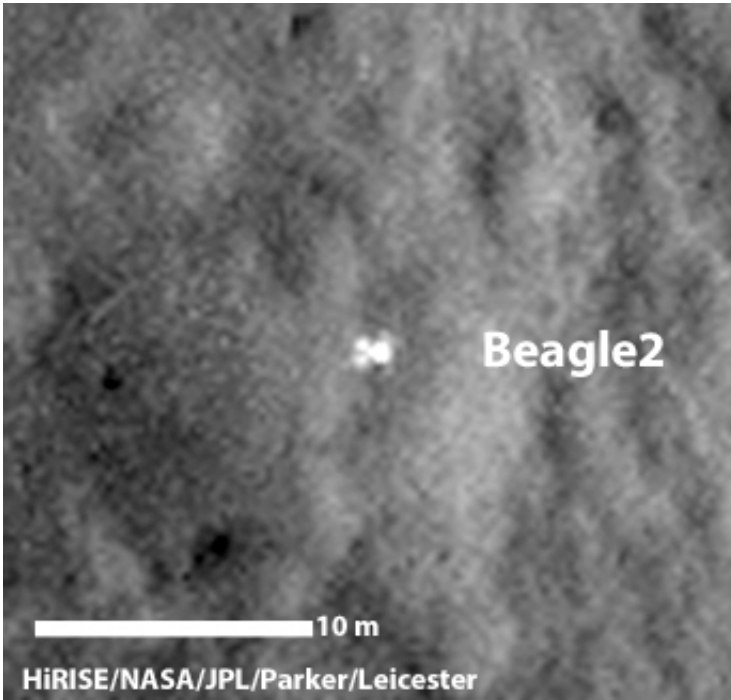
Zoomed-in view of the landing site shows Beagle 2's petal-like solar panels.
Credit: HiRISE/NASA-JPL/Univ. of Leicester

The imaging data may be consistent with only a partial deployment of Beagle 2 following landing, which would explain why no signal or data was received from the lander, as full deployment of all solar panels was needed to expose the RF antenna, which would transmit data and receive commands from Earth via orbiting Mars spacecraft.

The HiRISE images reveal only two or three of the motorized solar panels, but that may be due to their favorable tilts for sun glints. According to the UK Space Agency, if some panels failed to deploy, reasons could include obstruction from an airbag remaining in the proximity of the lander due to gas leakage, or a damaged mechanism or structure or broken electrical connection, perhaps due to unexpected shock loads during landing. The scenario of local terrain topology, including rocks blocking the deployment, is considered unlikely given images of the landing area, which show few rocks, but this cannot be ruled out. Further imaging and analysis is planned to narrow the options for what happened. Slope and height derived from the HiRISE images show that Beagle 2 landed on comparable flat terrain with no major hazards.
