# NASA image: Astronaut spacesuit testing for orion spacecraft

March 20 2015

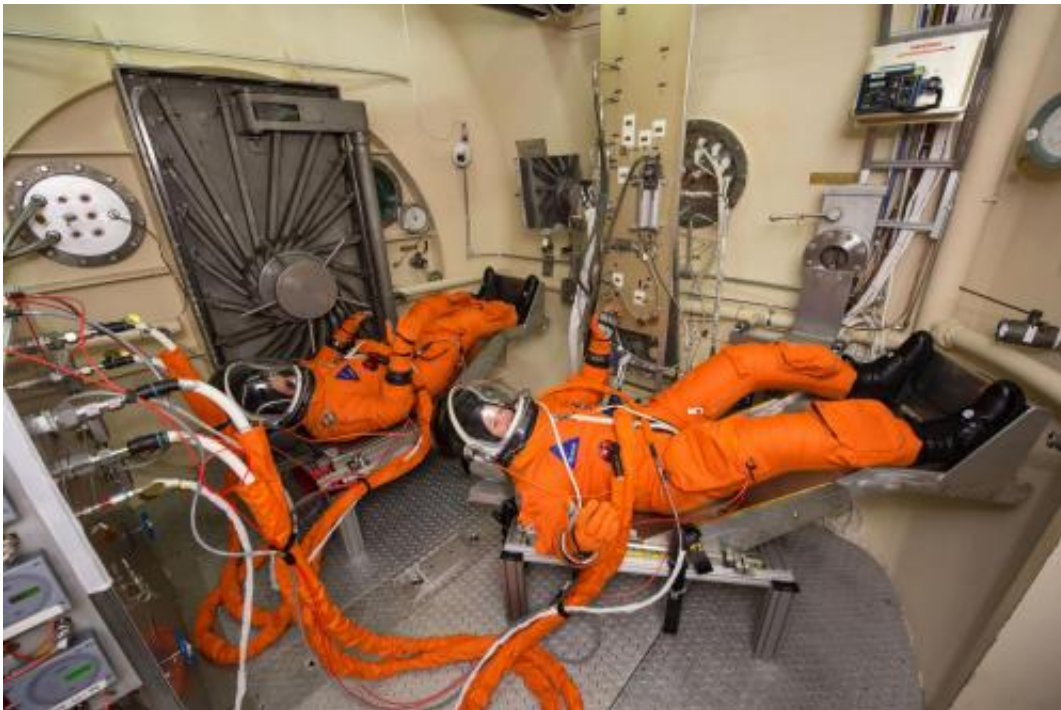
Engineers and technicians at NASA's Johnson Space Center in Houston are testing the spacesuit astronauts will wear in the agency's Orion spacecraft on trips to deep space.

On March 17, members of the Johnson team participated in a Vacuum Pressure Integrated Suit Test to verify enhancements to the suit will meet

test and design standards for the Orion spacecraft. During this test, the suit is connected to life support systems and then air is removed from Johnson's 11-foot thermal [vacuum chamber](#) to evaluate the performance of the suits in conditions similar to a spacecraft.

The suit, known as the Modified Advanced Crew Escape Suit, is a closed-loop version of the launch and entry suits worn by space shuttle astronauts. The [suit](#) will contain all the necessary functions to support life and is being designed to enable spacewalks and sustain the crew in the unlikely event the spacecraft loses pressure.

This is the first in a series of four tests with people in the suits to evaluate the performance of the spacesuit systems in an environment similar to a spacecraft.
