Pre-1950 structures suffered the most damage from August 2014 Napa quake

March 3 2015

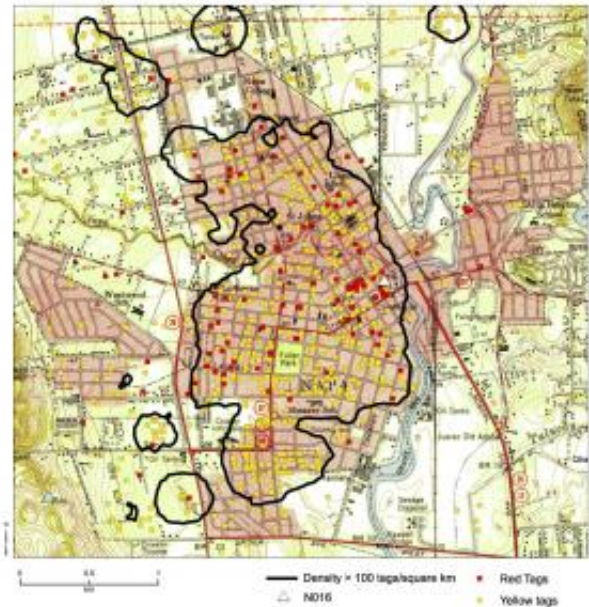
Red and yellow tags plotted on the street grid and topography of Napa. Fault traces are drawn as black lines. Note the five red tags aligned on the fault in Brown's Valley. The dark line running north-south through central Napa is State Route 29. The Napa River is not marked. The brown contours show tagging densities $>100/\text{km}^2$. The largest concentration of tags is located in central Napa. Credit: *Seismological Research Letters*

Boatwright et al., analyzed data provided by structural engineers who inspected and tagged damaged buildings after the earthquake. The 165 red tags (prohibited access) and 1,707 yellow tags (restricted access) stretched across the city but were primarily concentrated within the residential section that lies between State Route 29 and the Napa River, including the historic downtown area.

When comparing the distribution of red and yellow-tagged buildings to the underlying sedimentary basin, to the pre-1950 development of Napa

and to the recent alluvial geology of Napa Valley, the most severe damage correlates to the age of the buildings—pre-1950 construction—and their location within the basin. Less damaged areas to the east and west of central Napa lie outside of the [sedimentary basin](#), and the moderately damaged neighborhoods to the north lie inside the basin but are of more recent construction.

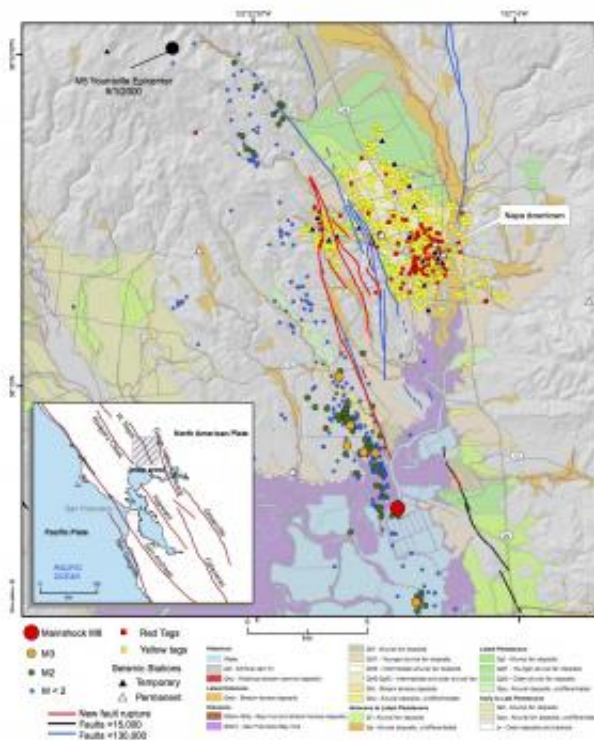
Locations of the mainshock (red dot), aftershocks, surface ruptures (red lines), and locations of permanent (unfilled triangles) and temporary (filled triangles) seismic stations. Credit: *Seismological Research Letters*

The South Napa earthquake occurred on the West Napa Fault system, a recognized but poorly studied fault lying between the longer Rodgers Creek and Green Valley faults, and caused strong ground motions, as detailed in the paper by Tom Brocher et al. The mapped surface rupture was unusually large for a moderate quake, extending nearly eight miles from Cuttings Wharf in the south to just west of Alston Park in the north.
