X-rays probe LHC for cause of short circuit

March 27 2015, by Rossano Giachino, Markus Albert

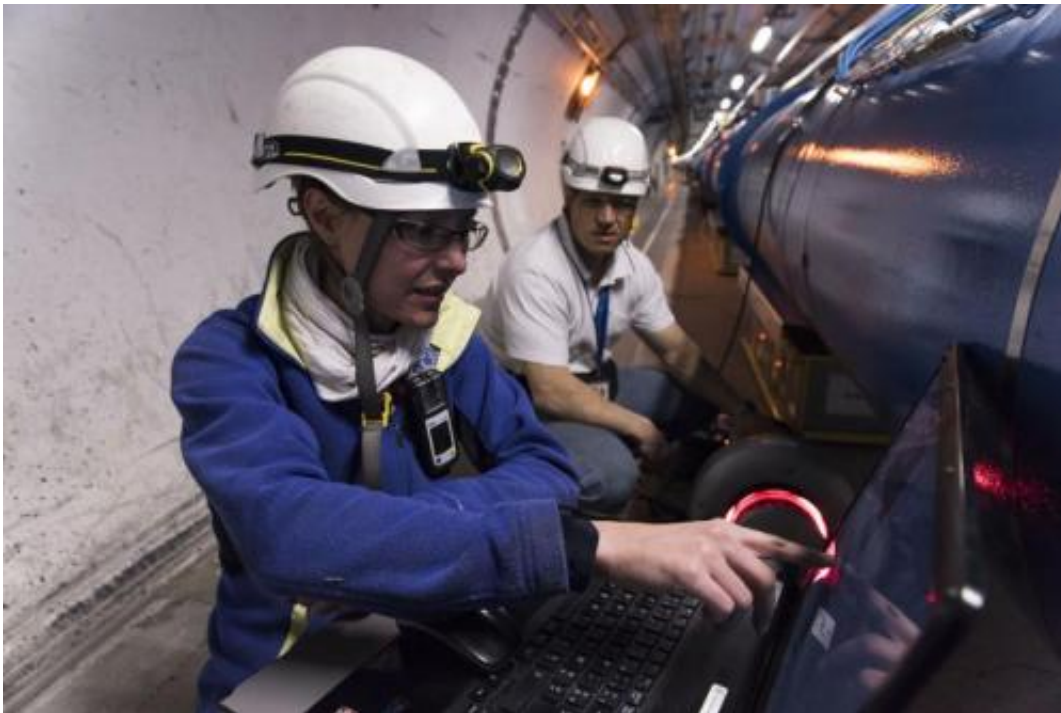
Engineers Aline Piguiet and Markus Albert take X-rays of the shorted superconducting dipole in sector 3-4 in the LHC tunnel . Credit: Maximilien Brice/CERN

X-rays have been taken of the region. It's a difficult location and although some debris can be seen, the results are inconclusive.

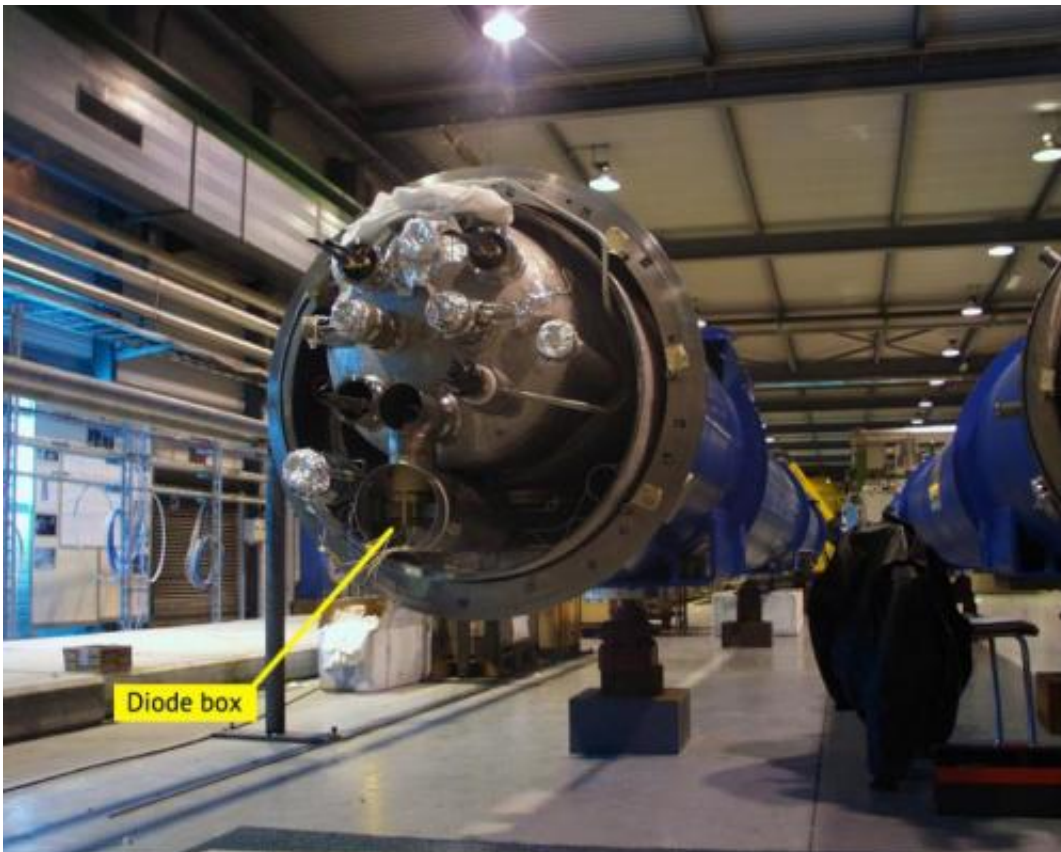
instrumentation, which includes voltage and current taps. The fault is located in the vertical tube that leads from the magnet enclosure to the diode box situated under the magnet (see below). The most probable scenario is that a small piece of metallic debris has inadvertently found its way into this tube and is making contact between the tube (earth) and one of the cables that leads to the diode.

Diode box

An essential element for the protection of the dipoles is a high-current bypass diode mounted under the magnet. The diode operates at a temperature of 1.9 K. The diode box that holds the diode contains superfluid helium and is connected to the main helium enclosure of the magnet.

When a magnet quench occurs, the current in the quenched magnet diverts to the diode in about 0.5 s, and the rest of the magnet chain in superconductive state slowly ramps down with time constants of the order of 100 s. Thus the diodes conduct a current pulse of up to 13 kA, which decays exponentially with a time constant of about 100 s. This can lead to a temperature rise inside the diode of up to 300 K.

Three main options are being explored. The first would inject an energy-

limited pulse of current and attempt to melt the offending object. The second option would involve pressurising the helium in the local cryogenic sector and then performing a fast pressure discharge to generate turbulent flow and so dislodge the object. Studies and preparation for both these options are ongoing and both could be attempted relatively quickly.

The third option involves a partial warm-up of the sector and opening the magnet interconnect concerned. This would allow direct access to the diode box. The warm-up, intervention, and subsequent cool-down would take around six weeks.
