First robot into Fukushima reactor stalls, but gets some data

April 13 2015, byMari Yamaguchi

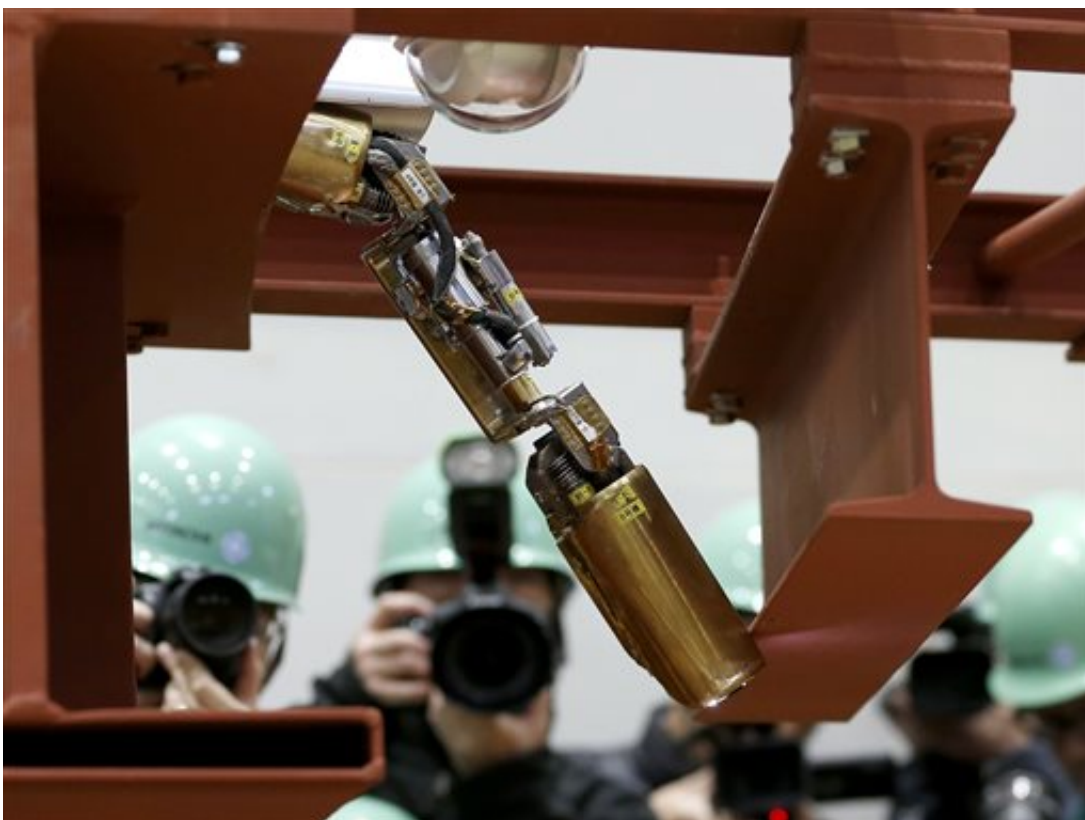
In this Thursday, Feb. 5, 2015 file photo, a remote-controlled robot that looks like an enlarged fiberscope crawls down into the mock-up of a primary containment chamber of Fukushima Dai-ichi nuclear plant, during a demonstration for the media at a government facility in Hitachi, Ibaraki Prefecture, northeast of Tokyo. Tokyo Electric Power Co., the operator of the wrecked Fukushima nuclear plant, said Monday, April 13, the first robot, the same type shown in the photo, sent inside one of melted reactors stalled before finishing its work but it collected data that indicates a path to send robots deeper into the reactor is intact. TEPCO said the robot stalled after completing two-

thirds of Friday's planned mission inside the Unit 1 containment vessel. (AP Photo/Shizuo Kambayashi)

The 60-centimeter (2-foot) -long, snake-shaped robot entered the containment chamber through a pipe and transformed into a U-shape crawler after it landed on the platform.
