New NASA photos show massive rocket explosion in Virginia

November 5 2015

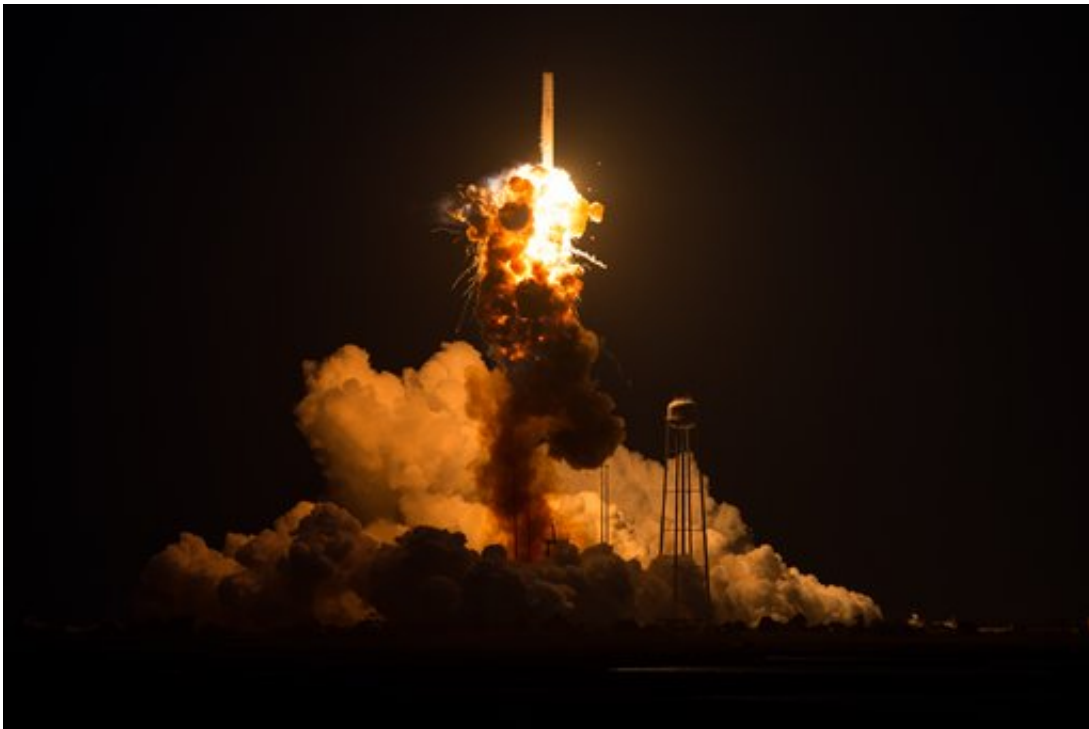
This Tuesday Oct 28, 2014 photo provided by NASA shows the Orbital Antares rocket, after it suffered a catastrophic anomaly moments after launch at NASA's Wallops Flight Facility in Virginia. The Cygnus spacecraft was filled with supplies slated for the International Space Station, including science experiments, experiment hardware, spare parts, and crew provisions. (Joel Kowsky/NASA via AP)

NASA's independent review team said last week that the initial fire was caused by friction from rubbing parts in a turbopump in one of the rocket's old Russian-built engines. The pump exploded seconds after liftoff, damaging a second engine, according to NASA's report. As the rocket fell toward the ground, controllers sent a destruct signal just before impact to minimize damage.

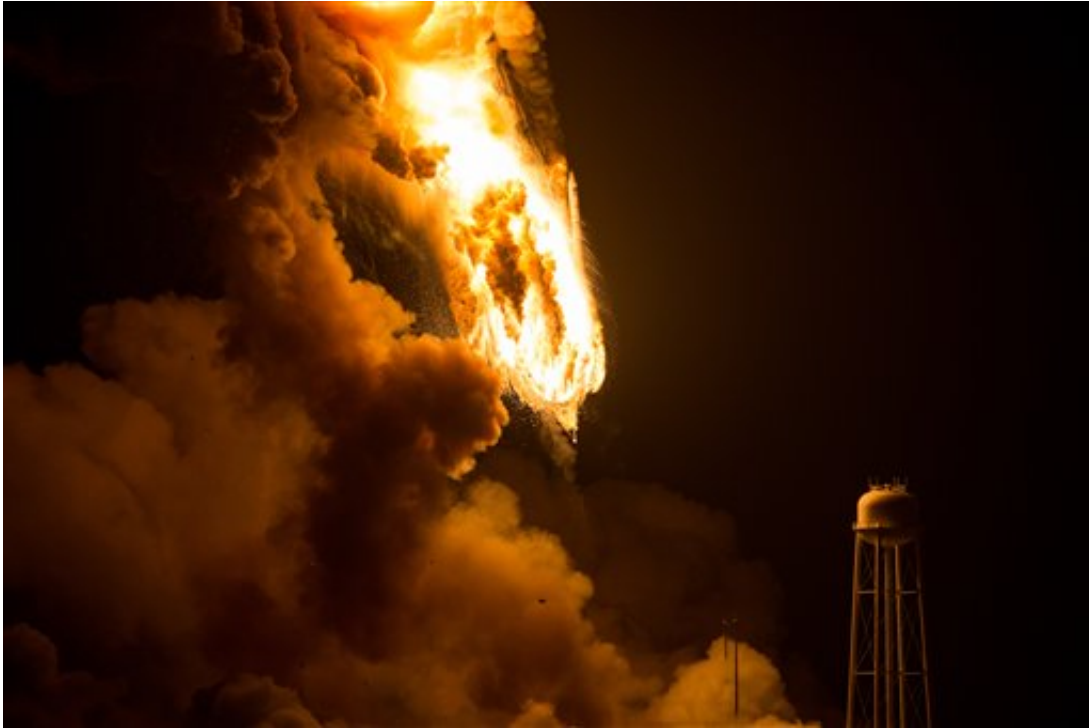
This Tuesday Oct 28, 2014 photo provided by NASA shows the Orbital Antares rocket, after it suffered a catastrophic anomaly moments after launch at NASA's Wallops Flight Facility in Virginia. The Cygnus spacecraft was filled with supplies slated for the International Space Station, including science experiments, experiment hardware, spare parts, and crew provisions. (Joel Kowsky/NASA via AP)

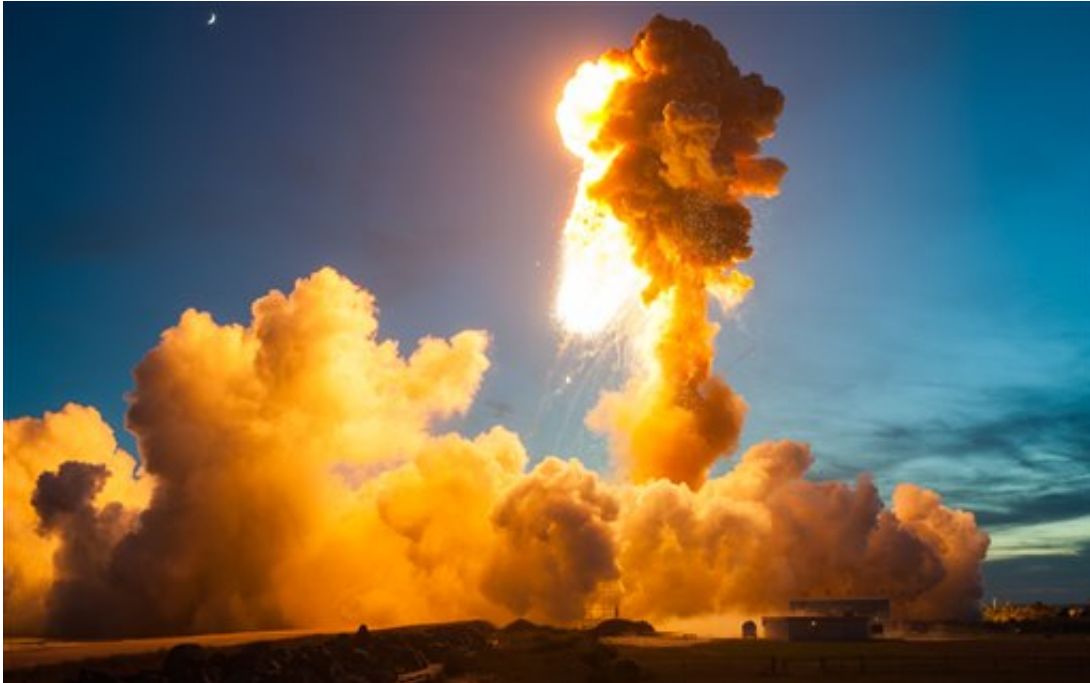
This Tuesday Oct 28, 2014 photo provided by NASA shows the Orbital Antares rocket, after it suffered a catastrophic anomaly moments after launch at NASA's Wallops Flight Facility in Virginia. The Cygnus spacecraft was filled with supplies slated for the International Space Station, including science experiments, experiment hardware, spare parts, and crew provisions. (Joel Kowsky/NASA via AP)

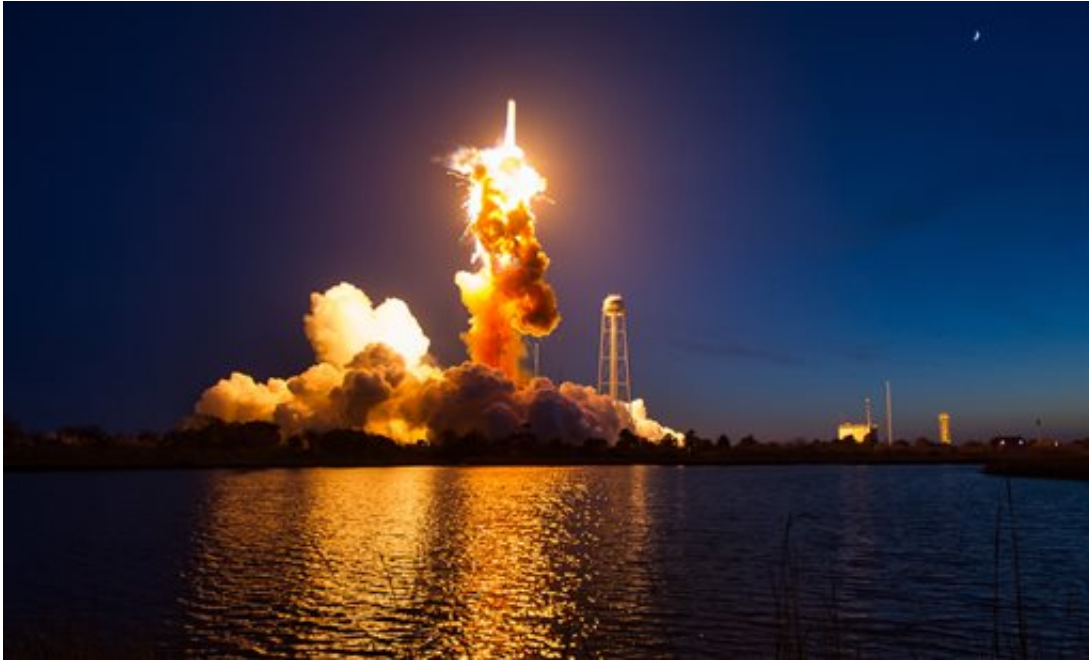
This Tuesday Oct 28, 2014 photo provided by NASA shows the Orbital Antares rocket, after it suffered a catastrophic anomaly moments after launch at NASA's Wallops Flight Facility in Virginia. The Cygnus spacecraft was filled with supplies slated for the International Space Station, including science experiments, experiment hardware, spare parts, and crew provisions. (Joel Kowsky/NASA via AP)

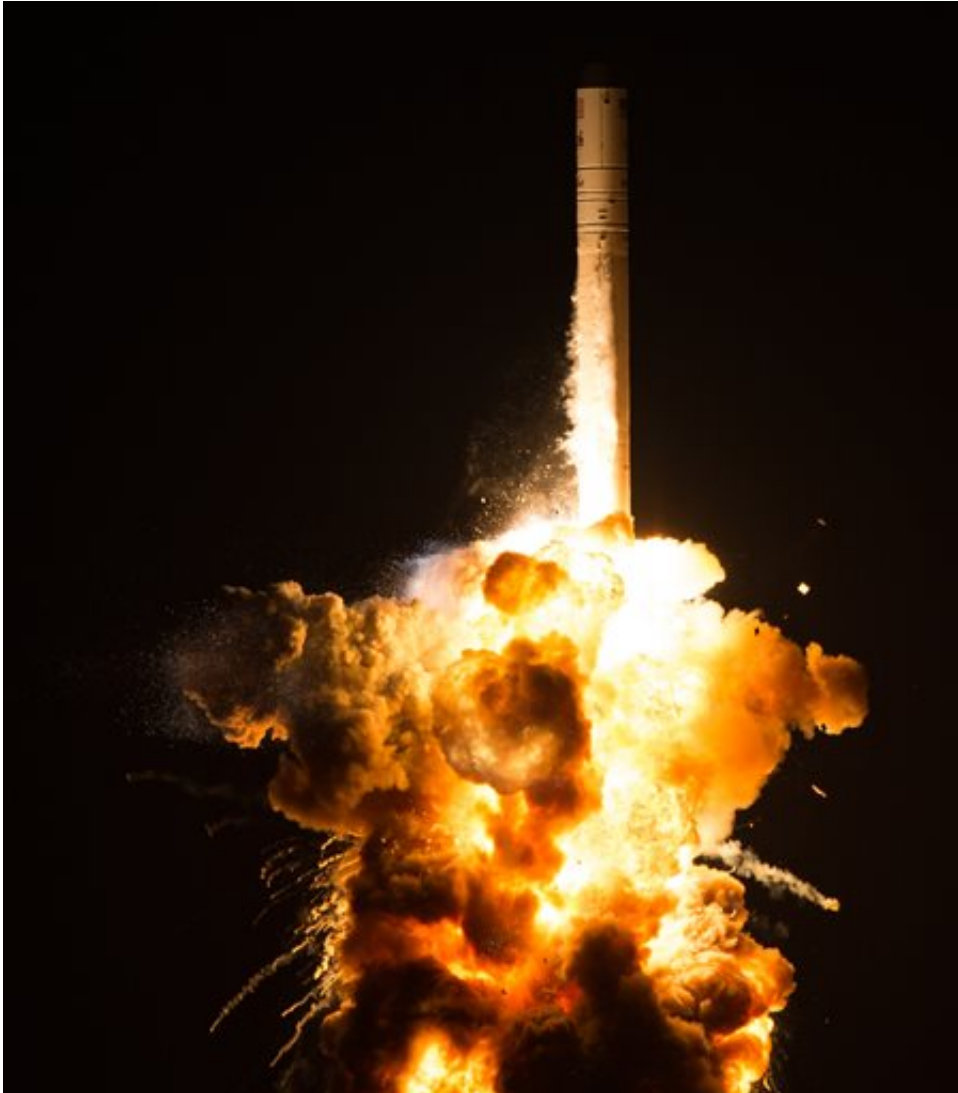
This Tuesday Oct 28, 2014 photo provided by NASA shows the Orbital Antares rocket, after it suffered a catastrophic anomaly moments after launch at NASA's Wallops Flight Facility in Virginia. The Cygnus spacecraft was filled with supplies slated for the International Space Station, including science experiments, experiment hardware, spare parts, and crew provisions. (Joel Kowsky/NASA via AP)
