Thin walls with potentially fatal consequences

Given the choice between safer and cheaper construction, many housing design companies in earthquake-prone developing countries see themselves forced to save on expensive construction materials and opt for the latter. EPFL structural engineers have gathered new data on how these structures respond to earthquakes, and in which circumstances they may fail.

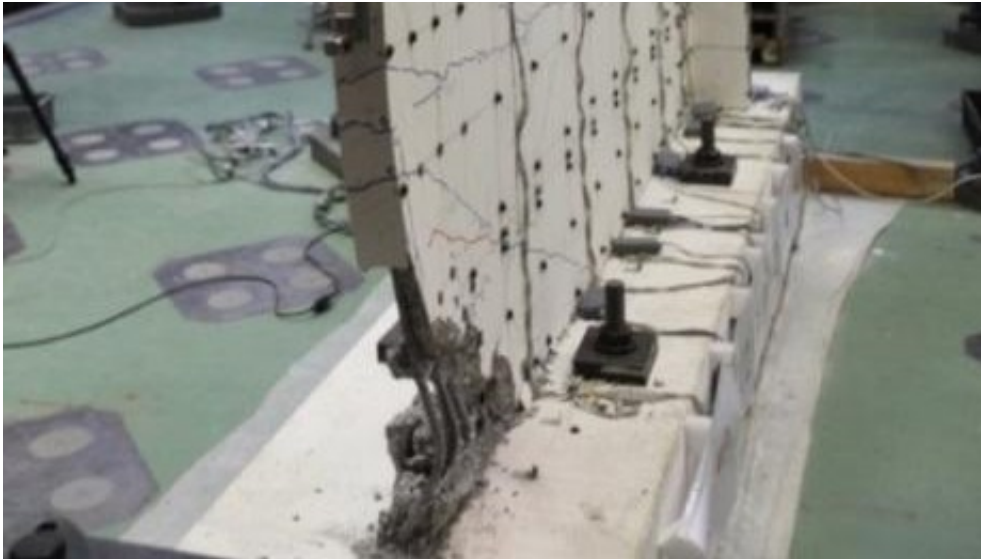
Credit: EPFL – EESD
