Geomorphic impact of the flooding caused by tropical storm Lee in September 2011

December 29 2015

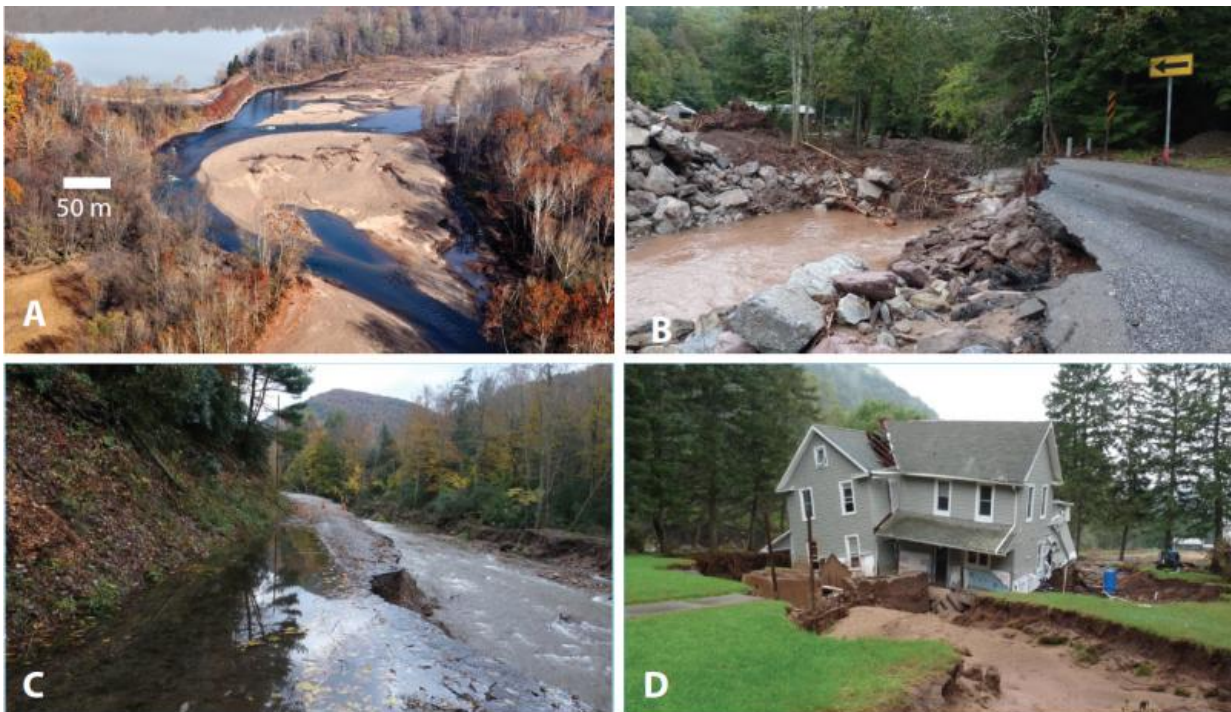
Examples of erosion and deposition in north-central Pennsylvania from Tropical Storm Lee. (A) Extensive gravel bars formed in a disequilibrium zone on lower Fishing Creek. (B) Washed out bridge in upper Muncy Creek. (C) Eroded road along Big Bear Creek, upper Loyalsock Creek watershed. (D) House eroded on a Pleistocene terrace, Loyalsock Creek. Credit: R. Craig Kochel et al. and *Geosphere*.

Channel widening (in places >100%) and bank erosion were common, and huge volumes of gravel were transported during the [flood](#). Flood flows resulted in a significant threshold, crossing where channel patterns shifted from single-channel to multi-thread along many reaches.

After the logging era, infrastructure (including homes, highways, and farms) was established on the floodplain that was protected by the berms. The 2011 flood breached these berms, aggraded channels with gravel bars to floodplain elevations, and resulted in numerous avulsions and chutes eroded through the insides of meander bends. These changes reconnected the modified single-channel system with its preexisting multi-thread channel system and resulted in extensive damage to highways, bridges, farms, homes, and other infrastructure in the region.
