# Fewer landslides than expected after 2015 Nepal earthquake

December 16 2015

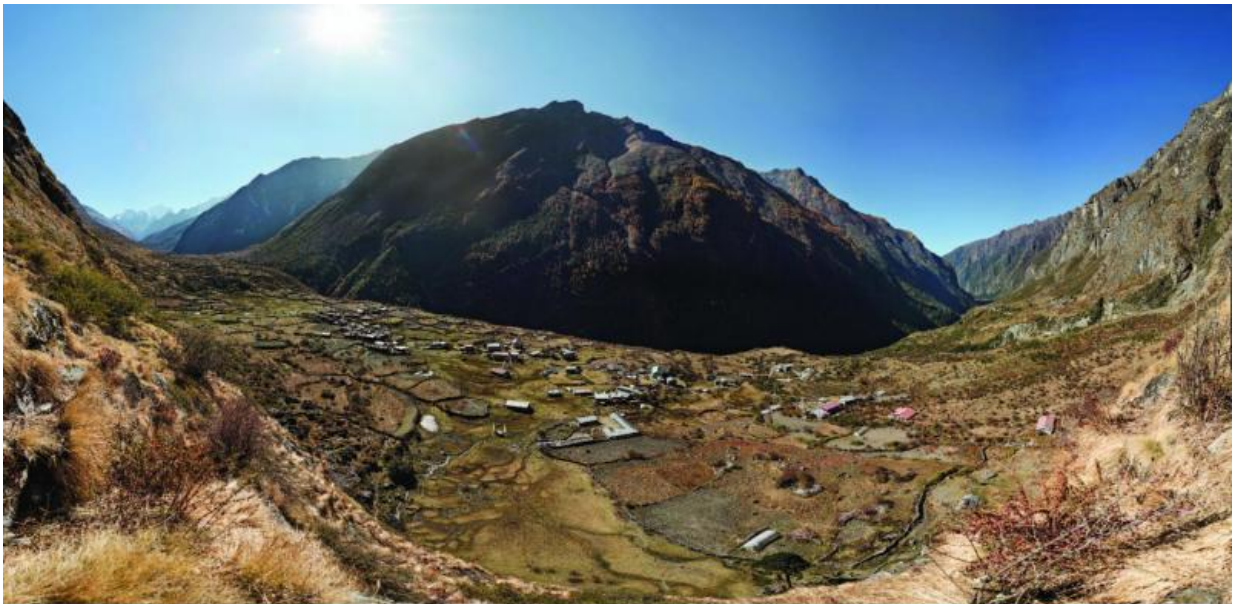
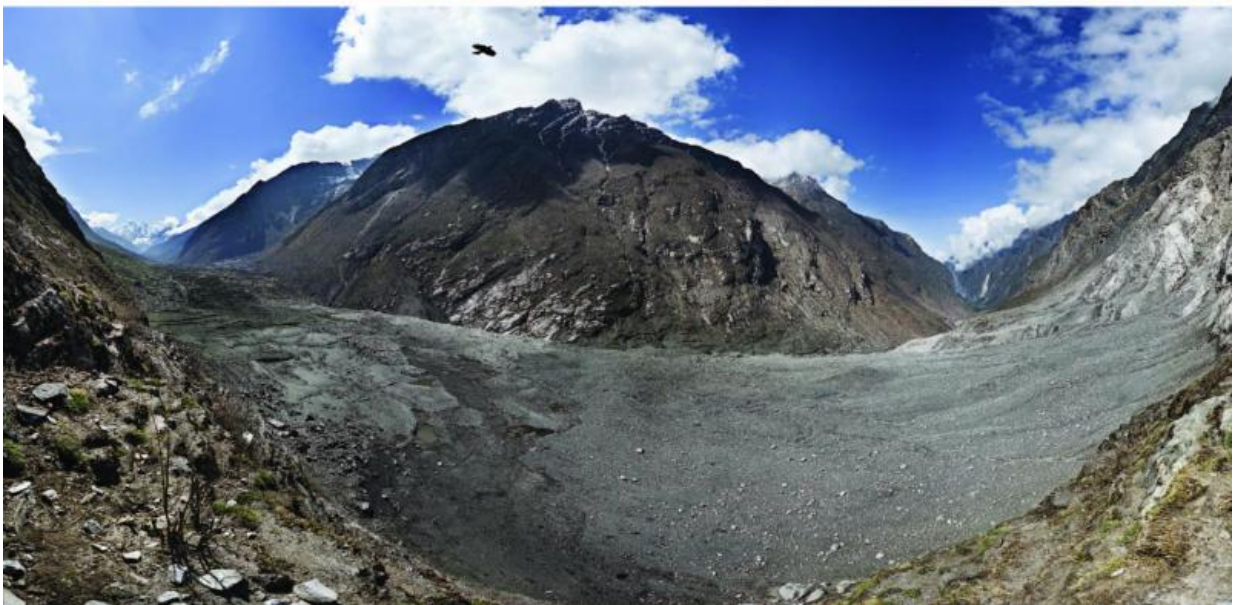
This composite photo shows the village of Langtang, located within the Himalayan mountain region of Nepal, before and after the April 25, 2015 Gorkha earthquake. More than 350 people are estimated to have died as a result of the earthquake-induced landslide. Credit: David Breashears/GlacierWorks
