Mysterious menominee crack is unusual geological pop-up feature

February 9 2016

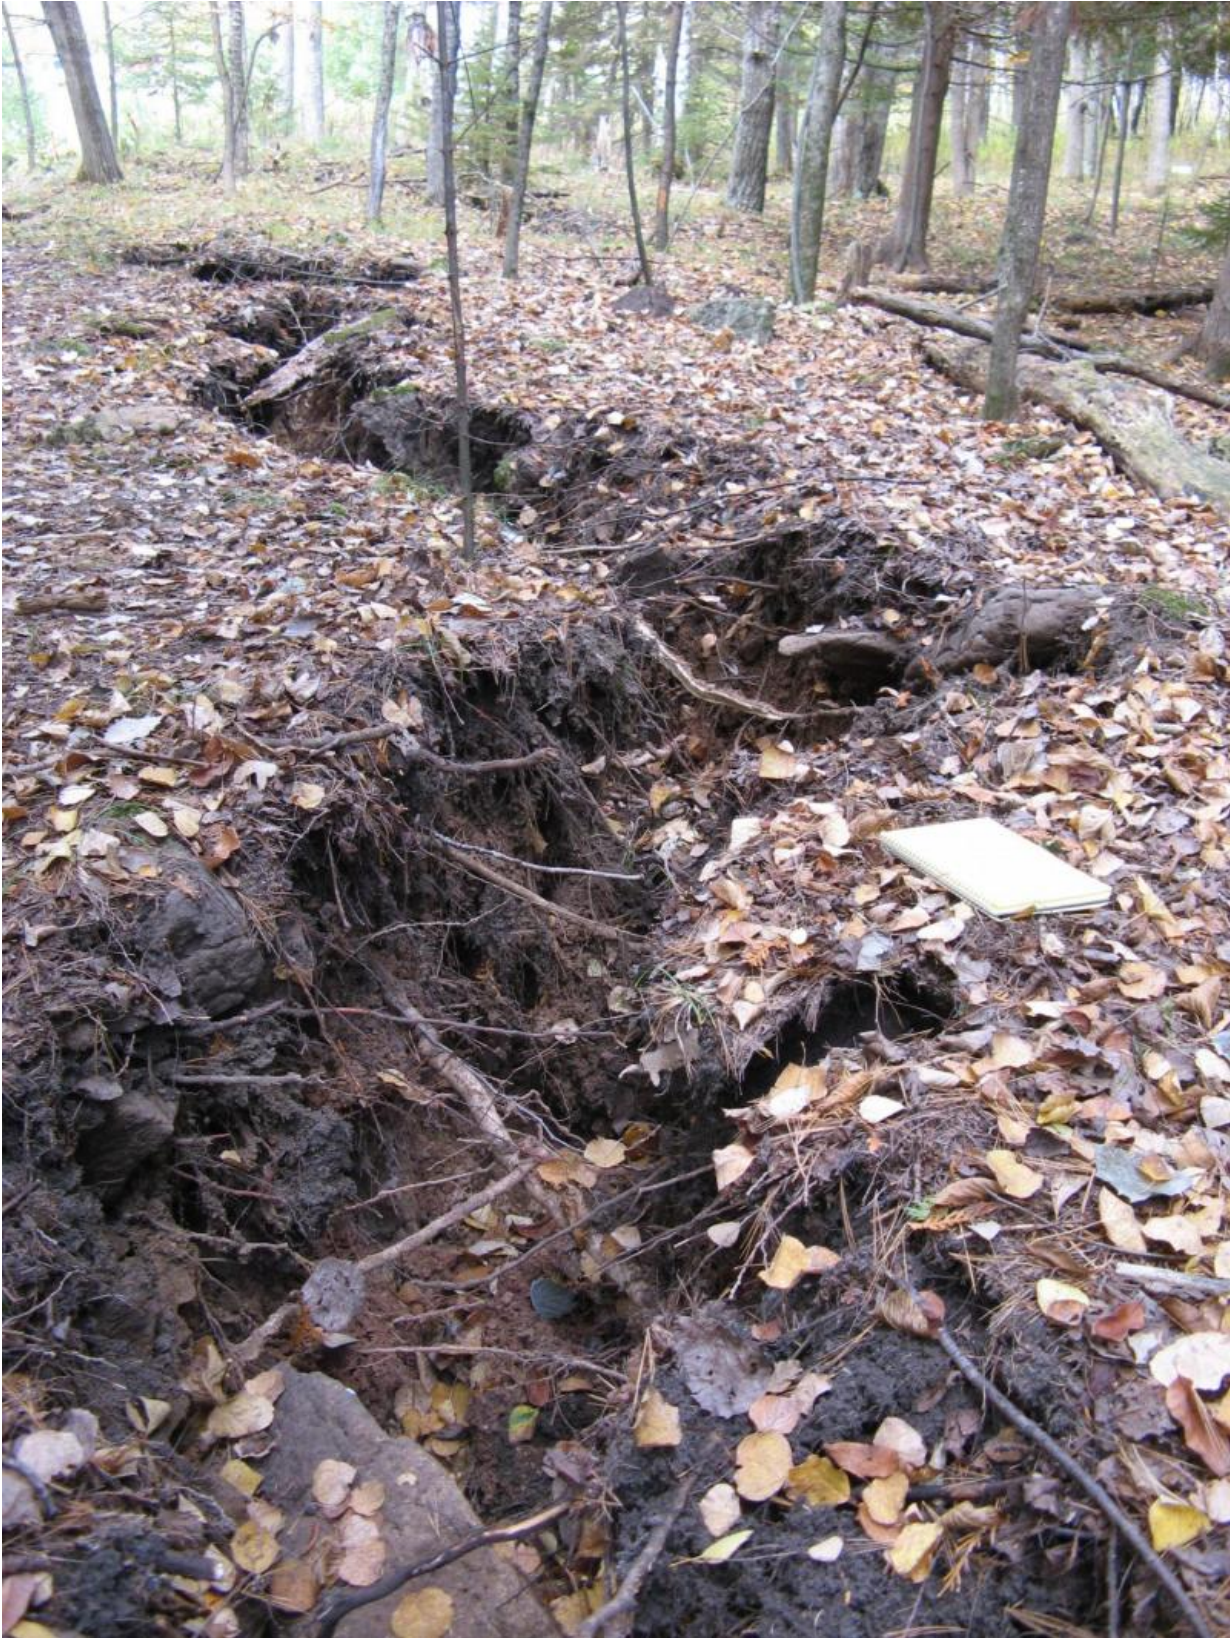
A photo taken in 2010 of the Menominee Crack, a 'pop-up' geological feature.
Credit: Wayne Pennington/ Michigan Technological University

big double-trunked white pine tree a few days earlier. The crack split the ground for 110 meters, and was as deep as 1.7 meters in some places. Tree trunks tilted at precarious angles on either side of the fracture.

In broken rock, the waves travel faster as they move parallel to cracks in the rock, and slower when they move perpendicular to the cracks and have to travel across the fractures. The scientists found a pattern of refraction speeds that seemed to be consistent with the intense bending and then fracturing of the brittle limestone of a pop-up feature.

play, Pennington and his colleagues had to do a little detective work. The limestone in the area may have been stressed almost to the point of cracking when the last glaciers retreated, they say. The recent removal of the double-trunked pine, which may have weighed as much as 2000 kilograms—over two tons—could have been the final straw, allowing the rock to bend upward when that weight was removed.

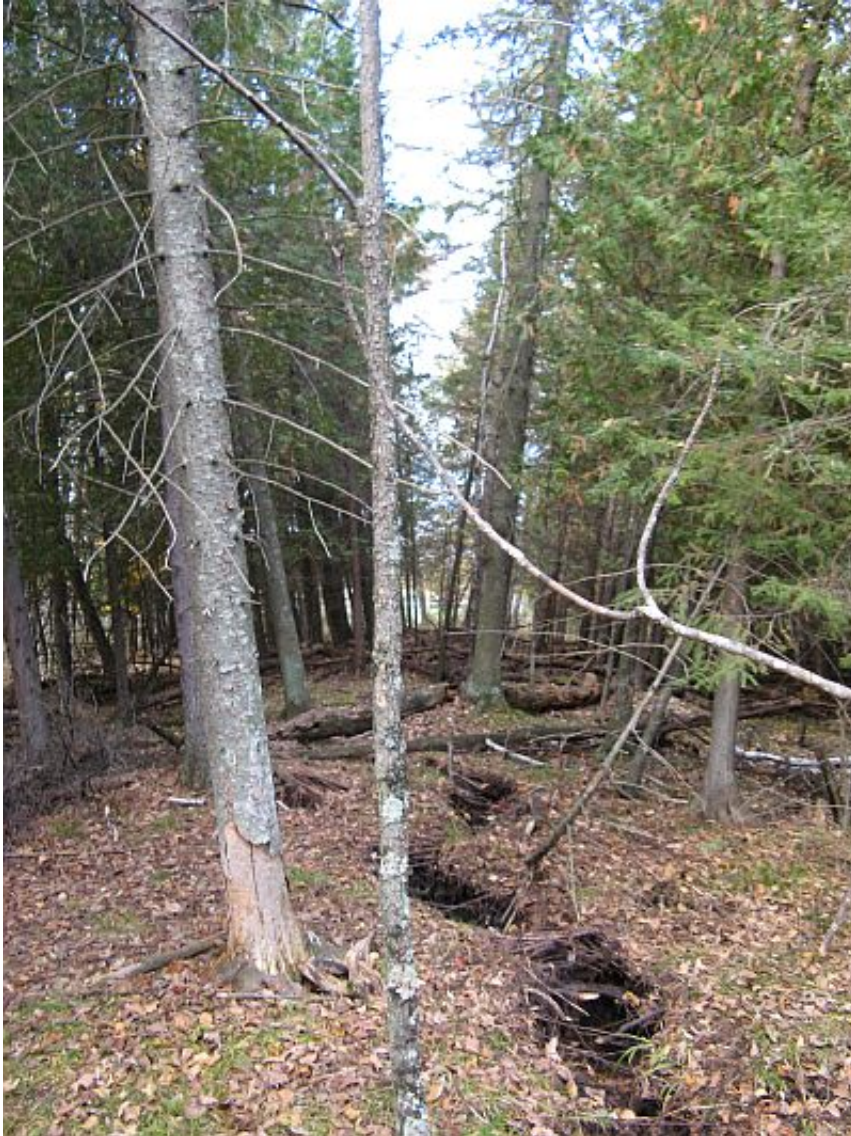
Trees tilt away from either side of the Menominee Crack 'pop-up' feature.
Credit: Wayne Pennington/ Michigan Technological University
