New tool provides successful visual inspection of space station robot arm

February 1 2016

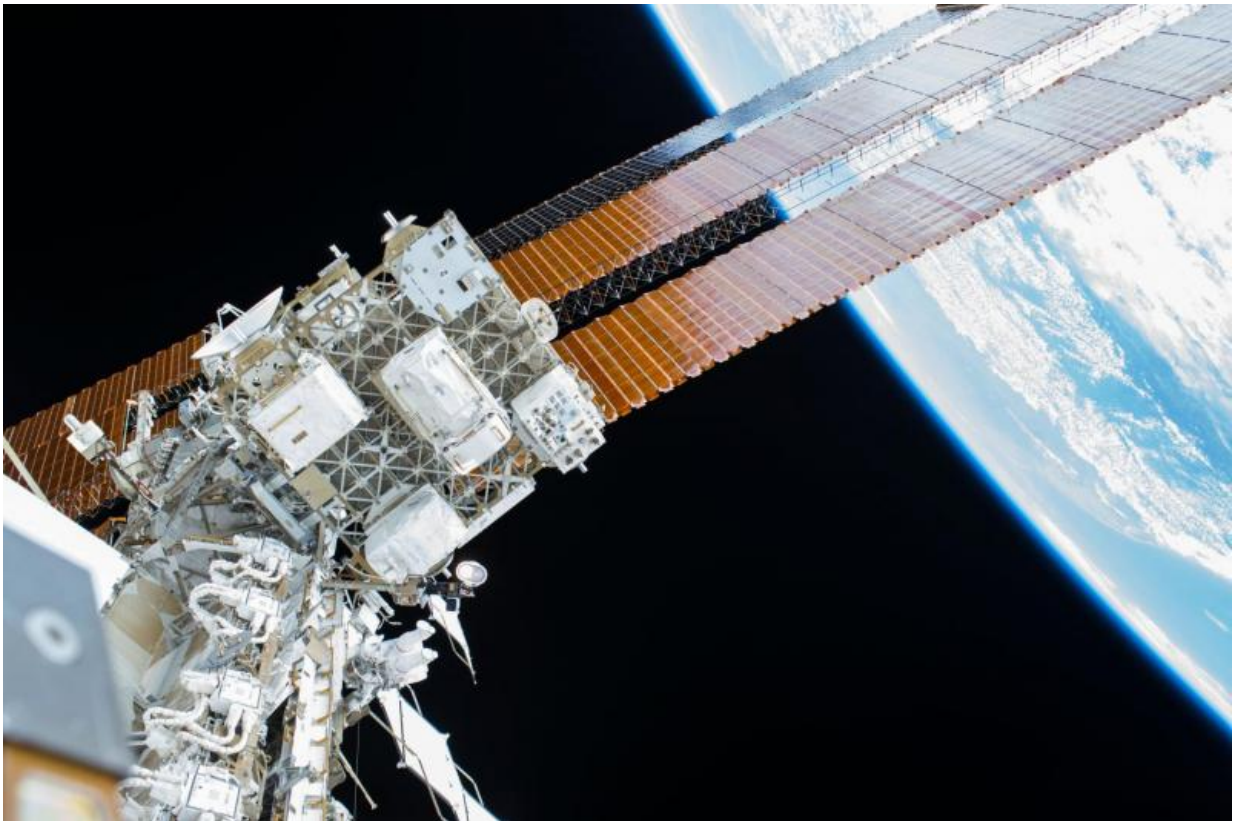
NASA's satellite servicing team tests new robotic technologies, tools and techniques using the Robotic Refueling Mission module (white platform, bottom right.) on the International Space Station. Credit: NASA

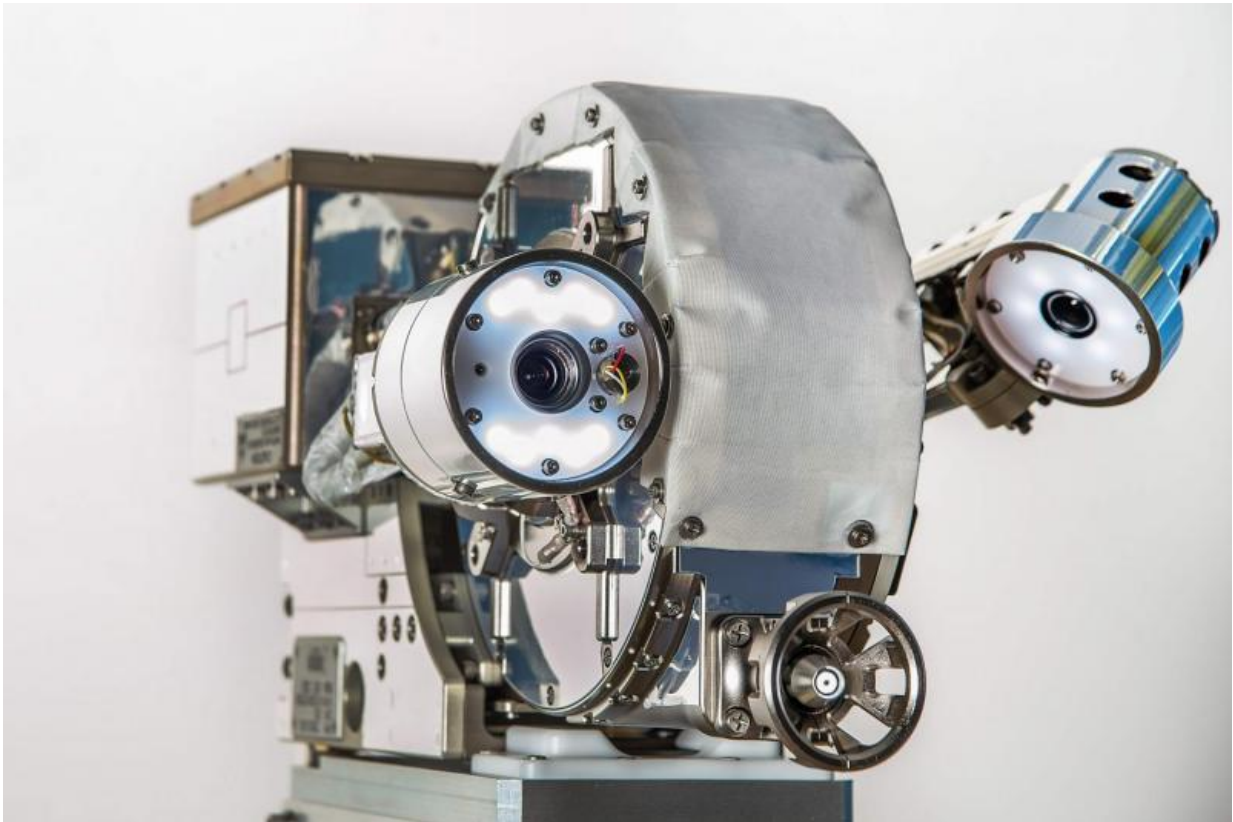
On Oct. 9., 2015, NASA used the zoom lens (left) on VIPIR, a new inspection space tool, to examine an unexplained discoloration on the SSRMS, the Space Station Remote Manipulator System. Credit: NASA/Chris Gunn

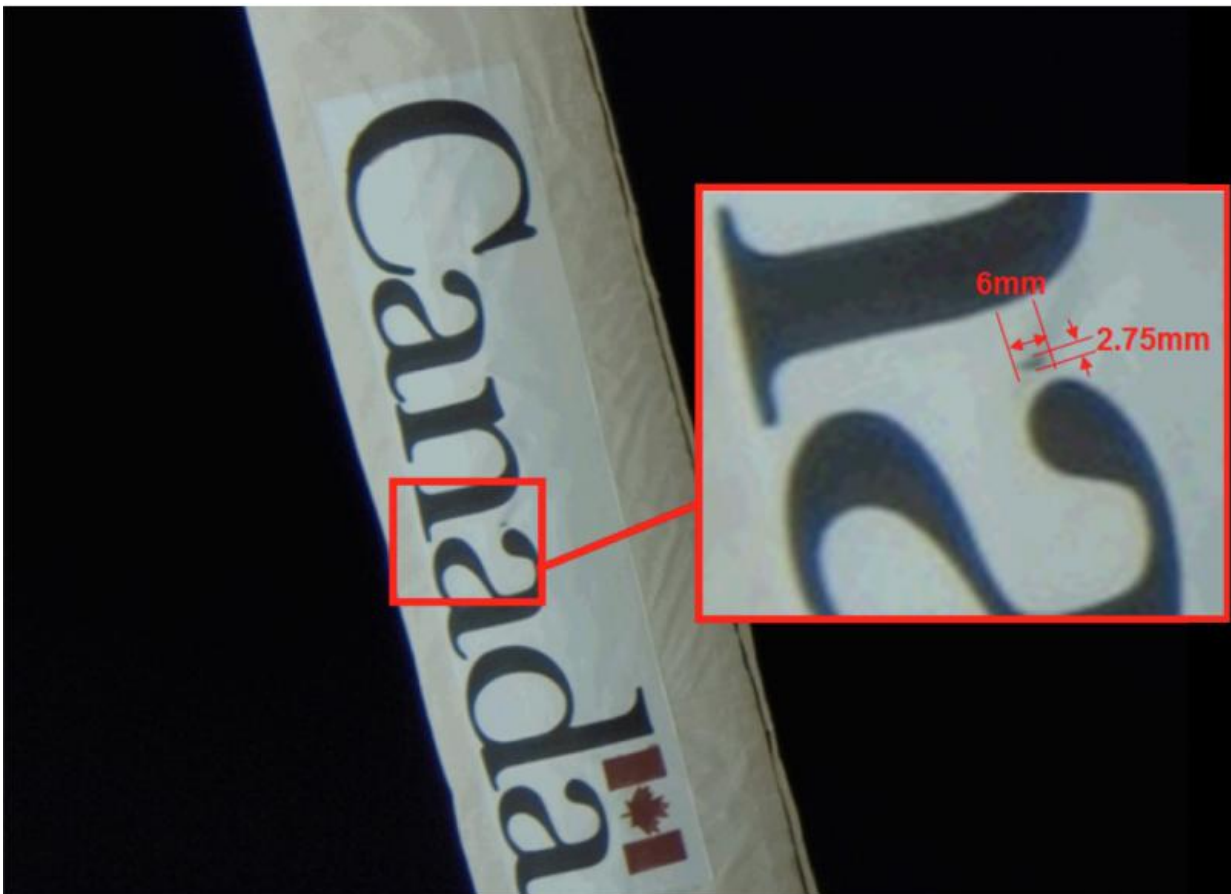
"The space station's fixed cameras could only tell us so much," says Ron Ticker, space station manager for development. "We suspected that it may have been a micrometeoroid strike, but without a closer look, we couldn't conclusively determine what had happened to create this marking."

An unusual black mark on the Space Station Remote Manipulator System -- a robotic arm on the International Space Station -- had mystified mission directors. Credit: NASA/JSC - Image Science and Analysis Group

"The results from VIPIR were phenomenal," said Ticker. "From a distance of approximately eight inches, VIPIR was able to resolve details as small as three-thousandths of an inch (.003") - about ten times thinner than the thickness of a credit card. From VIPIR's footage, we were able to discern that the black mark was in fact a raised mass at the inspection site."

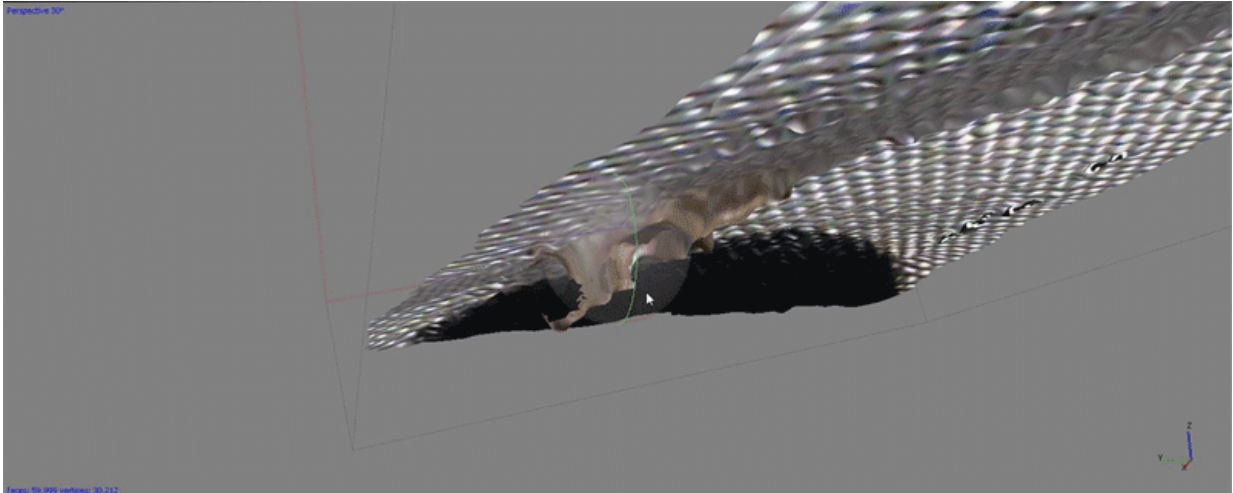
The Image Science and Analysis Group at Johnson is continuing to analyze the results from VIPIR's inspection. 3D models (as shown in this GIF), built from VIPIR imagery and supplemental data, are helping the team better understand the raised mass on the space station's arm. Credit: NASA/JSC – Image Science and Analysis Group

The Image Science and Analysis Group is now analyzing the results from VIPIR's inspection to determine the cause. Initial finds from a 3D analytical tool confirm the slightly elevated structure for most of the anomaly. Further work is planned to try to characterize internal detail

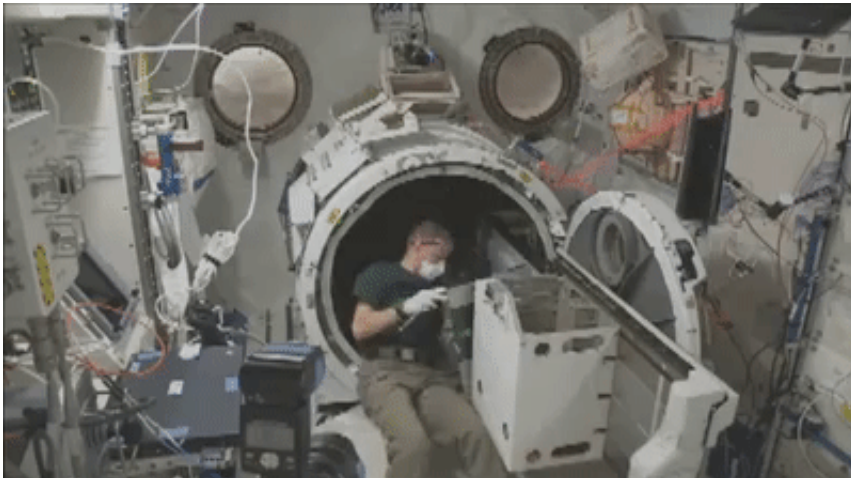
NASA astronaut Tim Kopra and ESA astronaut Tim Peake remove the RRM task board from the slide table of the Japanese Experiment Module (JEM) airlock. Credit: NASA

During the week of Jan. 4, the team completed the last scientific objective on the RRM checklist: exposing a special set of solar cells to the sunlight to assess their performance. The RRM project is hosting this experiment in collaboration with NASA's Glenn Research Center in Cleveland. On Jan. 8, the RRM task board holding this investigation
