Post-wildfire erosion can be major sculptor of forested western mountains

April 18 2016

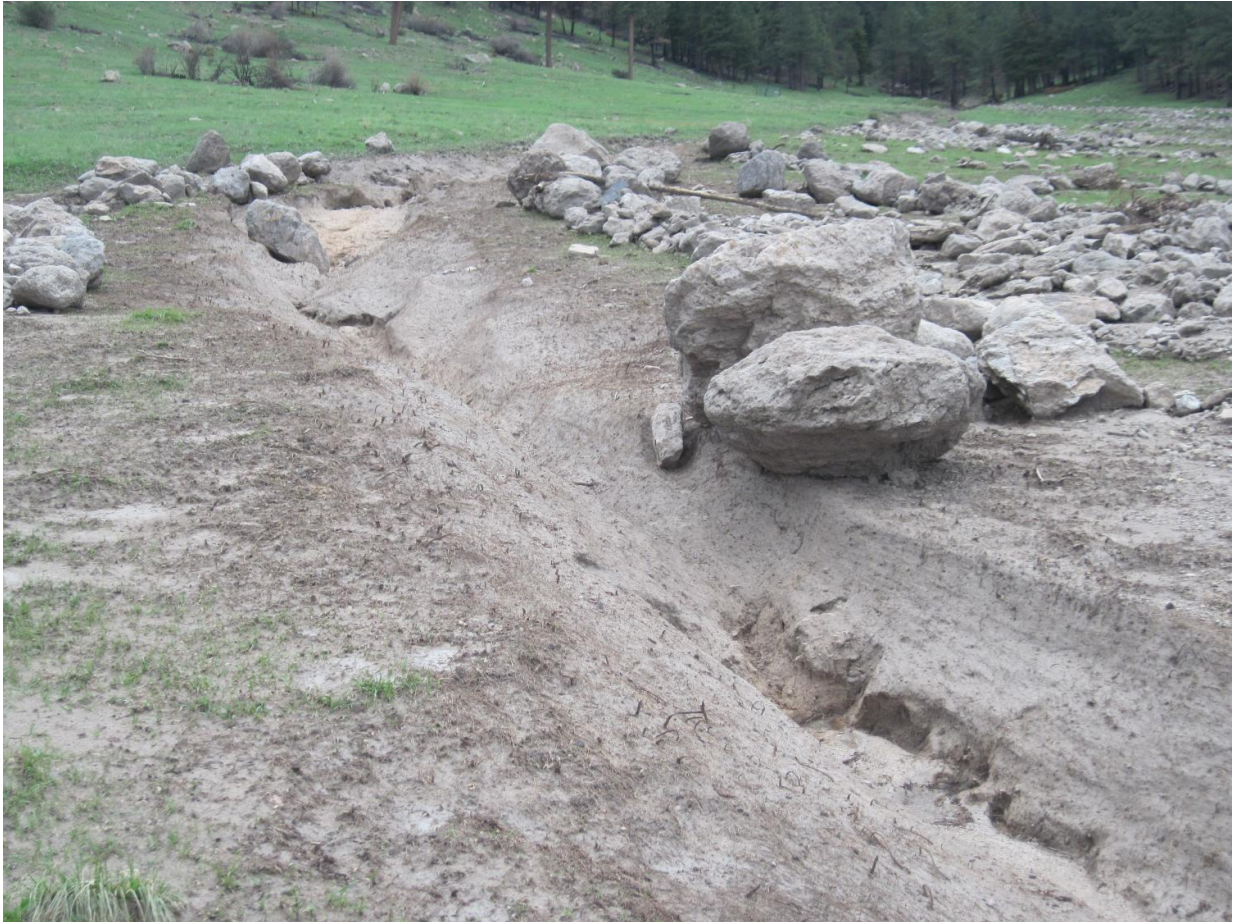
Two weeks after New Mexico's 2011 Las Conchas fire severely burned Cerro del Medio, post-storm flooding carried debris from the mountain into meadow below, including the 1.5 meter by 1 meter boulder in the foreground of the photo. Credit: Caitlin Orem

A nearby mountain with similar terrain, Cerro del Medio, had a severe forest fire in 2011, giving the team the opportunity to measure post-wildfire erosion directly. Post-fire, the increase in erosion was obvious—boulders the size of office desks had rolled down the slopes and into the meadow below.

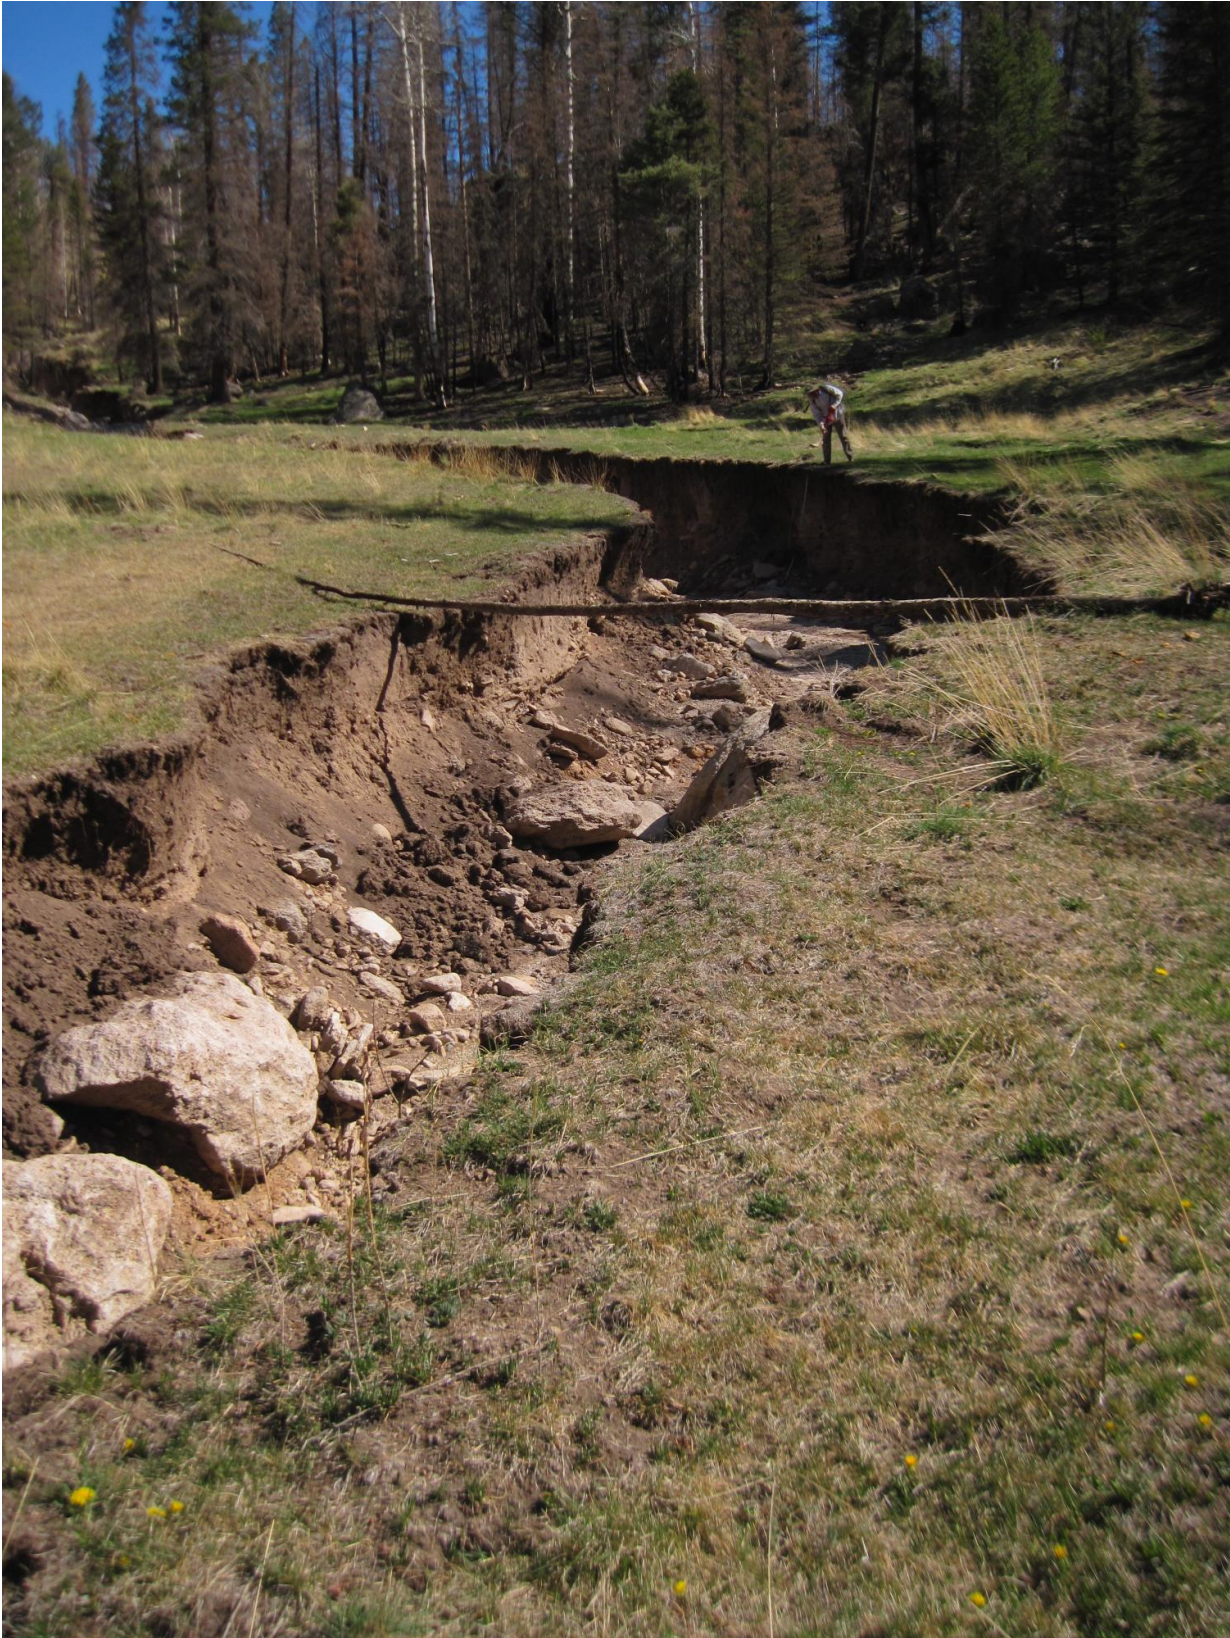
Once the 2011 Las Conchas fire burned this forested region of New Mexico's Valles Grande, water from summer rainstorms tore this ravine through a grassy meadow. The ravine is greater than 2 meters deep. Credit: Caitlin Orem

"Over millennia there's a gradual transfer of soil from high spots to low spots," Pelletier said. "Most of the post-fire erosion is in the streambed. In the time period between fires, soil is still moving, but it's moving to fill in the hole created by the flooding just after the fire."
