# Ancient temples in the Himalaya reveal signs of past earthquakes

July 26 2016

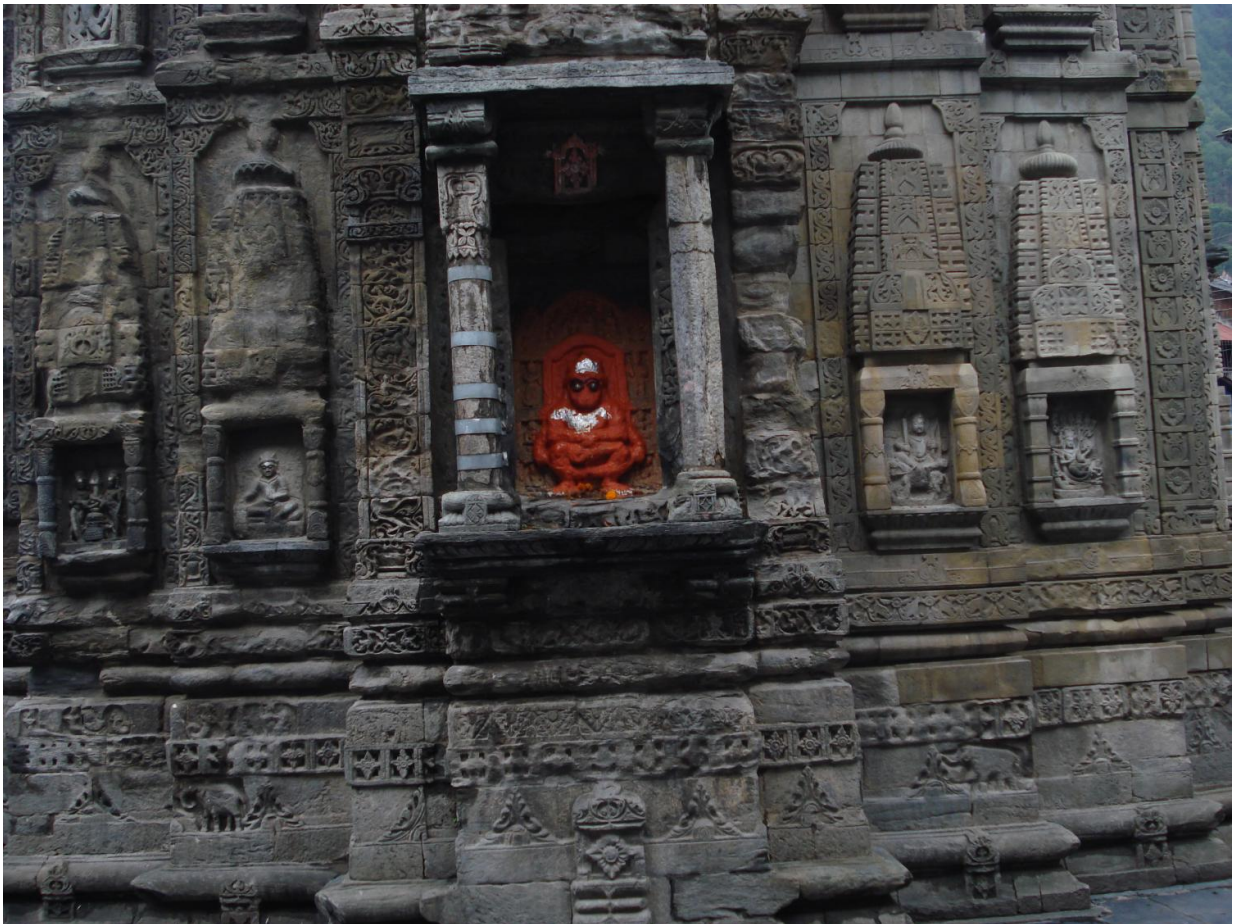
Damaged and clamped pillar at Lakshi Narayan temple, Chamba, India. Damage likely to have occurred during the 1555 Kashmir earthquake. Credit: Mayank Joshi

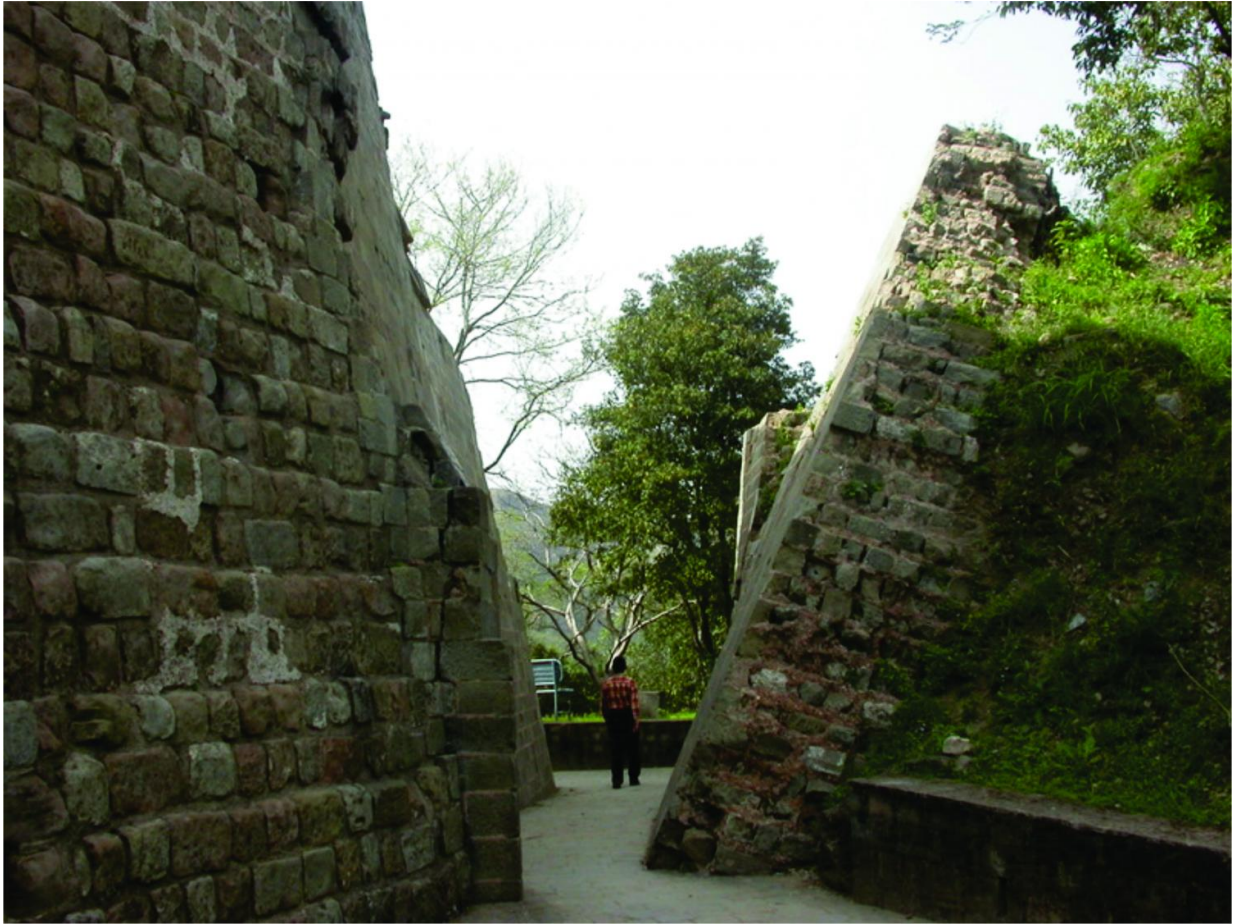
A tilted wall in the Kangra Fort at Kangra, India due to 1905 Kangra earthquake.  
Credit: Mayank Joshi

Other earthquake damage uncovered by the researchers included upwarping of stone floors, cracked walls, and a precariously leaning fort wall.

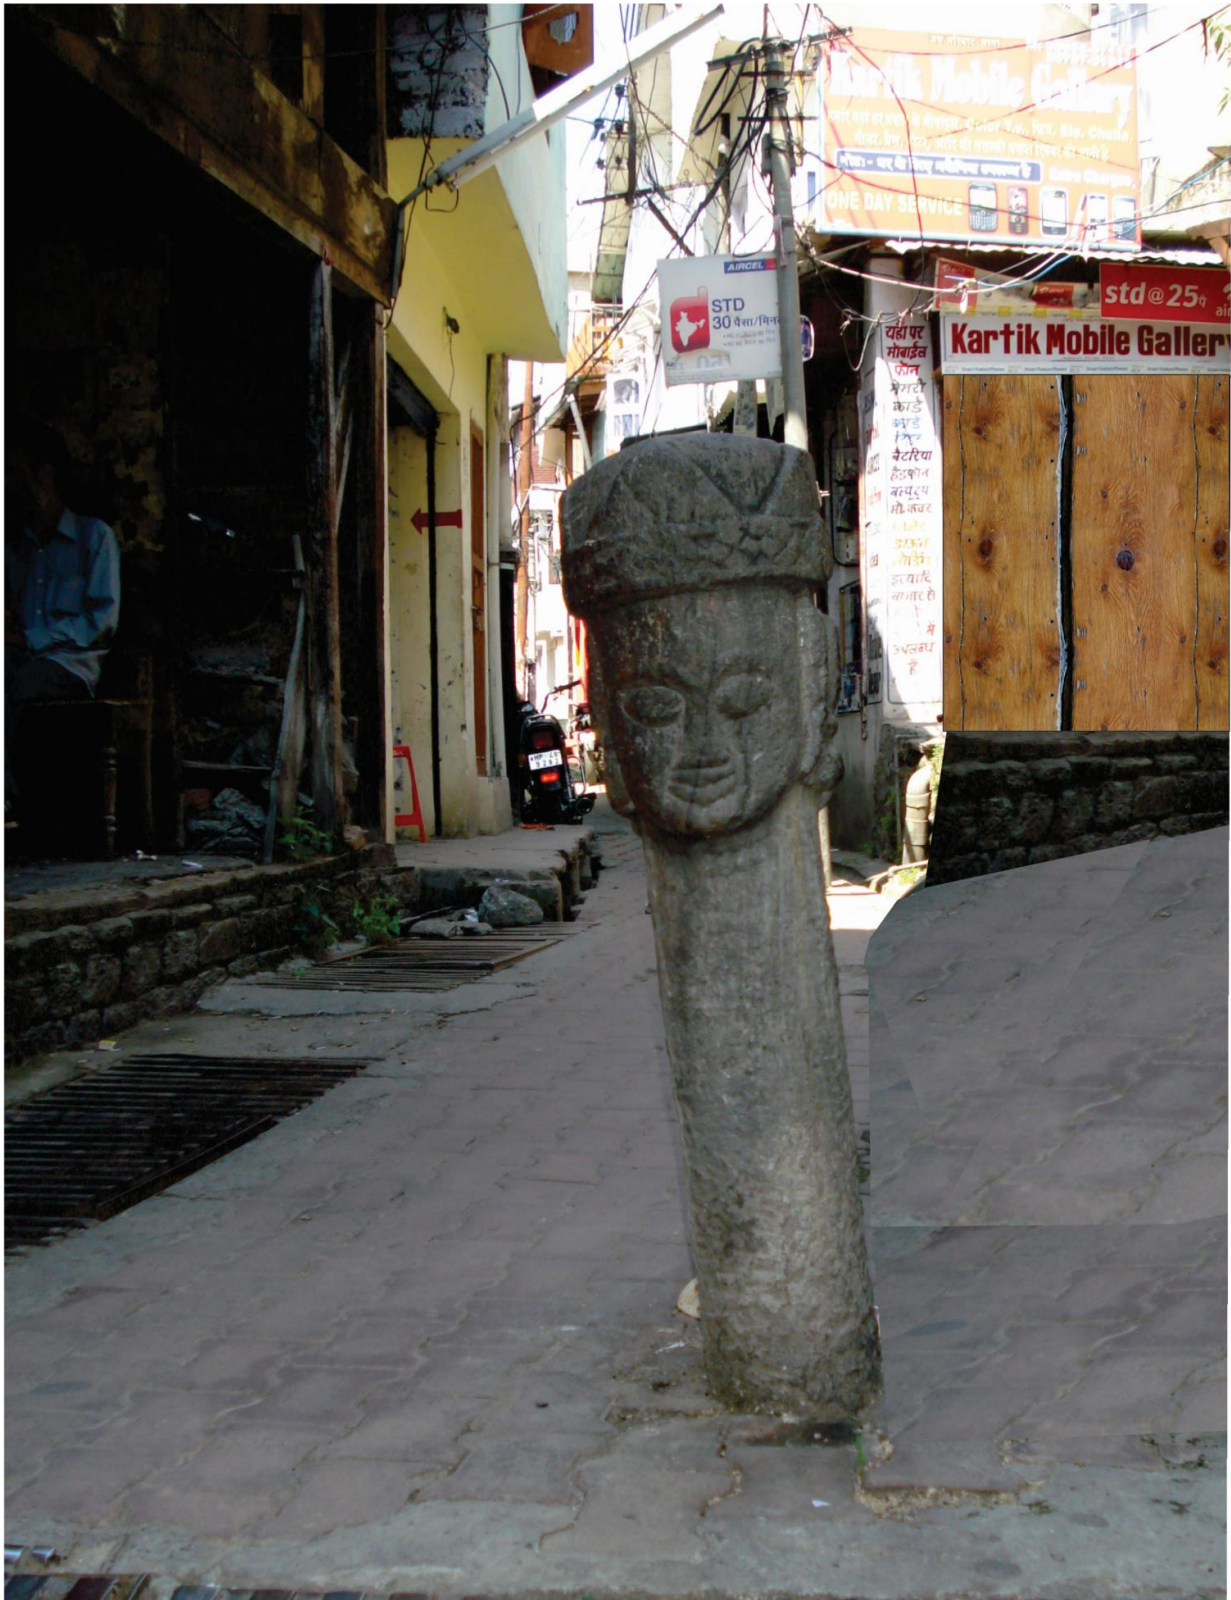
Outside the Lakshi Narayan temple, in Chamba, India, a stone pillar with human

face carving is tilted. The tilting is likely the result of the 1555 Kashmir earthquake. Credit: Mayank Joshi

"In the Chamba-area [temples](#), there are some marker features that indicate that the body of the temple structure has suffered some internal deformation," said Joshi. "The pillars and temple structures are tilted with respect to their original positions. The rooftop portions show tilting or displacement."
