Ancient temples in the Himalaya reveal signs of past earthquakes

July 26 2016

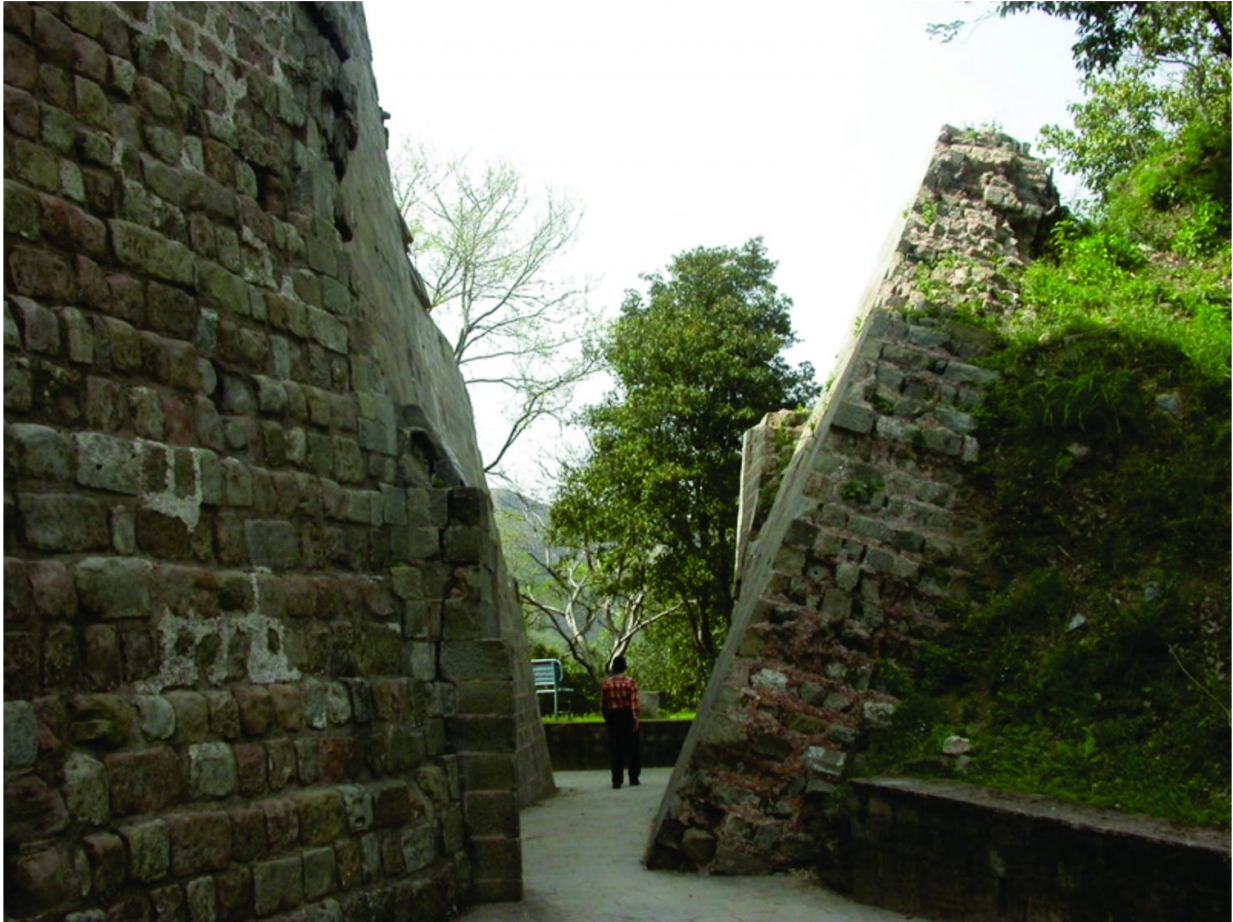
A tilted wall in the Kangra Fort at Kangra, India due to 1905 Kangra earthquake.
Credit: Mayank Joshi

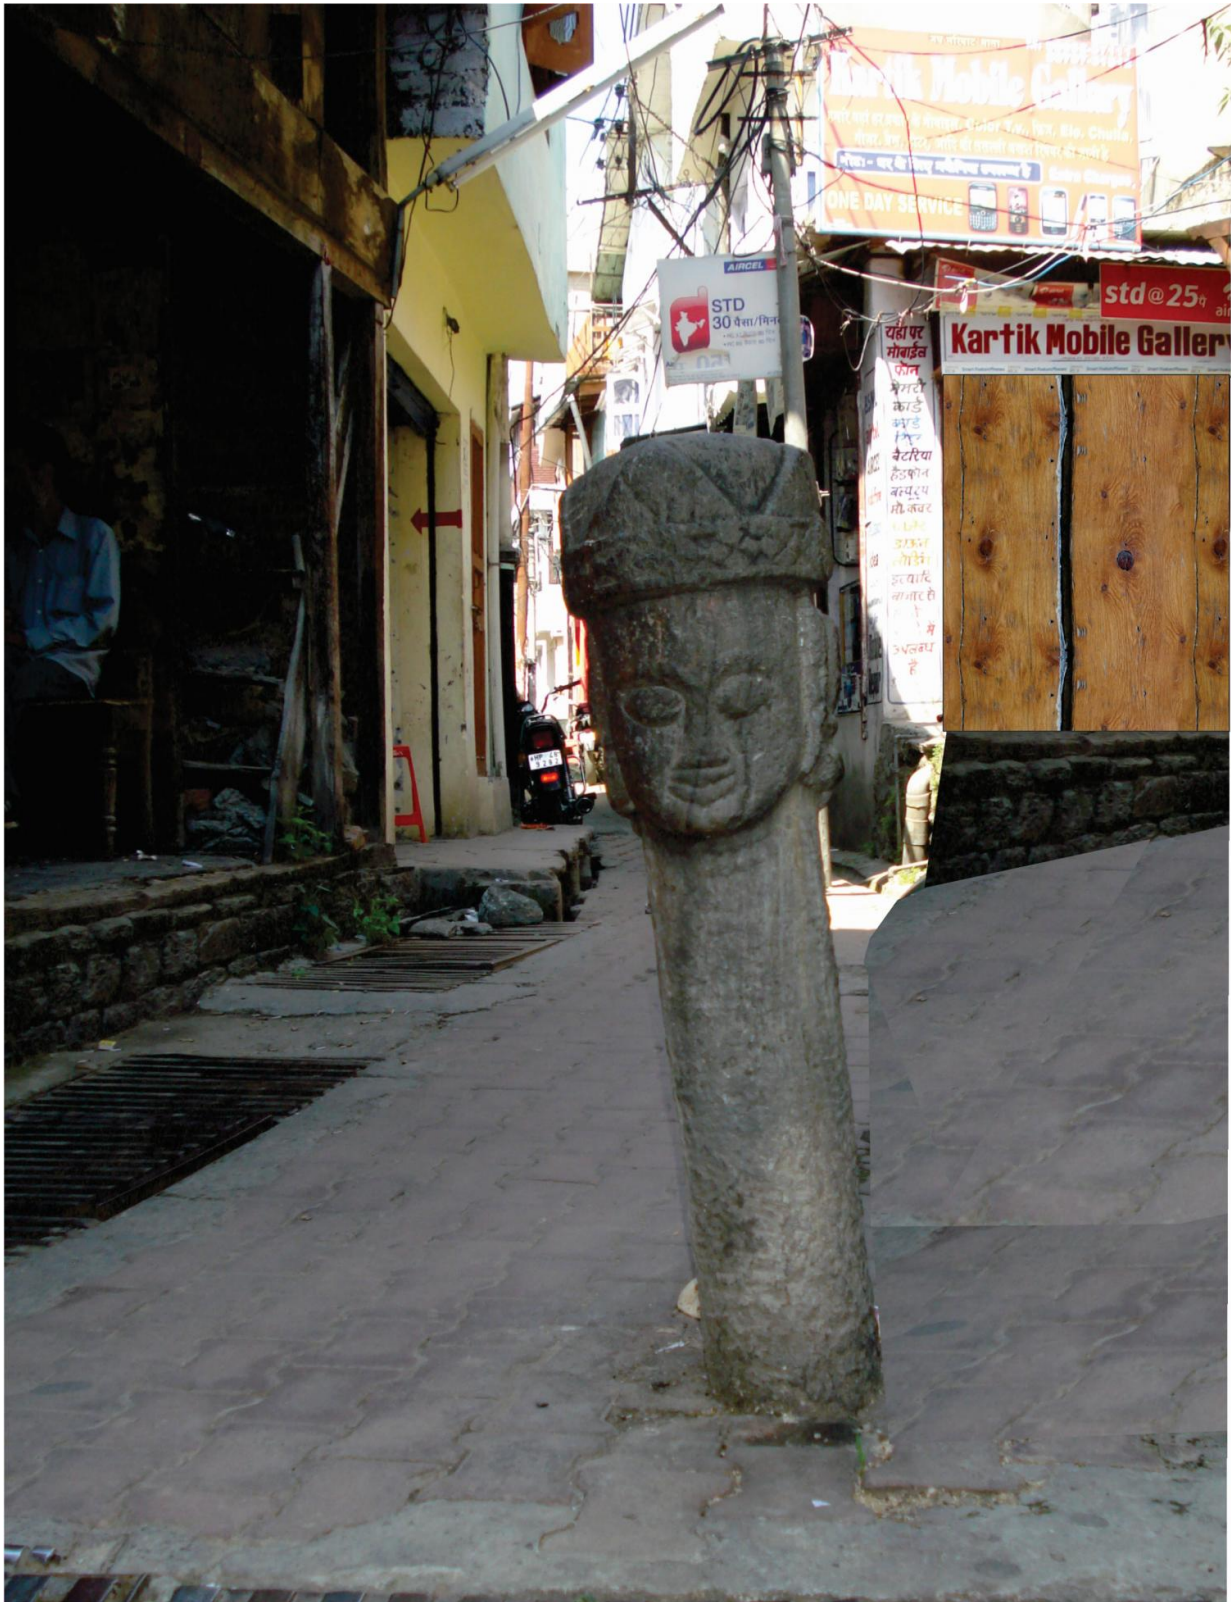
Outside the Lakshi Narayan temple, in Chamba, India, a stone pillar with human

face carving is tilted. The tilting is likely the result of the 1555 Kashmir earthquake. Credit: Mayank Joshi

"In the Chamba-area [temples](#), there are some marker features that indicate that the body of the temple structure has suffered some internal deformation," said Joshi. "The pillars and temple structures are tilted with respect to their original positions. The rooftop portions show tilting or displacement."
