Schiaparelli crash site in colour

November 4 2016

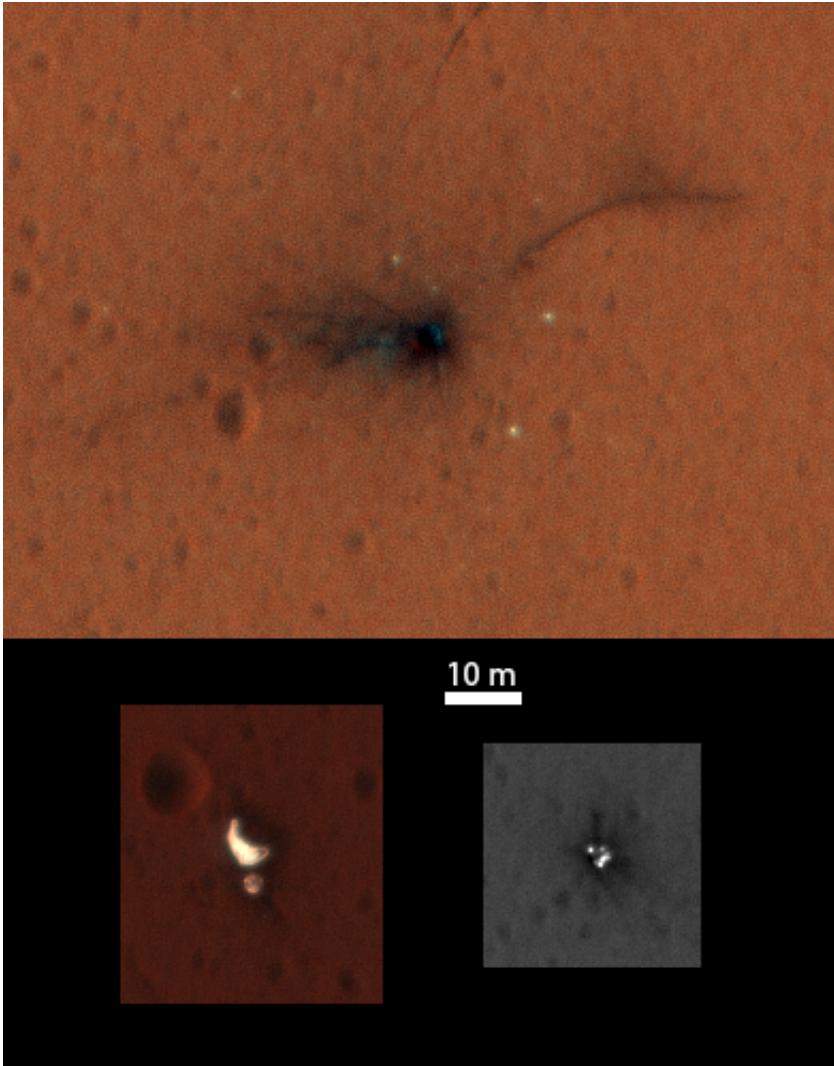
Composite of the ExoMars Schiaparelli module elements seen by NASA's Mars Reconnaissance Orbiter High Resolution Imaging Science Experiment (HiRISE) on 1 November 2016. Both the main impact site (top) and the region with the parachute and rear heatshield (bottom left) are now captured in the central portion of the HiRISE imaging swath that is imaged through three different filters, enabling a colour image to be constructed. The front heatshield (bottom

right) lies outside the central colour imaging swath. The colours have been graded according to the specific region to best reveal the contrast of features against the martian background. Credit: NASA/JPL-Caltech/University of Arizona

The new image of Schiaparelli and its hardware components was taken by NASA's Mars Reconnaissance Orbiter, or MRO, on 1 November. The main impact site is now captured in the central portion of the swath that is imaged by the high-resolution camera through three filters, enabling a colour image to be constructed.

For example, a number of the bright white spots around the dark region interpreted as the impact site are confirmed as real objects – they are not

likely to be imaging 'noise' – and therefore are most likely fragments of Schiaparelli.

Interestingly, a bright feature can just be made out in the place where the dark crater was identified in last week's image. This may be associated with the module, but the images so far are not conclusive.

A bright fuzzy patch revealed in the colour image alongside the dark streaks to the west of the crater could be surface material disturbed in the impact or from a subsequent explosion or explosive decompression of the module's fuel tanks, for example.

A stereo reconstruction of this image in the future will also help to confirm the orientation of the rear heatshield. The pattern of bright and dark patches suggest it is sitting such that we see the outside of the heatshield and the signature of the way in which the external layer of insulation has burned away in some parts and not others – as expected.

Finally, the front heatshield has been imaged again in black and white – its location falls outside of the colour region imaged by MRO – and shows no changes. Because of the different viewing geometry between the two image sets, this confirms that the bright spots are not specular reflections, and must therefore be related to the intrinsic brightness of the object. That is, it is most likely the bright multilayer thermal insulation that covers the inside of the front heatshield, as suggested last week.

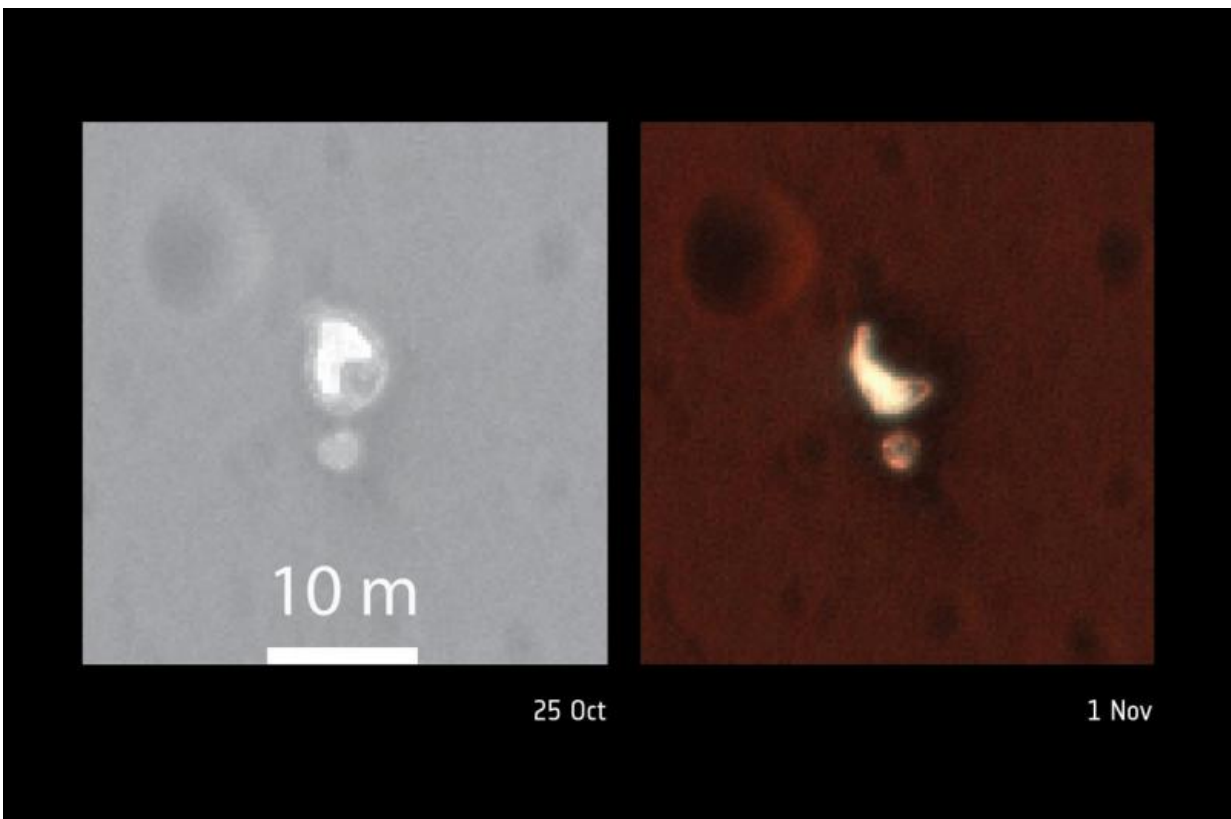
A comparison of the 25 October image taken by NASA's Mars Reconnaissance Orbiter HiRISE camera with that taken on 1 November. In the week that elapsed, the outline of Schiaparelli's parachute on the martian surface has apparently changed, which is interpreted as movement due to local wind. The parachute has a maximum diameter of 12 m, and it is attached to the rear heatshield, which measures about 2.4 m across. Aside from the obvious difference of the 1 November being in colour, the images have slightly different projections: in the colour image north is about 7° west of straight up. In addition,

the 25 October image was looking to the east, while the 1 November image was taken looking slightly to the west. Credit: NASA/JPL-Caltech/University of Arizona

About 0.9 km to the south, the parachute and rear heatshield have also now been imaged in colour. In the time that has elapsed since the last image was taken on 25 October, the outline of the parachute has changed. The most logical explanation is that it has been shifted in the wind, in this case slightly to the west. This phenomenon was also observed by MRO in images of the parachute used by NASA's Curiosity rover.
