NASA Webb Telescope structure is sound after vibration testing detects anomaly

December 28 2016, by Ken Kremer

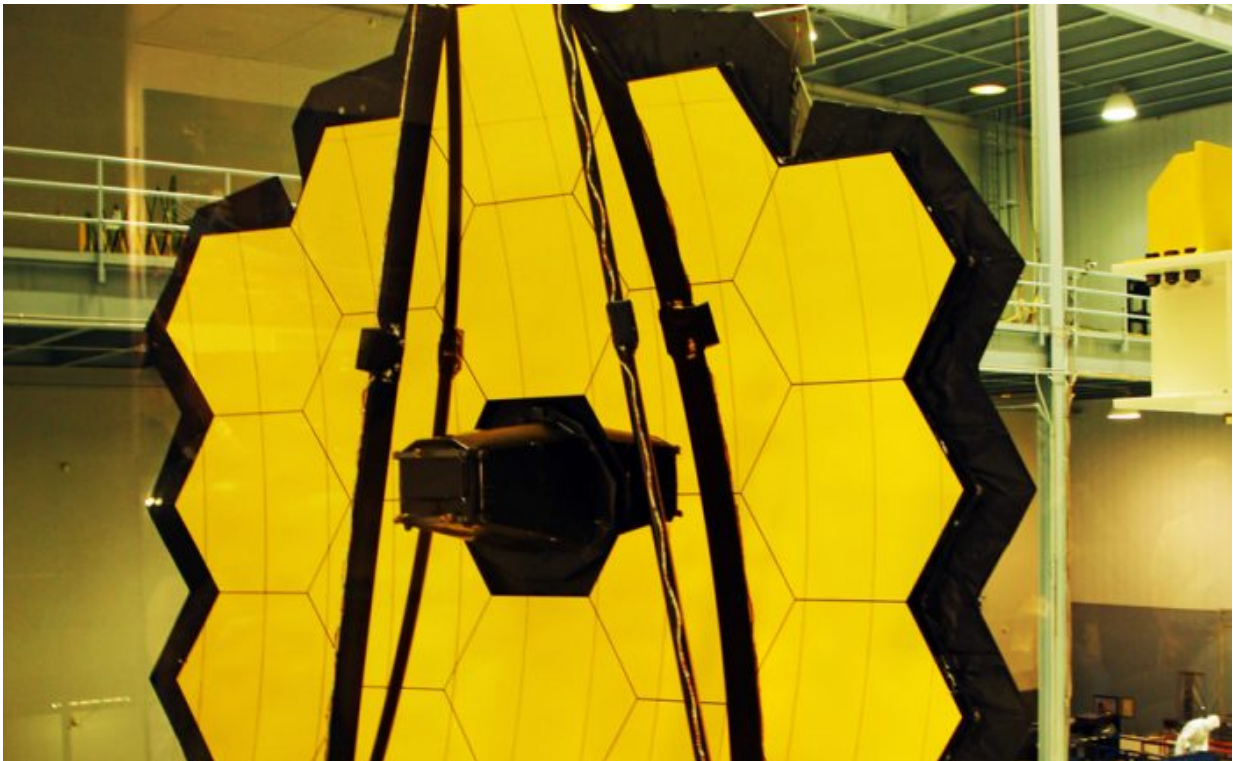
The 18-segment gold coated primary mirror of NASA's James Webb Space Telescope is raised into vertical alignment in the largest clean room at the agency's Goddard Space Flight Center in Greenbelt, Maryland, on Nov. 2, 2016. The secondary mirror mount booms are folded down into stowed for launch configuration. Credit: Ken Kremer/kenkremer.com

The 6.5 meter diameter 'golden' primary mirror is comprised of 18 hexagonal segments – looking honeycomb-like in appearance.

Each of the 18 hexagonal-shaped [primary mirror](#) segments measures just over 4.2 feet (1.3 meters) across and weighs approximately 88 pounds (40 kilograms). They are made of beryllium, gold coated and about the size of a coffee table.

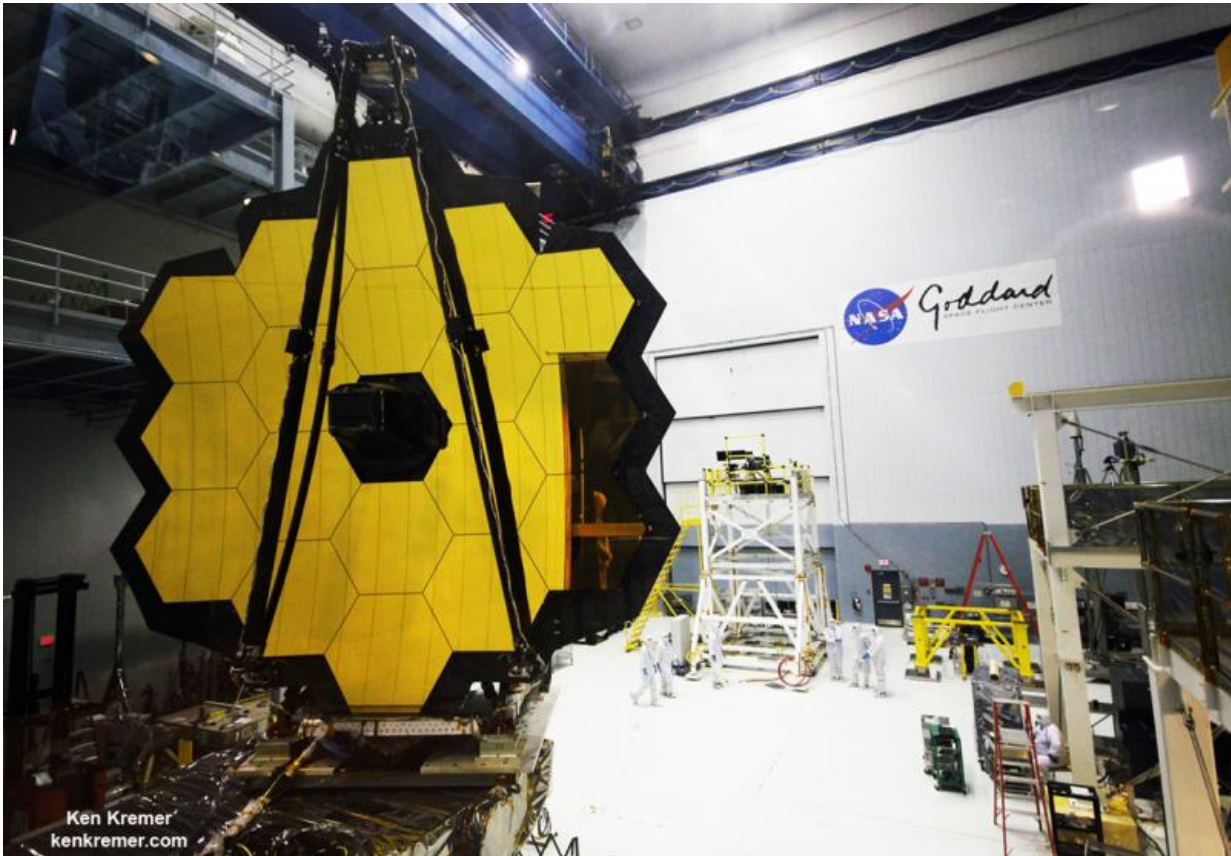
Technicians work on the James Webb Space Telescope in the massive clean room at NASA's Goddard Space Flight Center, Greenbelt, Maryland, on Nov. 2, 2016, as the completed golden primary mirror and observatory structure stands gloriously vertical on a work stand, reflecting incoming light from the area and observation deck. Credit: Ken Kremer/kenkremer.com

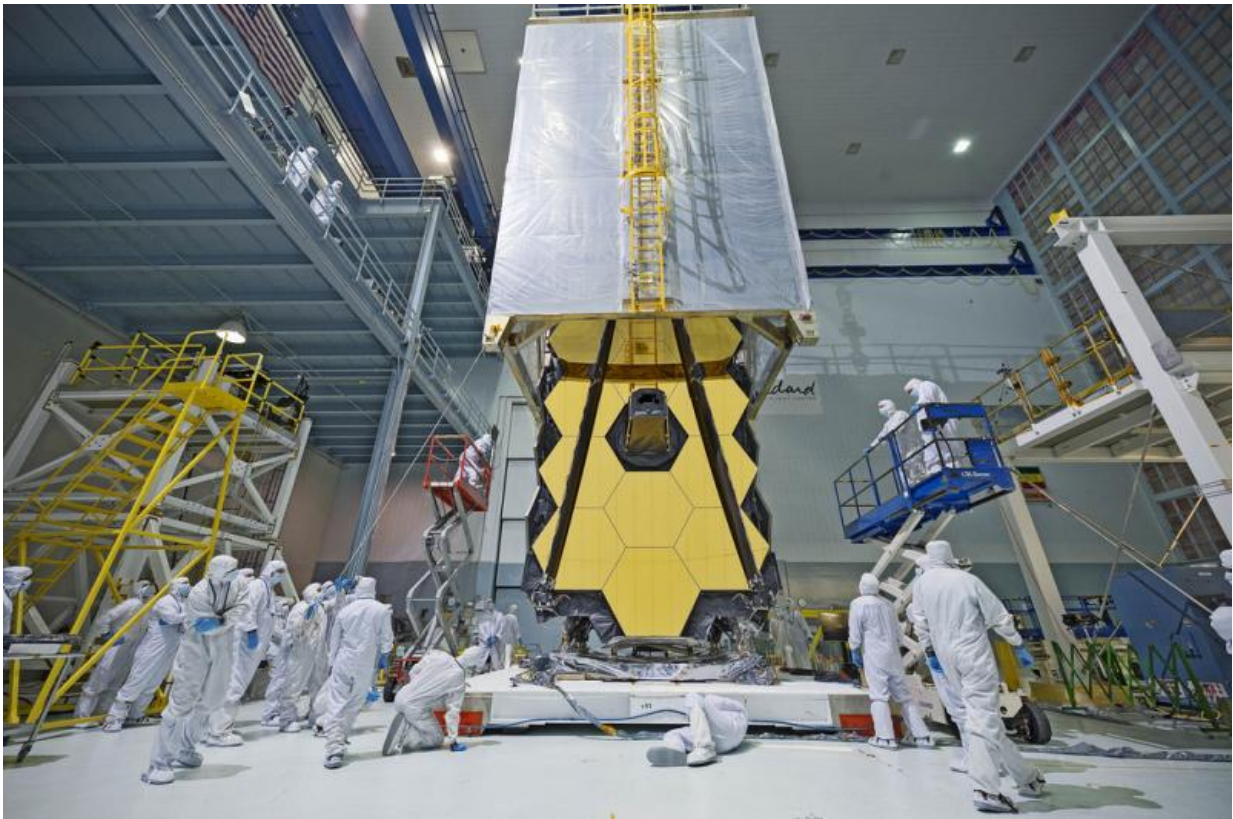
NASA's James Webb Space Telescope placed inside a "clean tent" in Nov. 2016 to protect it from dust and dirt as engineers at NASA's Goddard Space Flight Center in Greenbelt, Maryland transport it out of the relatively dust-free cleanroom and into a shirtsleeve environment to conduct vibration and acoustics tests to confirm it is fit for launch in 2018. Credit: NASA/Chris Gunn

To carry out the vibration and acoustics tests conducted on equipment

located in a shirtsleeve environment, the telescope structure was first carefully placed inside a 'clean tent' structure to protect it from dirt and grime and maintain the pristine clean room conditions available inside Goddard's massive clean room – where it has been undergoing assembly for the past year.
