Cleaner robot pulled from Fukushima reactor due to radiation

February 9 2017, by Mari Yamaguchi

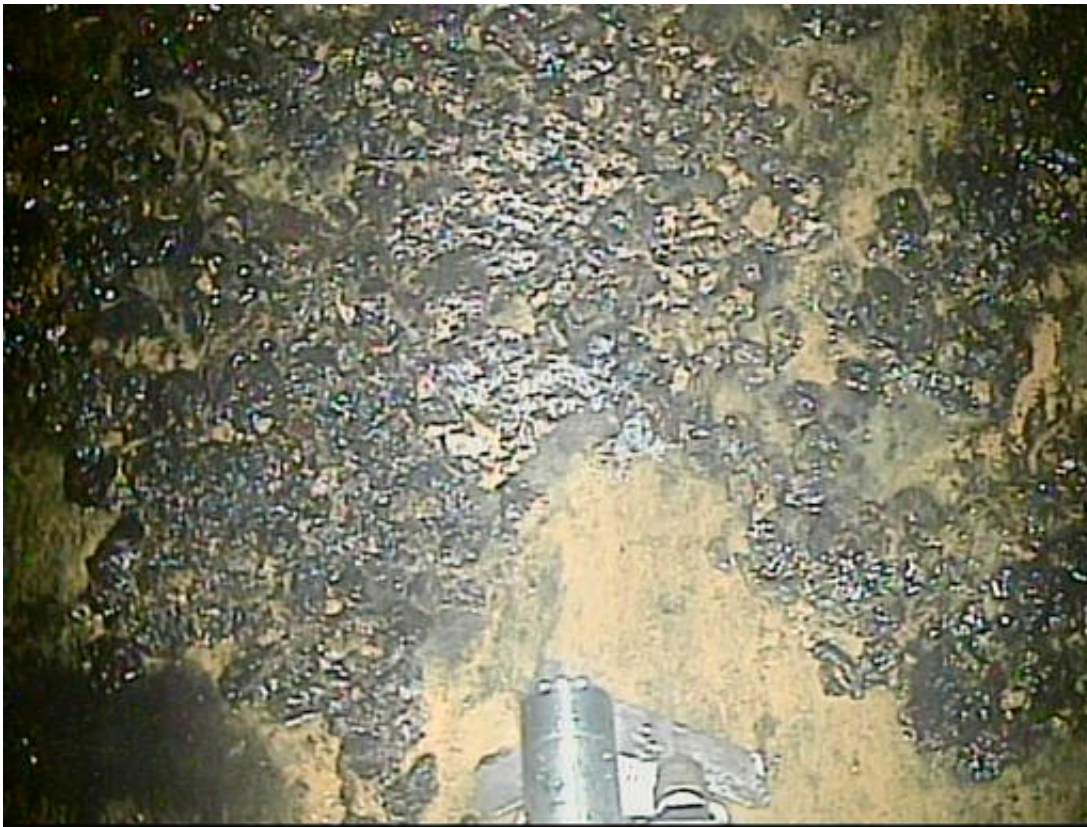
In this image released by Tokyo Electric Power Co. (TEPCO), a remote-controlled "cleaning" robot, bottom, enters the reactor containment chamber of Unit 2 for inspection and cleaning a passage for another robot as melted materials are seen at Fukushima Dai-ichi nuclear power plant in Okuma town, Fukushima prefecture, northeastern Japan, Thursday, Feb. 9, 2017. The "cleaning" robot that entered one of three tsunami-wrecked Fukushima reactor containment chambers was withdrawn before completing its mission due to glitches most likely caused by high radiation. (TEPCO via AP)

During Thursday's cleaning mission, the robot went only part way into a space under the core that TEPCO wants to inspect closely. It crawled down the passage while peeling debris with a scraper and using water spray to blow some debris away. The dark brown deposits grew thicker and harder to remove as the robot went further.

After about two hours, the two cameras on the robot suddenly developed a lot of noise and their images quickly darkened—a sign of a problem caused by high radiation. Operators of the robot pulled it out of the chamber before completely losing control of it.

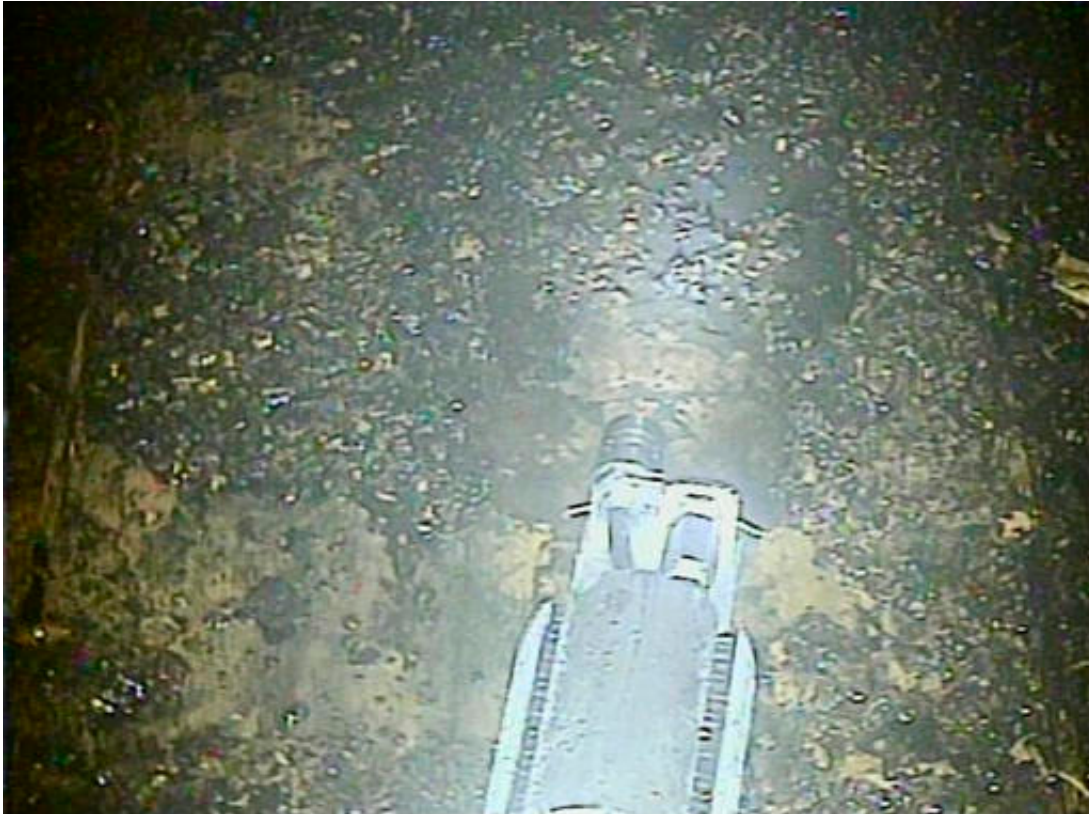
In this image released by Tokyo Electric Power Co. (TEPCO), a remote-controlled "cleaning" robot enters the reactor containment chamber of Unit 2 for inspection and cleaning a passage for another robot as melted materials are seen at Fukushima Dai-ichi nuclear power plant in Okuma town, Fukushima prefecture, northeastern Japan, Thursday, Feb. 9, 2017. The "cleaning" robot that entered one of three tsunami-wrecked Fukushima reactor containment chambers was withdrawn before completing its mission due to glitches most likely caused by high radiation. (TEPCO via AP)

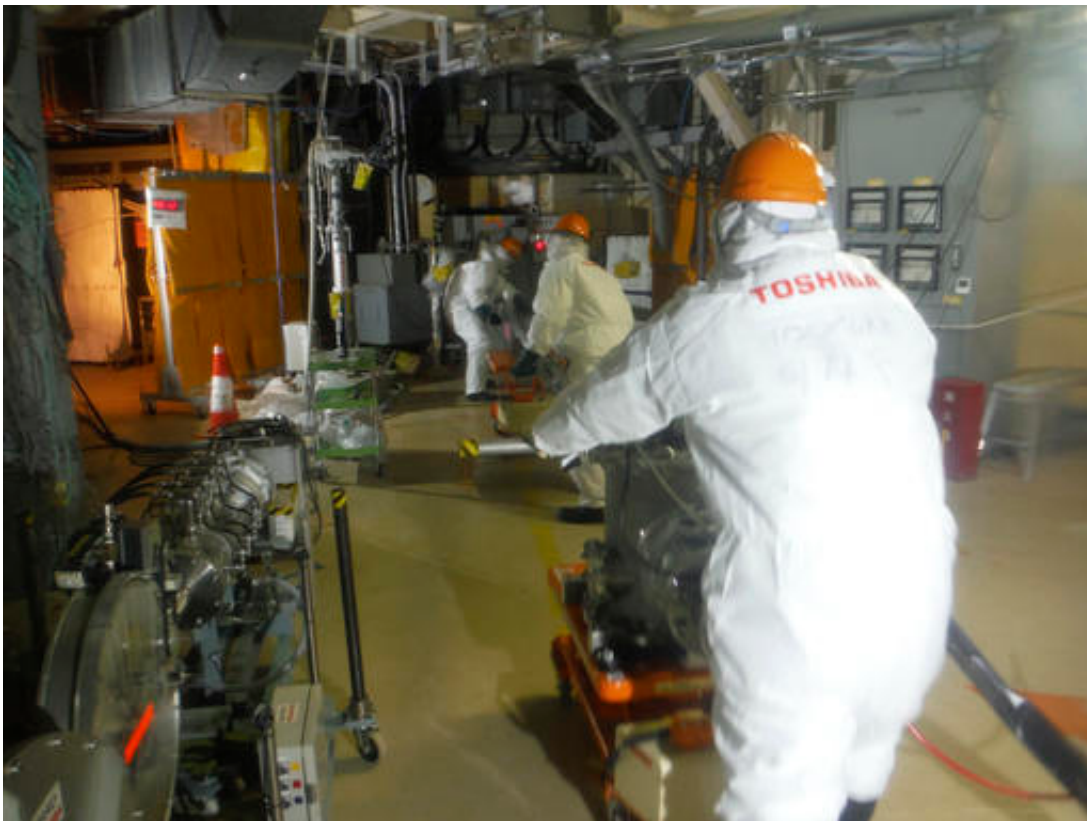
In this photo released by Tokyo Electric Power Co. (TEPCO), workers prepare to operate a remote-controlled "cleaning" robot at Unit 2 of Fukushima Dai-ichi nuclear power plant in Okuma town, Fukushima prefecture, northeastern Japan, Thursday, Feb. 9, 2017. The "cleaning" robot that entered one of three tsunami-wrecked Fukushima reactor containment chambers was withdrawn before completing its mission due to glitches most likely caused by high radiation.

Both of the robots are designed to withstand up to 1,000 Sieverts of radiation. The cleaner's two-hour endurance roughly matches an estimated radiation of 650 Sieverts per hour based on noise analysis of the images transmitted by the [robot](#)-mounted cameras. That's less than one-tenth of the radiation levels inside a running reactor, but still would kill a person almost instantly.

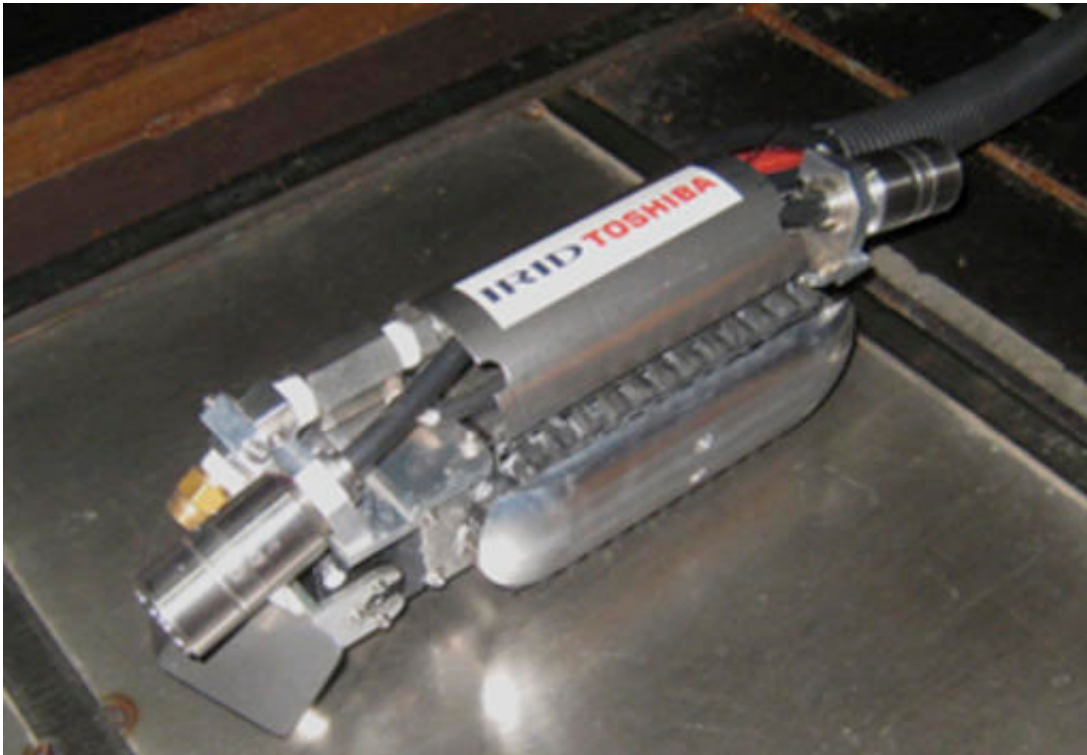
This undated photo released by Tokyo Electric Power Co. (TEPCO) shows a remote-controlled "cleaning" robot which is to be used for inspection inside the reactor containment chamber of Unit 2 at Fukushima Dai-ichi nuclear power plant. The "cleaning" robot that entered one of three tsunami-wrecked Fukushima reactor containment chambers on Thursday, Feb. 9, 2017, was withdrawn before completing its mission due to glitches most likely caused by high radiation. (TEPCO via AP Photo)
