Robot probes show Japan reactor cleanup worse than expected

February 17 2017, by Mari Yamaguchi

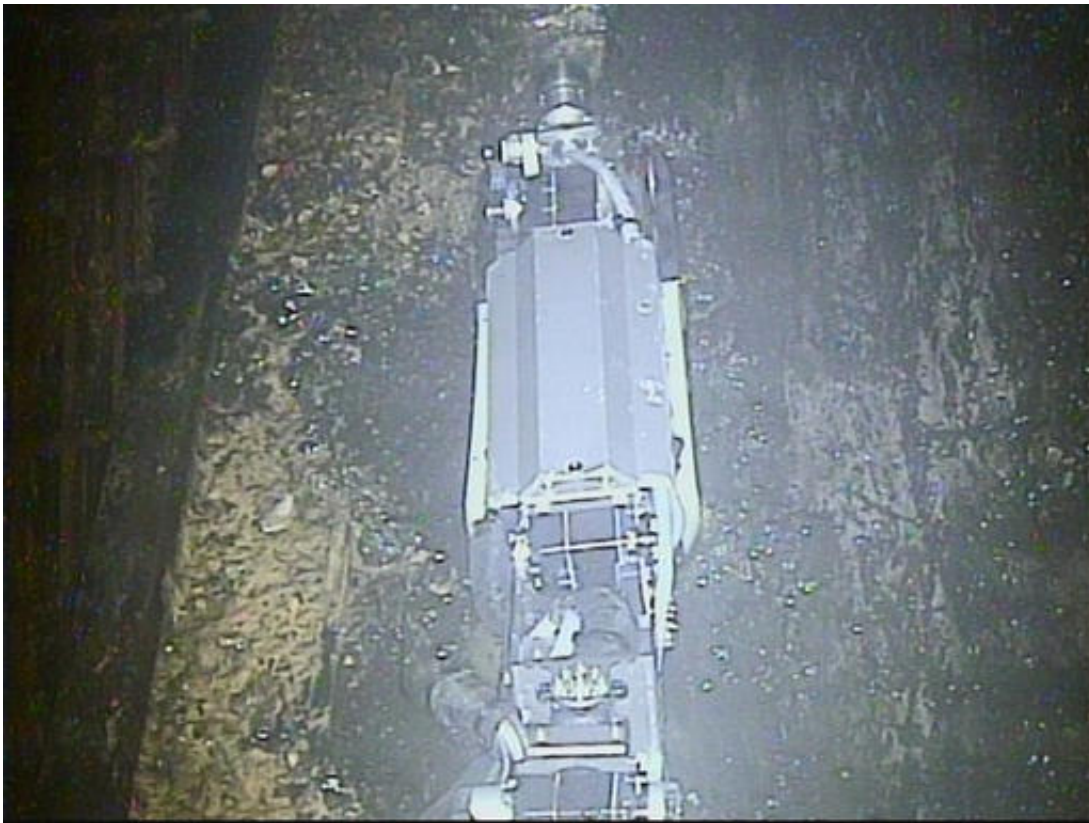
This Feb. 16, 2017 photo released by Tokyo Electric Power Co. (TEPCO) shows a remote-controlled "scorpion" robot inside the Unit 2 reactor's containment vessel at Fukushima Dai-ichi nuclear power plant in Okuma town, Fukushima prefecture, northeastern Japan. Robot probes sent to one of Japan's wrecked Fukushima nuclear reactors have suggested worse-than-anticipated challenges for the plant's ongoing cleanup. (TEPCO via AP Photo)

The plant's operator Tokyo Electric Power Co. said the remote-controlled "scorpion" robot was sent into the Unit 2 reactor's containment vessel Thursday to investigate the area around the core that had melted six years ago, but its crawling function failed while climbing over highly radioactive debris.

The robot, carrying a dosimeter, thermometer and two small cameras, transmitted some data and visuals but could not locate melted fuel—key information to determine how to remove debris out of the reactor. The robot was abandoned inside the vessel at a location where it won't block a future probe.
