Engineers shine light on deadly landslide

April 26 2017

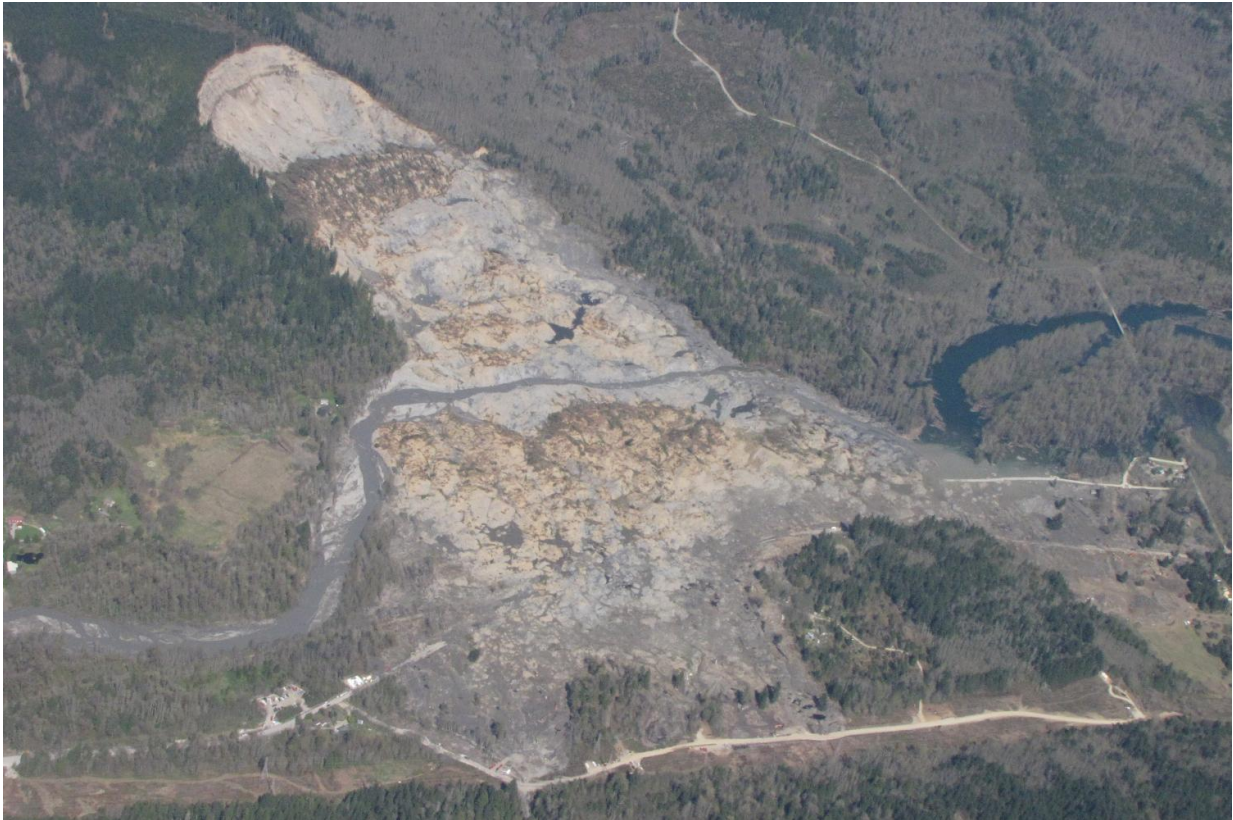
An aerial image of the Oso landslide on April 13, 2014. Credit: Photo courtesy Tim Stark

The area has seen its share of landslides, but this one was different. It traveled much farther across the valley than any other recent slides for the site.

"Every 30 to 40 years, the area would have a small [slide](#) that would come down and block the river," University of Illinois civil and environmental engineering professor Tim Starkk said. "But the 2014 slide was like a huge squeegee pushed the prior slide debris across the valley."

"Most of the slides in this area originate from about halfway up the slope, but this flow contained sediments and vegetation from the top of the slope," Stark said, "The higher up the slope the landslide starts, the more [potential energy](#) it will have."

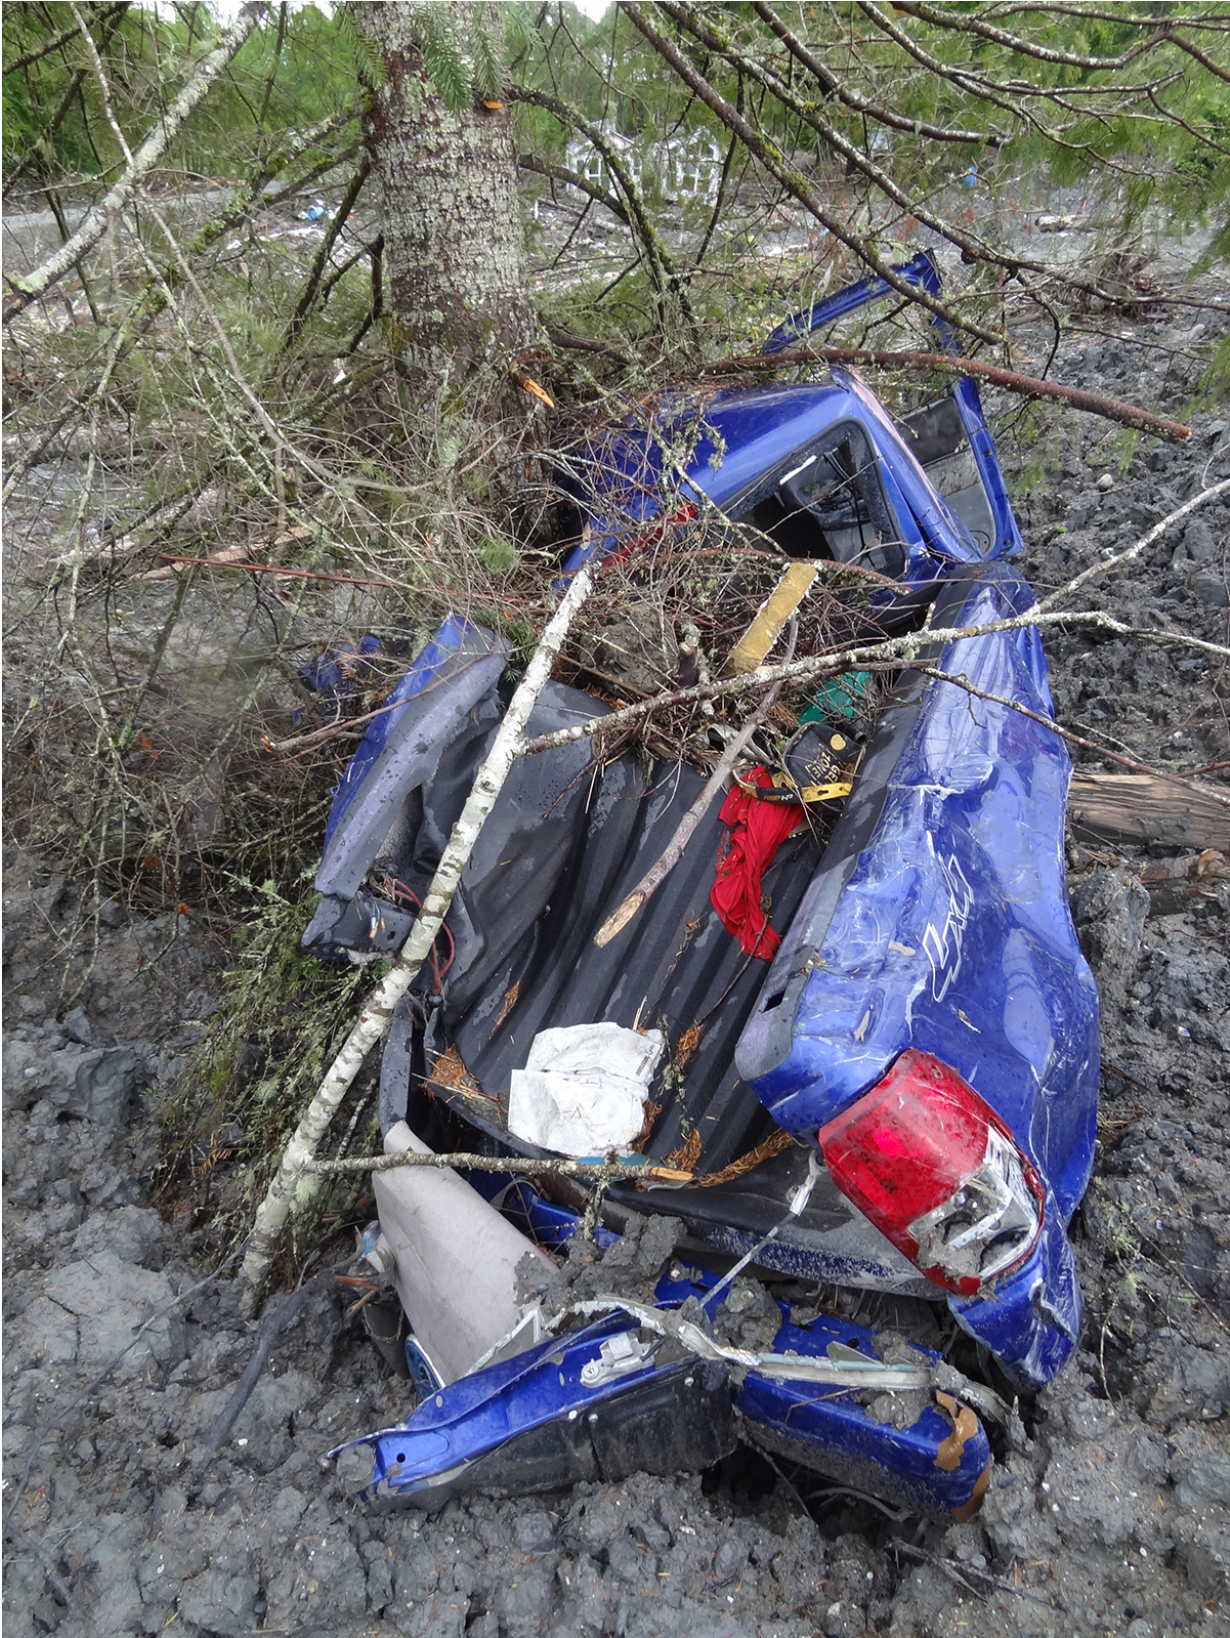
A pickup truck was plucked from its parking spot in the Steelhead neighborhood and wrapped around tree. Credit: Tim Stark
