# Image: Sentinel-1 sees Mocoa landslide

April 5 2017

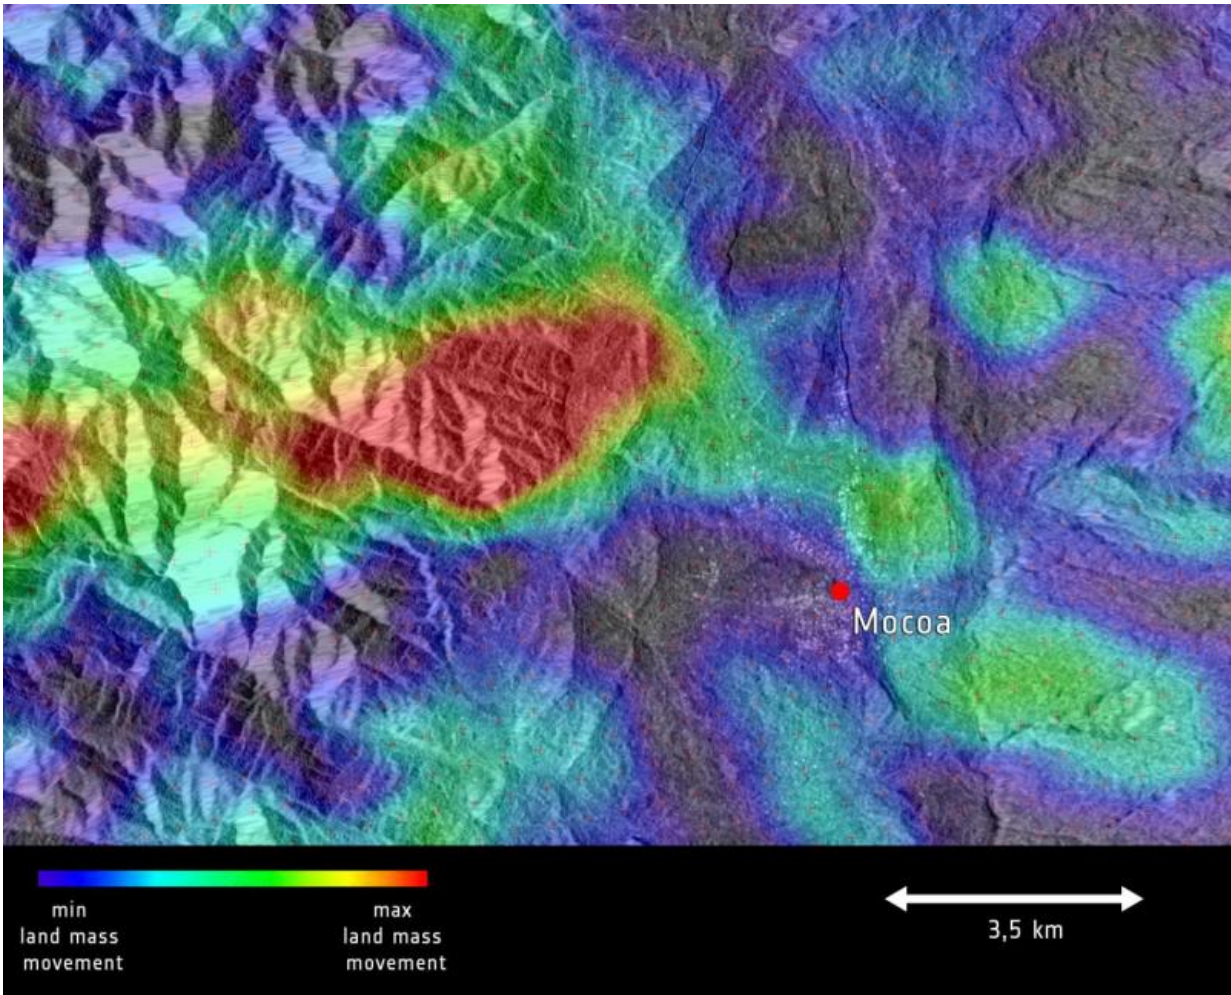
Sentinel-1 radar coverage from before and after the 1 April 2017

mudslide in Mocoa, Colombia, shows the extent of movement of the disaster that claimed over 260 lives, injured hundreds more and left scores displaced.

Triggered by heavy rain, the landslide caused greatest movement (red) on top of a mountain. It then pushed mud down across the city of Mocoa (green) and crossed the nearby river.

The Sentinel-1-derived data product (from scans on 20 March and 1 April) has been overlaid onto a Sentinel-1 radar image. Sentinel-1 is a two-satellite mission for Europe's Copernicus environment monitoring programme.
