Possible melted fuel seen for first time at Fukushima plant

July 21 2017, by Mari Yamaguchi

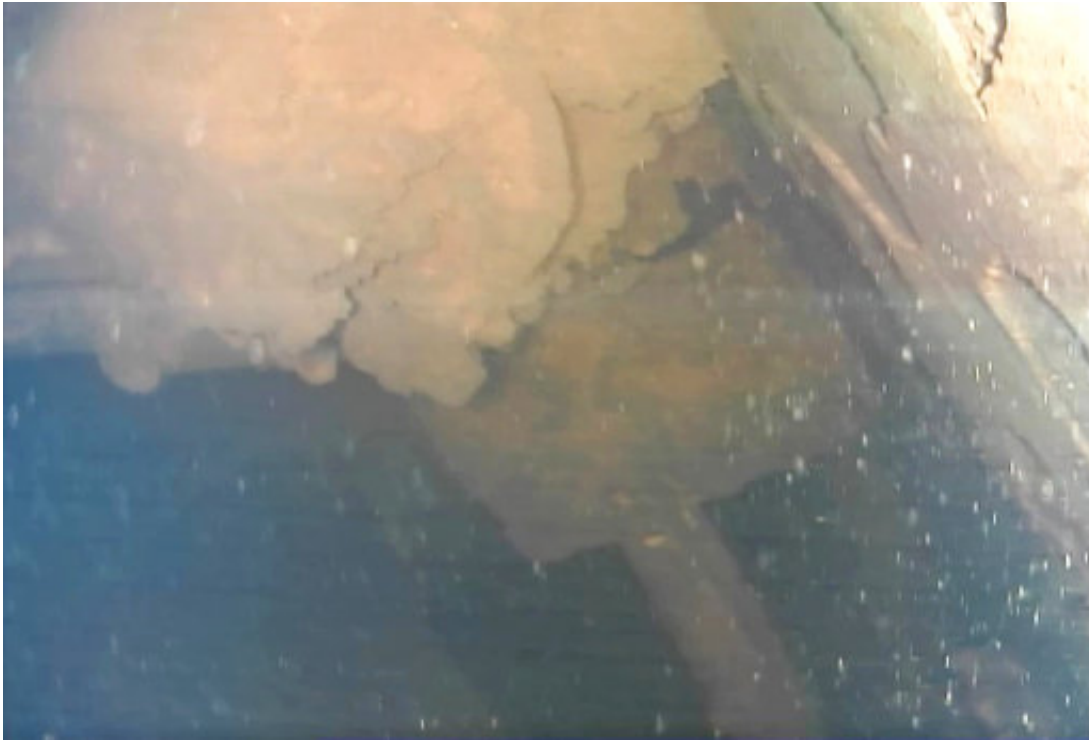
This image captured by an underwater robot provided by International Research Institute for Nuclear Decommissioning shows lava-like lumps believed to contain melted fuel inside the Unit 3 reactor at Fukushima Dai-ichi nuclear plant in Okuma town, northeastern Japan, Friday, July 21, 2017. Plant operator Tokyo Electric Power Co. said the robot found the objects Friday on its second mission inside the primary containment vessel of the Unit 3 reactor at Fukushima, which was destroyed by a massive earthquake and tsunami. Experts believe the fuel melted and much of it fell to the chamber's bottom and is now submerged by radioactive water. (International Research Institute for Nuclear Decommissioning via AP)

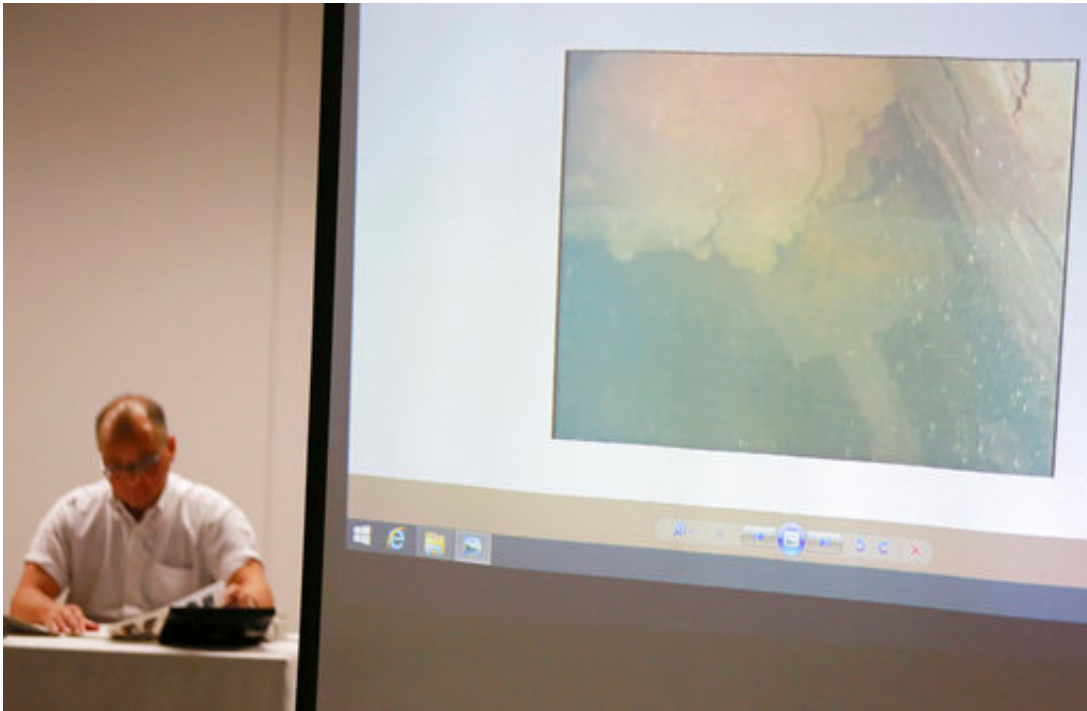
Tokyo Electric Power Co. (TEPCO) shows an image captured by an underwater robot inside the Unit 3 reactor at Fukushima nuclear plant during a press conference at the TEPCO headquarters in Tokyo Friday, July 21, 2017. The plant operator said the robot found the objects on its second mission Friday inside the primary containment vessel of the reactor at the plant destroyed in the march 2011 earthquake and tsunami. Experts say the melted fuel has mostly fallen to the chamber's bottom and submerged by radioactive water. (AP Photo/Eugene Hoshiko)

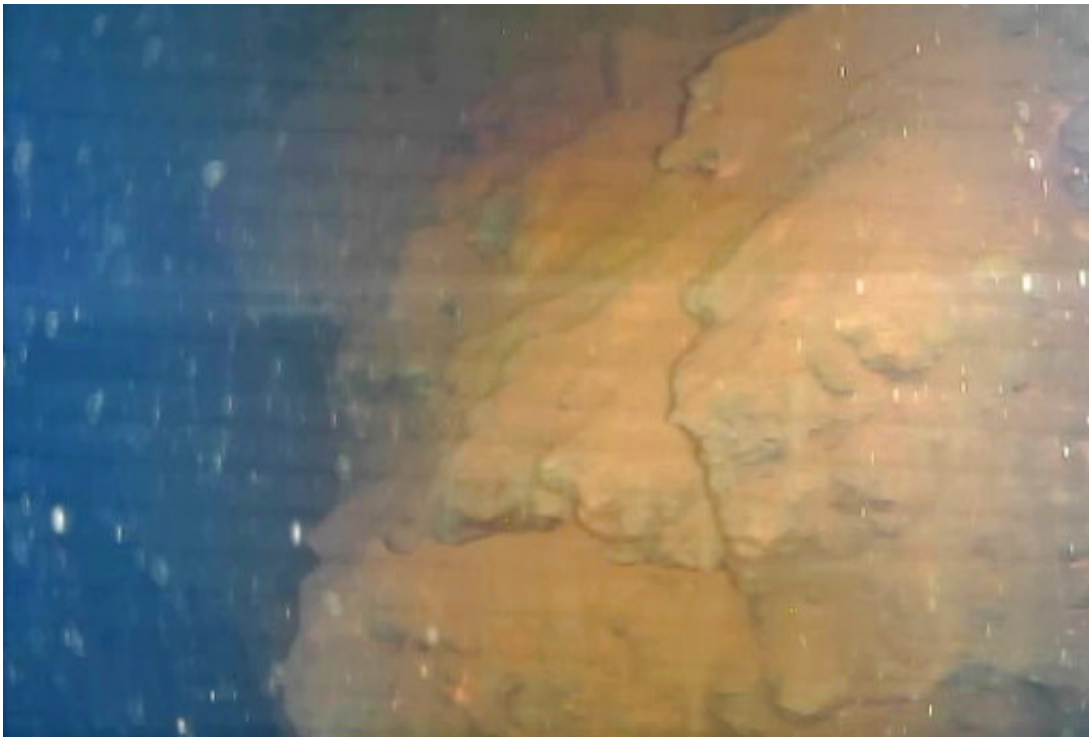
This image captured by an underwater robot provided by International Research Institute for Nuclear Decommissioning shows lava-like lumps believed to contain melted fuel inside the Unit 3 reactor at Fukushima Dai-ichi nuclear plant in Okuma town, northeastern Japan, Friday, July 21, 2017. Plant operator Tokyo Electric Power Co. said the robot found the objects Friday on its second mission inside the primary containment vessel of the Unit 3 reactor at Fukushima, which was destroyed by a massive earthquake and tsunami. Experts believe the fuel melted and much of it fell to the chamber's bottom and is now submerged by radioactive water. (International Research Institute for Nuclear

Decommissioning via AP)
