The impacts of a chemical reaction known to cause structural problems in concrete dams

September 14 2017, by Anne Wilson Yu

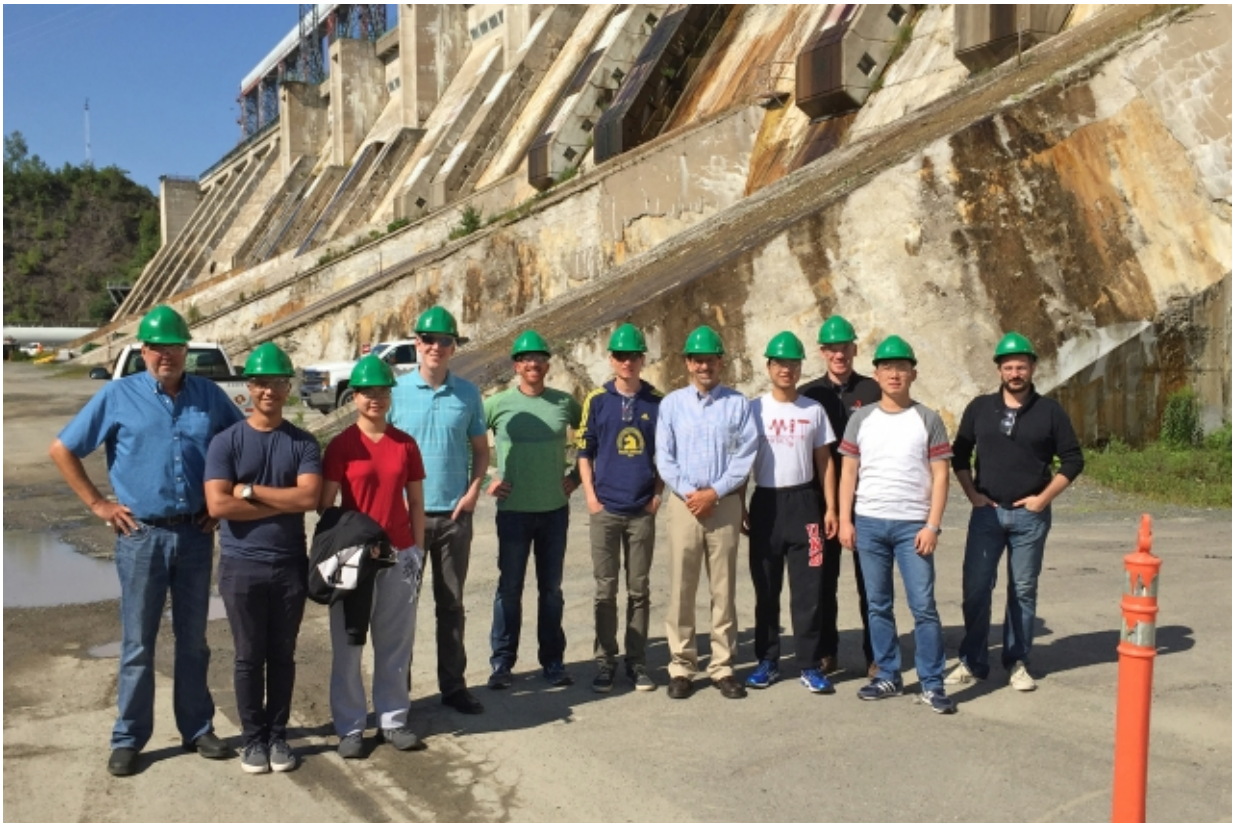
Researchers from the MIT Concrete Sustainability Hub, the University of New Brunswick, and Oregon State University visited the Mactaquac Dam in New Brunswick, Canada, in August. Credit: Jeremy Gregory/MIT Concrete Sustainability Hub

The Mactaquac Dam has swelled some 9 to 12 inches in height since it was constructed 50 years ago. Cracking is visible throughout the structure, but the issues extend well beyond the concrete.

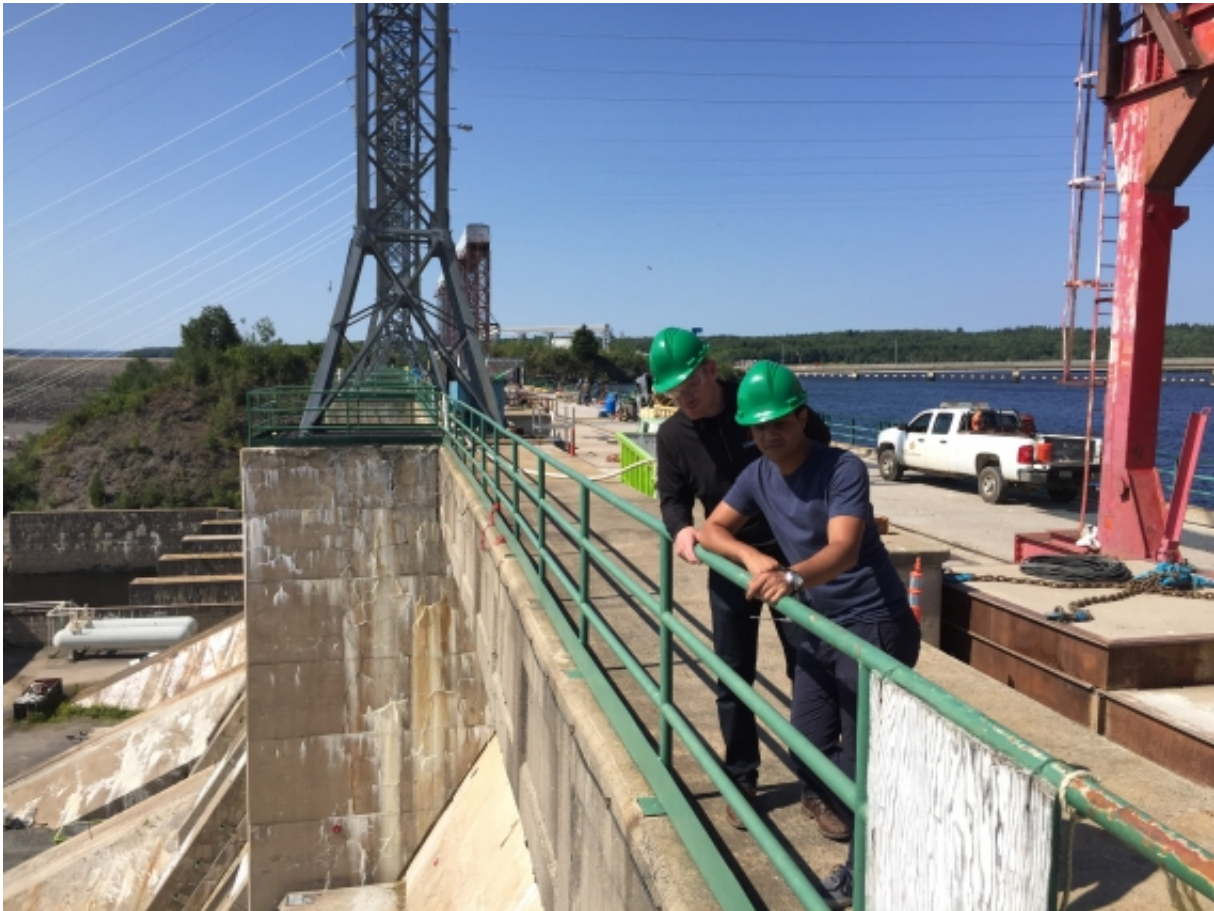
As part of a larger concrete durability project, researchers from the MIT Concrete Sustainability Hub, the University of New Brunswick, and Oregon State University are studying a chemical reaction known as alkali-silica reaction, which can cause cracking and result in structural problems in concrete infrastructure. Credit: Jeremy Gregory/MIT Concrete Sustainability Hub

"Concrete is a mix of cement, crushed rock, sand, and water. Alkali-silica reaction, the cause of the major issues in New Brunswick, occurs when alkalis in the cement pore solution encounter reactive forms of silica in the rock used to make the concrete," explains Jeremy Gregory, executive director of the MIT Concrete Sustainability Hub (CSHub).

"The reaction produces a gel which expands as it absorbs water and exerts pressure that can cause cracking and result in structural problems in concrete infrastructure."

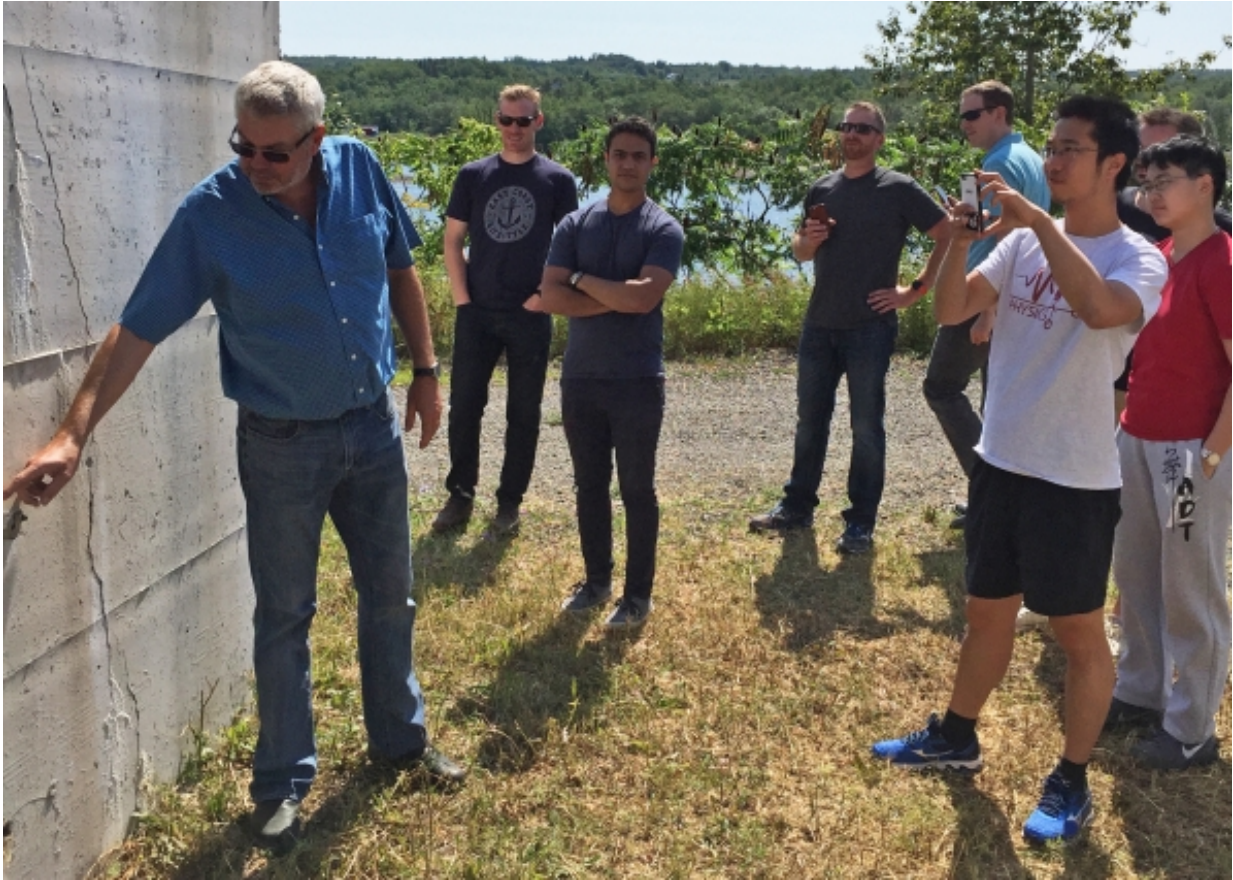
Edmond Zhou (right), a researcher with the MIT Concrete Sustainability Hub and MIT grad student in physics, takes a picture of at a test site set up by research collaborators from the University of New Brunswick near the Mactaquac Dam. Credit: Jeremy Gregory/MIT Concrete Sustainability Hub
