# Why Britain's coastline is crumbling

December 1 2017

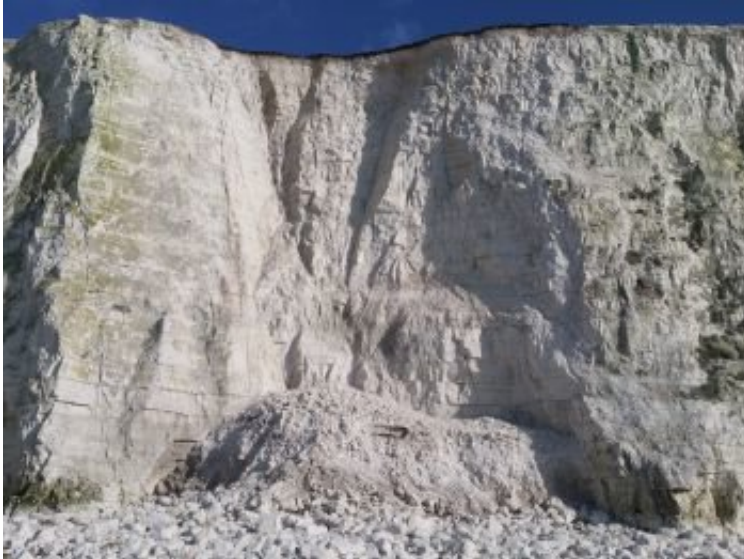
Example of a "wedge" rockfall at Telscombe, East Sussex. Credit: University of Sussex

Another other type of large fall, a "wedge failure", occurs when two cracks intersect at an angle, causing a wedge of rock to slide away like a piece of cake

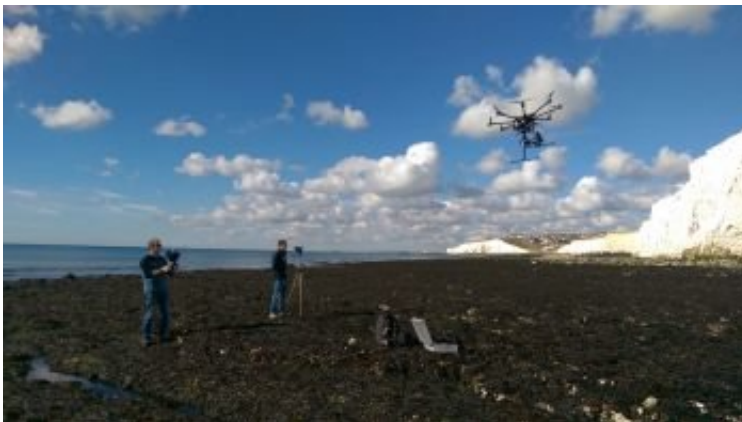
Dr John Barlow is using a drone to photographically map the Sussex coastline.  
Credit: University of Sussex

It is these weaknesses that Dr Barlow is now studying. With the aid of a drone aircraft that's photographically mapping a section at Telscombe in East Sussex, he and his team have been able to make highly accurate 3D models of the cliff face.
