Understanding the impact of defects on the properties of MoS₂

December 22 2017

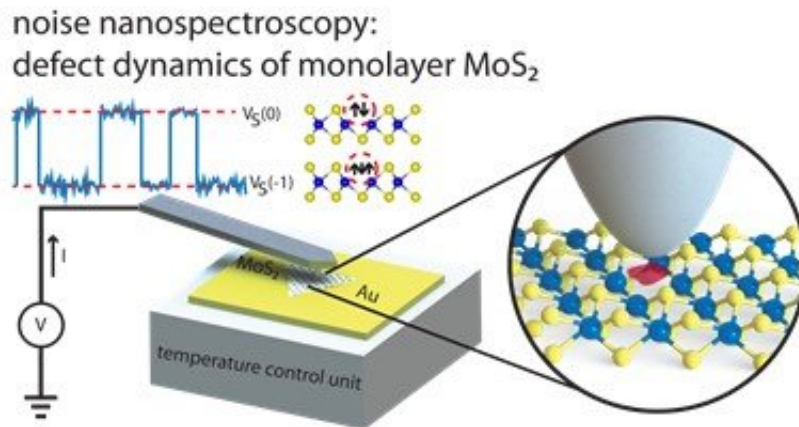
The study on 2-D molybdenum disulfide (MoS₂) defects employed low frequency noise measurements and conductive atomic force microscopy (C-AFM). The enlarged image shows an AFM cantilever tip pointing to an area with one sulfur monovacancy (area shaded red). As current flows through the AFM tip and the sample, switching events between different ionization states (neutral and charged -1) are measured. With a radius of around 25 nanometers, the AFM tip covers an area that contains around 1-8 sulfur monovacancies. Credit: IBS, published on *Nature Communications*

In IBS, a team of physicists, material scientists, and electrical engineers worked closely together to explore the electronic properties of sulfur vacancies in MoS₂ monolayers, using a combination of atomic force microscopy (AFM) and noise analysis. The scientists used a metallic AFM tip to measure the noise signal, i.e., the variation of electrical current passing through a single layer of MoS₂ placed on a metal substrate.

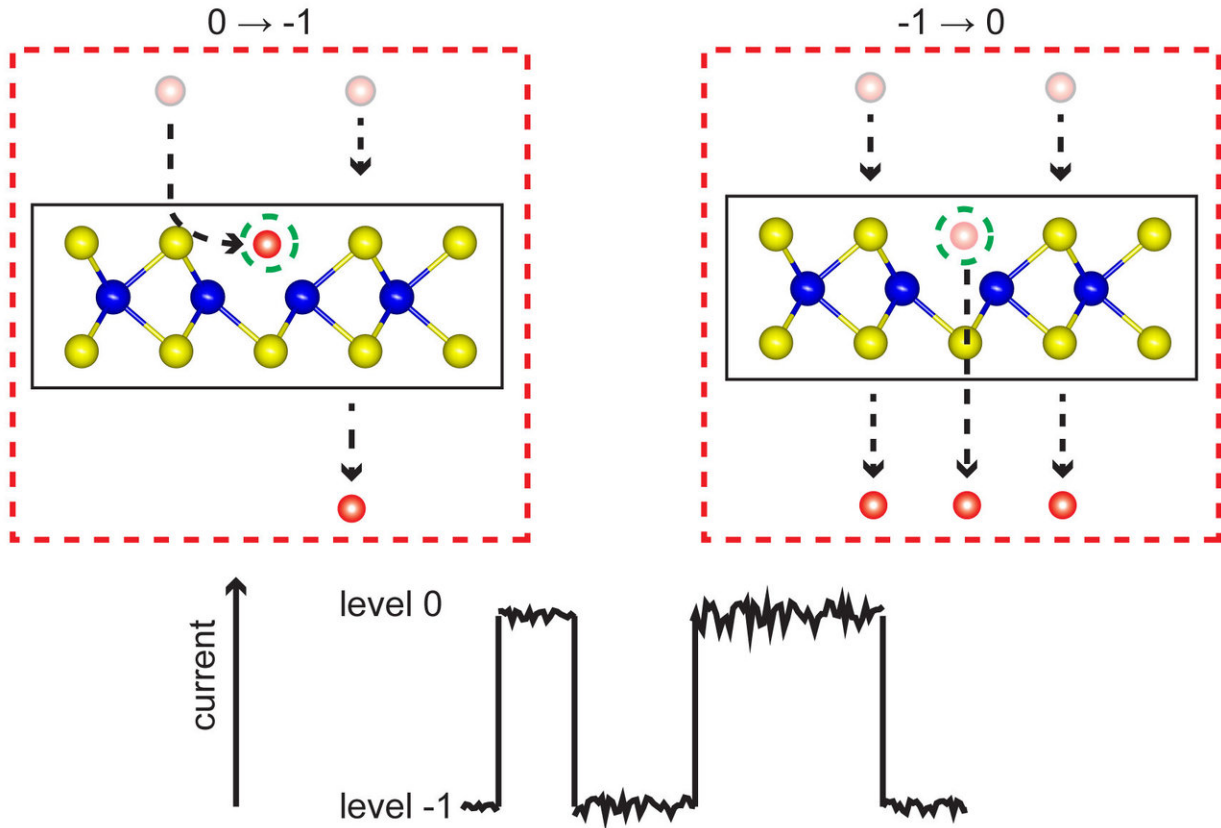
The top graph illustrates the switching processes between the neutral level (0 state) and the charged level (-1 state) that occur when an electron (red circle) from the flowing current is trapped (top left) or released (top right) at the sulfur vacancy defect (marked by green circle). The lower graph shows switching events in the current that occur when electrons from the current passing through the MoS₂ sample are trapped at the vacancy, or released from the vacancy.

The most common defects in MoS₂ are instances of missing single sulfur atoms, also known as sulfur monovacancies. In a perfect sample, each sulfur atom has two valence electrons that bind to two molybdenum electrons. However, where a [sulfur atom](#) is missing, these two molybdenum electrons are left unsaturated, defining the neutral state (0 state) of the defect. However, the team observed rapid switching events in their noise measurements, indicating the state of the vacancy switched between neutral (0 state) and charged (-1 state).

"The switching between 0 and -1 is happening continuously. While an electron resides at the vacancy for a while, it is missing from the current, such that we observe a current drop," explains Michael Neumann, one of the co-first authors of the study. "This goes a long way towards understanding the known anomalies of MoS₂, and it is very interesting that sulfur vacancies alone are enough to explain these anomalies,
