Problem with new US weather satellite could affect pictures (Update)

May 23 2018, by Marcia Dunn

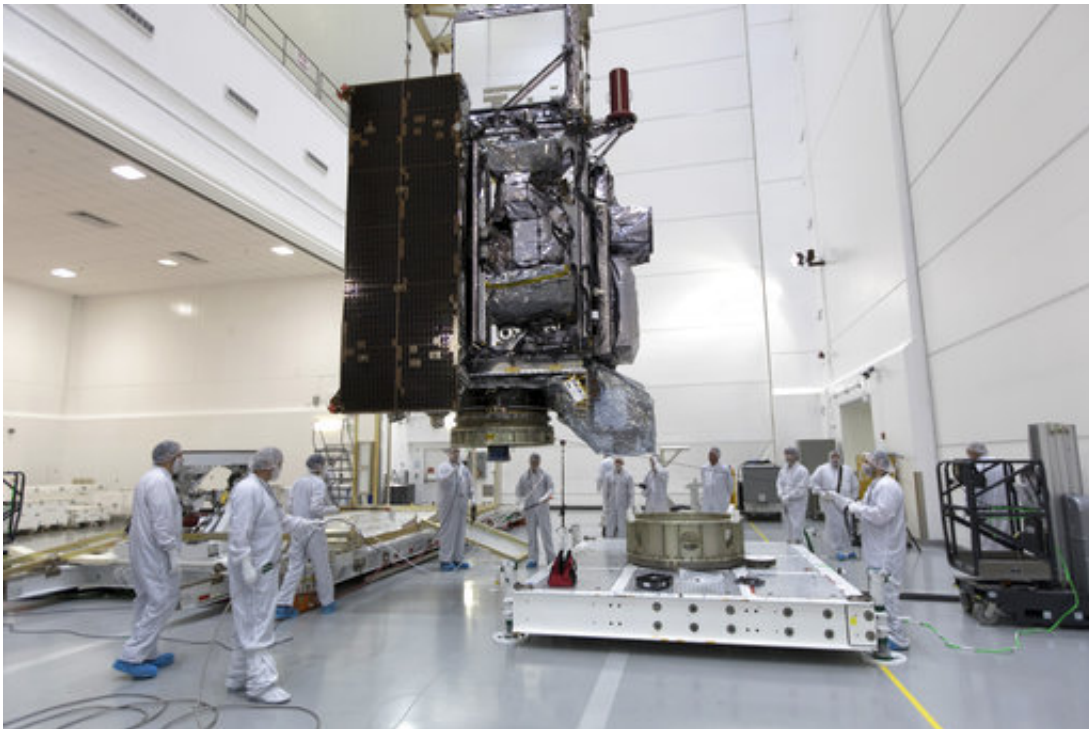
In this Dec. 6, 2017 photo made available by NASA, technicians and engineers move the National Oceanic and Atmospheric Administration's Geostationary Operational Environmental Satellite-S (GOES-S) to a work stand at Astrotech Space Operations in Titusville, Fla., near Kennedy Space Center. On Wednesday, May 28, 2018, NOAA said that the GOES-17's imager is not providing proper cooling for its infrared sensors. (Leif Heimbold/NASA via AP)

The trouble is with the GOES-17 satellite's premier instrument for taking images of hurricanes, wildfires, volcanic eruptions and other natural calamities, the National Oceanic and Atmospheric Administration said Wednesday. The imager's infrared sensors aren't getting properly cooled.

Fahrenheit (minus 200 degrees Celsius). The imager's cooling system—which uses propolyne—is not maintaining that frigid temperature during the warmer part of each orbit, and so the channels aren't working well about half the time.
