Team's pic of crack in the act could prevent engineering failures

August 23 2018

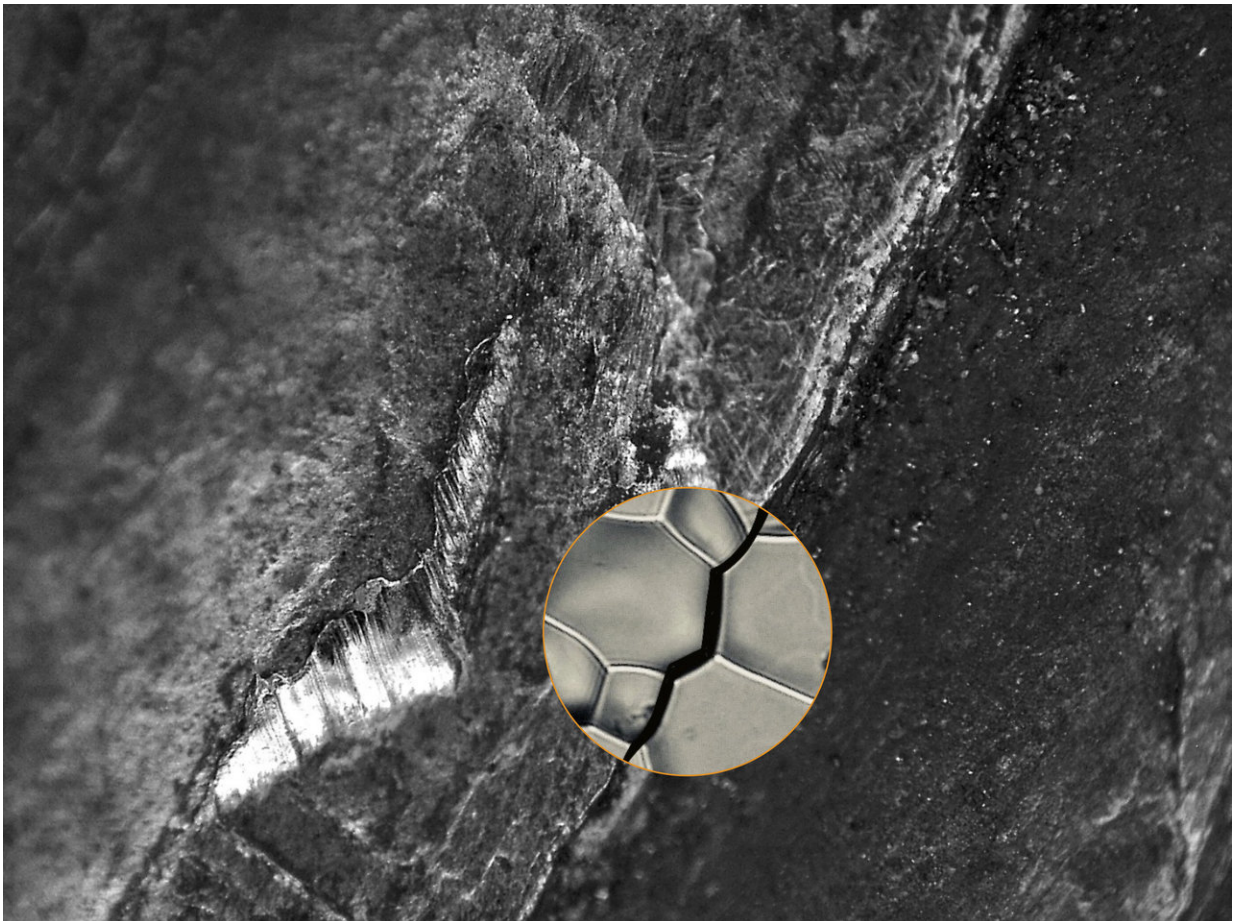
Advanced imaging provides clues to predicting fracture in metals. In this study, cracks in a nickel alloy embrittled by hydrogen were caught 'red handed' as they propagated along grain boundaries. Credit: Texas A&M University

"You can make progress on old problems when you have new tools," said Demkowicz. The researchers employed two different synchrotron tools, high-energy diffraction microscopy and X-ray absorption tomography, to analyze the microscopic structure of a crack in a superalloy of nickel. The study represents the first time the microscopy technique was used by researchers not involved in its development. The combined experimental [tool](#) and analysis software are unique in the world.

A metal is composed of microscopic crystals, or grains. In nickel superalloys, the fractures brought on by hydrogen embrittlement travel along the boundaries between those grains. Hanson said the unique tools at the APS beamline 1-ID allow for the first time to not only look at the grain orientations around a crack in progress, but also the grain boundaries. From those observations, the team identified 10 grain boundaries that are more resistant to cracks.
