# Why does concrete swell and crack?

October 5 2018

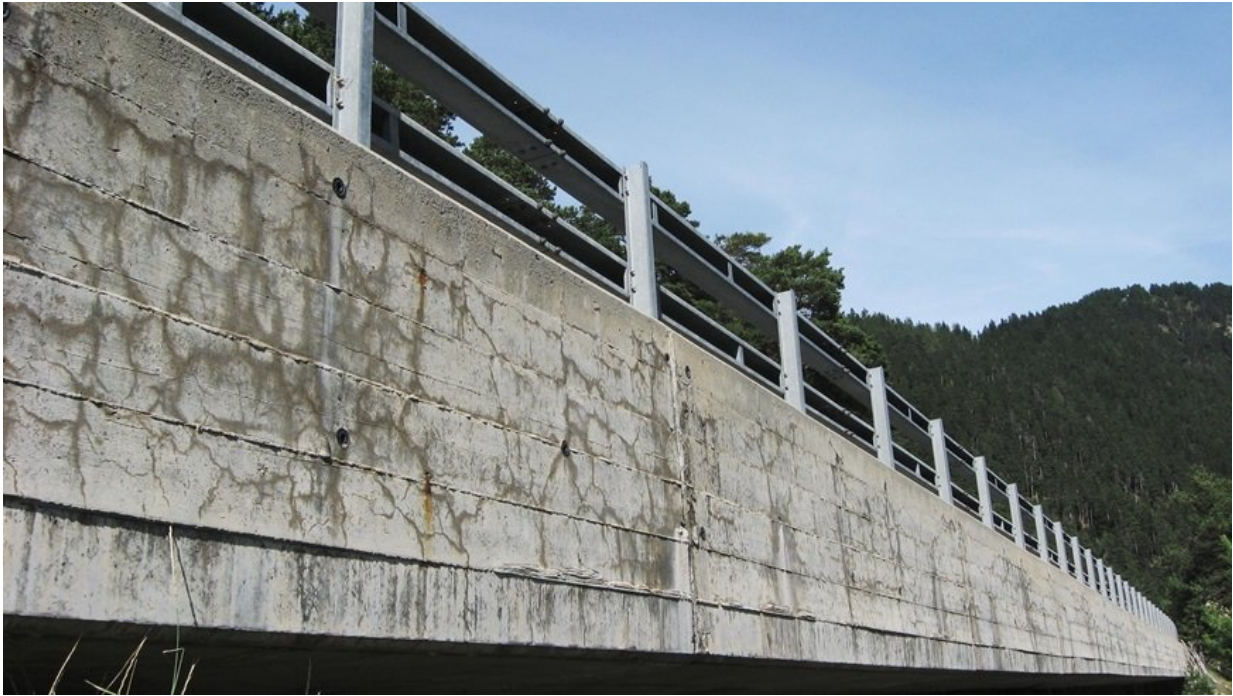
Concrete structures that have been damaged by AAR (alkali-aggregate reaction) exhibit these typical cracks. The dark color around the edges of the cracks is caused by leaking AAR products. Credit: Swiss Federal Laboratories for Materials Science and Technology

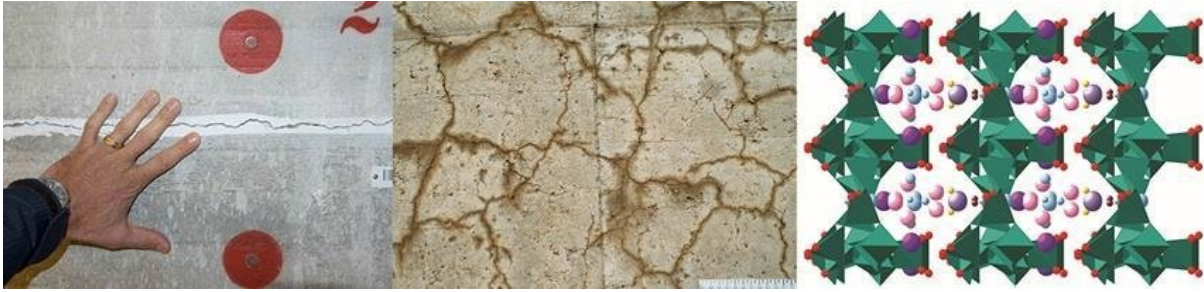
The cracks in the concrete caused by AAR form in tiny crystal fissures (middle photo) and are immediately visible to the naked eye (left-hand photo). An alkali calcium silicate hydrate, the structure of which was clarified with Empa's help in 2016, is behind the damage (right-hand photo).

In 2015 a team of scientists from Empa and the Paul Scherrer Institute (PSI) succeeded in identifying the structure of the aqueous crystal that triggers the swelling in concrete. This structure had previously been the subject of much speculation.
