Why does concrete swell and crack?

October 5 2018

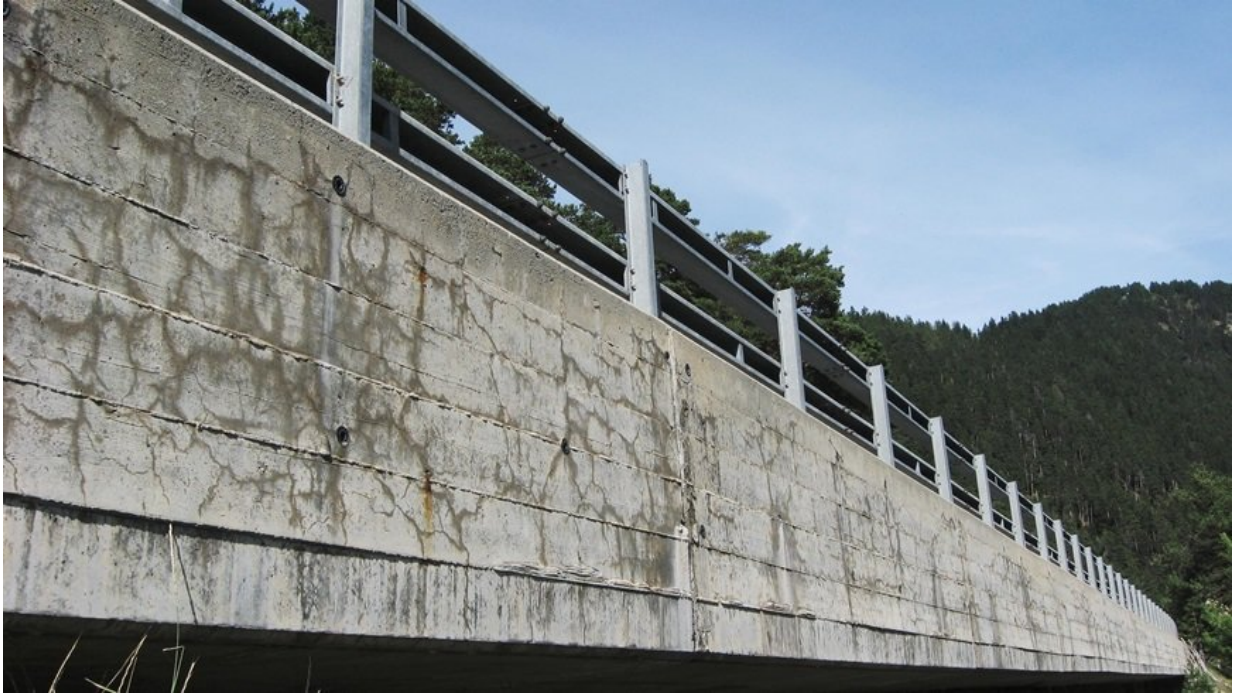
Concrete structures that have been damaged by AAR (alkali-aggregate reaction) exhibit these typical cracks. The dark color around the edges of the cracks is caused by leaking AAR products. Credit: Swiss Federal Laboratories for Materials Science and Technology

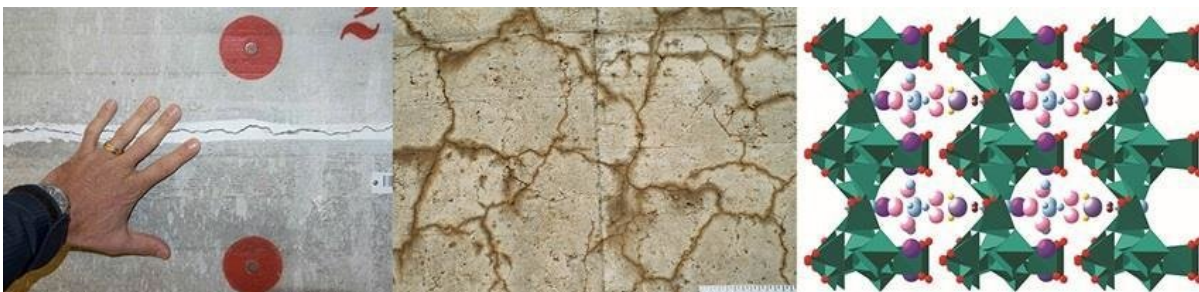
The cracks in the concrete caused by AAR form in tiny crystal fissures (middle photo) and are immediately visible to the naked eye (left-hand photo). An alkali calcium silicate hydrate, the structure of which was clarified with Empa's help in 2016, is behind the damage (right-hand photo).
