Biocolonizer species are putting the conservation of the granite at Machu Picchu at risk

February 15 2019

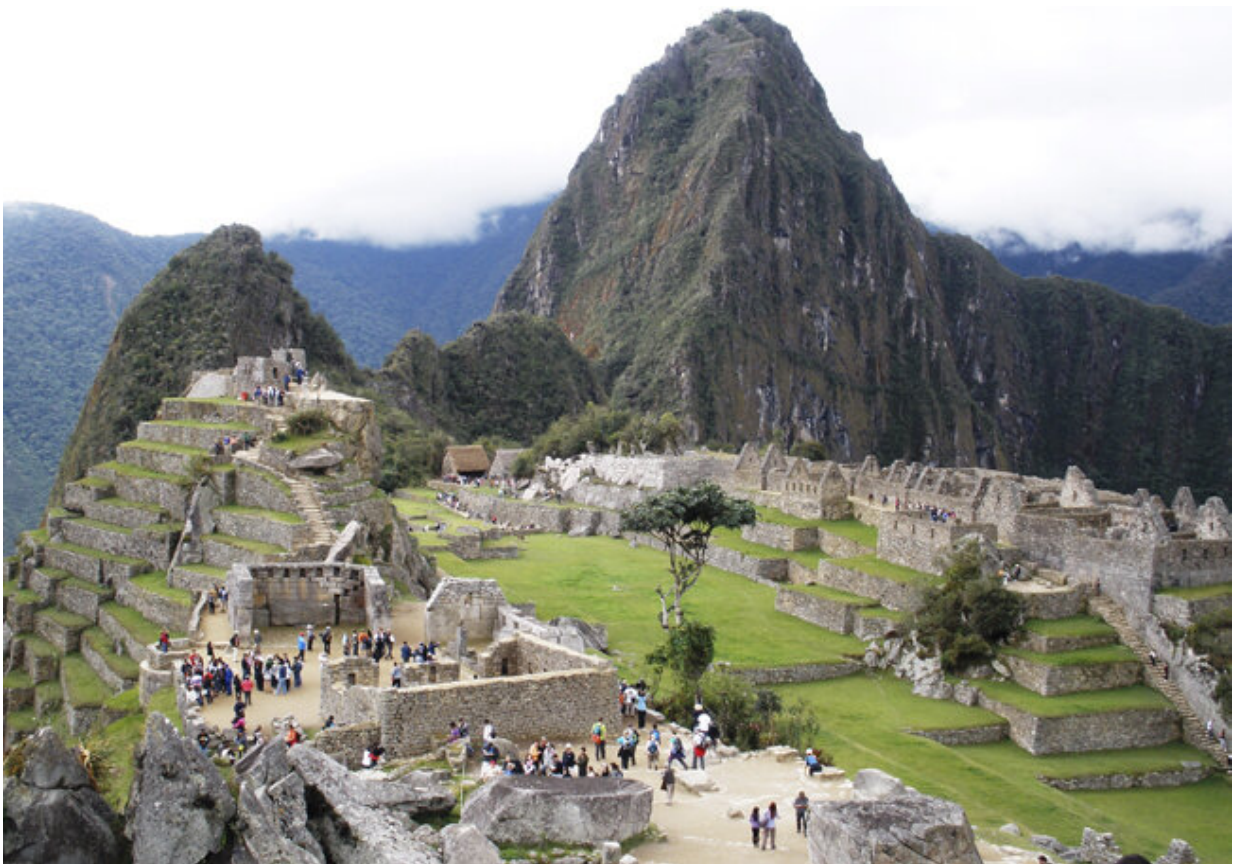
There is a wide variety of biocolonizer species that are putting the conservation of the granite at Machu Picchu at risk. Credit: Héctor Morillas / UPV/EHU

The UPV/EHU's IBeA research group has used a non-destructive methodology to determine the role of specific algae, lichens, mosses and cyanobacteria that may be causing exfoliation and delamination processes that are degrading the Sacred Rock of Machu Picchu, one of the most important symbols in the Peruvian archaeological city.

Morillas said, "Once these species penetrate the material through some kind of minor deterioration that has been forming, they attach themselves to the material itself so that they can feed off the minerals of the rock, gradually degrading it. As time passes, these micro-organisms can cause minor delamination that could result in the progressive loss of this rock."
